Re Substantial Performance
 Localized Balcony Repairs
 CAPREIT Limited Partnership
 270 Sheldon Ave, Toronto, Ontario
 Our Reference: CCC-242069-02

Field Observation Report # 10

Project:	Localized Balcony Repairs
Location:	270 Sheldon Ave, Toronto, Ontario
Our Reference:	CCC-242069-02
Date:	December 5, 2024
Type of Observations	Balcony railing refurbishment and concrete repairs
Locations Observed	East and South elevations
Total Pages:	5

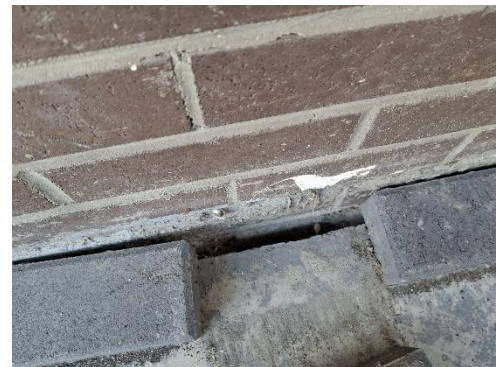
Unit 101 - Concrete floor slab separated from the wall creating gap. Tenant complains about rodent access. Contractor to seal gap with concrete. Contractor shall install caulking joint at wall-to-slab junction as per scope of work.

- a. View of concrete slab separation from wall in unit 101. Contractor shall install caulking joint at wall-to-slab junction as per scope of work.

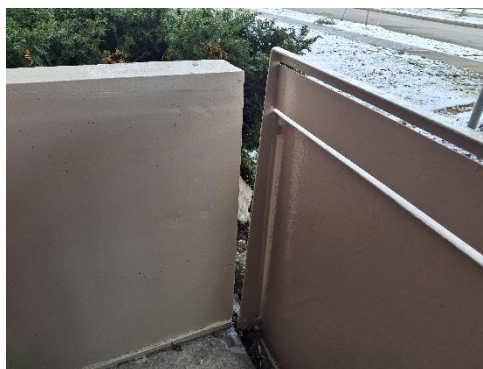
Unit 107 - Fix/bolt loose railing end to concrete knee wall to make it firmer.

- b. View of loose railing from concrete wall in unit 107.

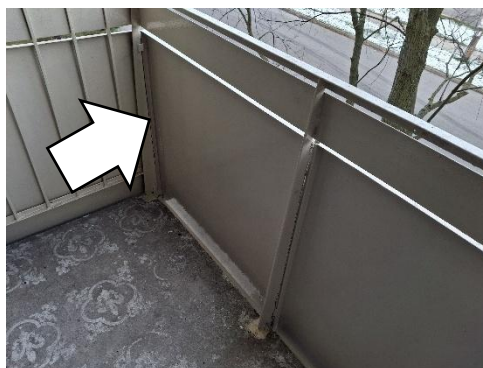
Unit 211 – Base of Left end panel needs one additional weld.

- c. Additional welding needed in unit 211 Left end panel.

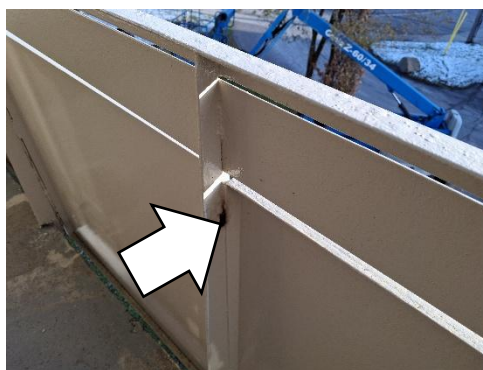
Unit 301 - Middle panel needs paint touch up.

- d. Painting touch up of welding joint in unit 301.

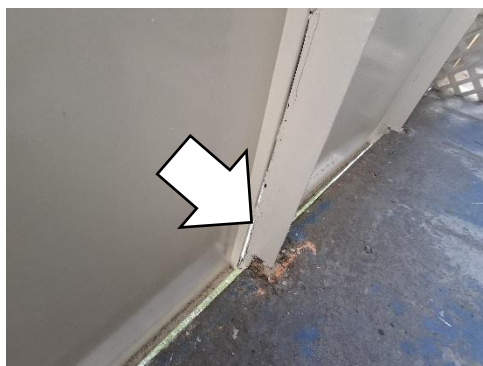
Unit 403 - Middle panel needs one additional welding joints at the base.

- e. Additional welding needed at base of middle panel of unit 403.

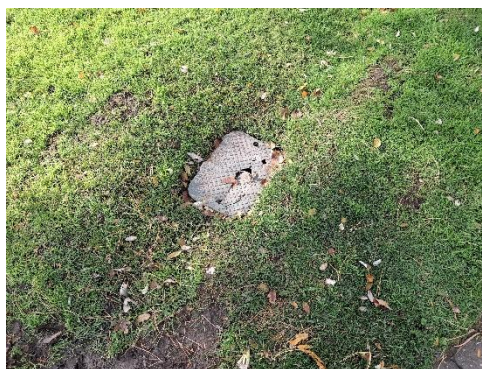
- f. View of cracked drain cover in lawn.

1. Clean debris and any garbage/construction waste on site. [Outstanding](#)
2. Replace areas of grass/sod (lawn) damaged by construction activities. [Outstanding](#)
3. Replace drain cover in lawn. [Outstanding](#)

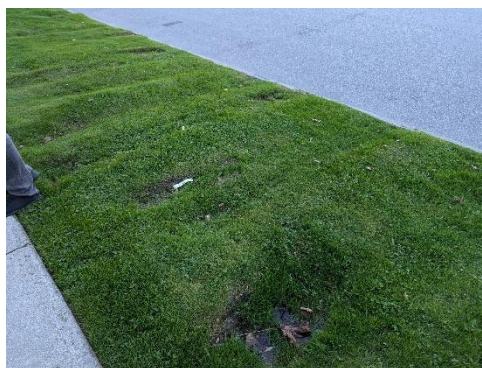
- g. Damaged grass/sod (lawn)

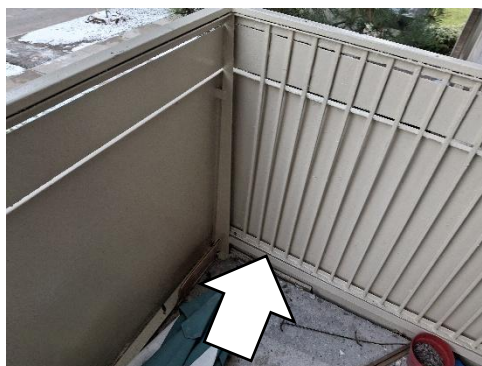
Unit 503 - Contractor to remove all remaining form board.

- h. Removed formboard at edge of concrete in unit 503.
