Re: Demolition and Heritage Preservation Services
500 Howard Street, Oshawa, Ontario, L1H 4Y8
Substantial Performance
Project No.: 20210777

FIELD REVIEW REPORT #37- Substantial Completion Walkthrough

Project Name: Demolition and Heritage Preservation Services

Location: 500 Howard Street, Oshawa, Ontario

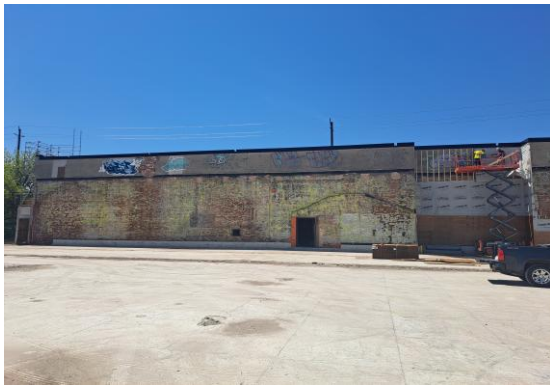
- .1 Installation of pressure treated plywood for weather proofing of part 1 building on the east side was underway, to be reviewed by Heritage Architect for further comments (Refer to Photo#1).
- .2 Site demobilization was ongoing, office trailer has been removed (Refer to photo#2).
- .3 Quote for anti-graffiti painting on the installed pressure treated plywood along east and north side of part 1 building is to be reviewed by Metrolinx for further instruction (Refer to photo#3).
- .4 Repair of damaged door for part 1 building was ongoing outside of site, to be reviewed by Heritage Architect for further comments.

Photo #1- Installation of pressure treated plywood for weather proofing of part 1 building on the east side was underway, to be reviewed by Heritage Architect for further comments.

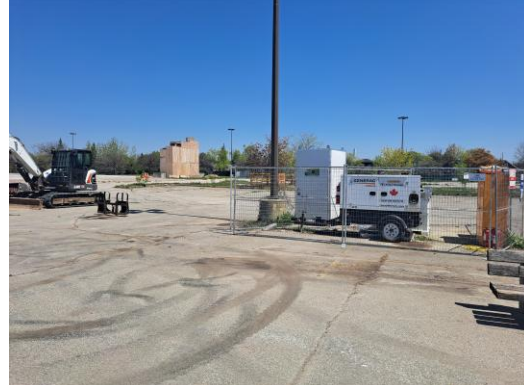
Photo #2- Site demobilization was ongoing, office trailer has been removed.

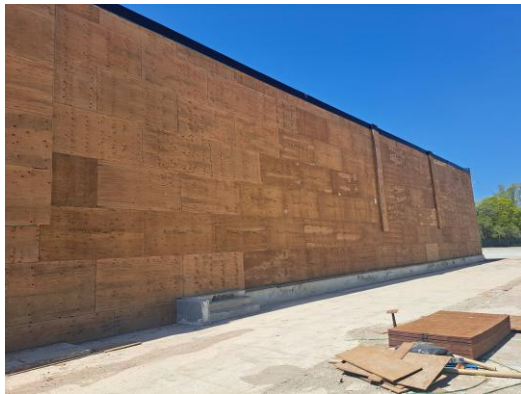
Photo #3- Quote for anti-graffiti painting on the installed pressure treated plywood along east and north side of part 1 building is to be reviewed by Metrolinx for further instruction.

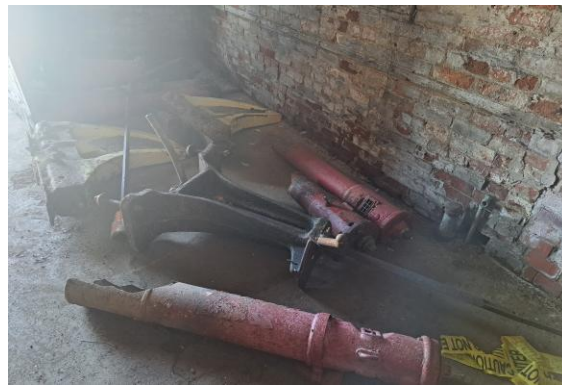
- .1 Fire hydrants and track stoppers adjacent to the building part 2 have been cut, removed and stored at part 1 building (Refer to photo#4).

Photo #4- Fire hydrants and track stoppers adjacent to the building part 2 have been cut, removed and stored at part 1 building.

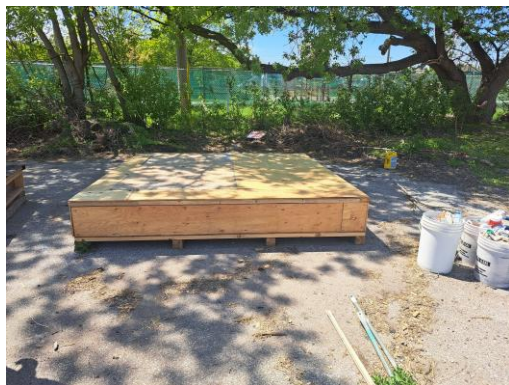
- .1 Waterproofing membrane at top of Mosaic Knob Hill Farm Logo skid was not installed, to be reviewed by Heritage Architect for further comments (Refer to photo#5)

Photo #5- Waterproofing membrane at top of Mosaic Knob Hill Farm Logo skid was not installed, to be reviewed by Heritage Architect for further comments

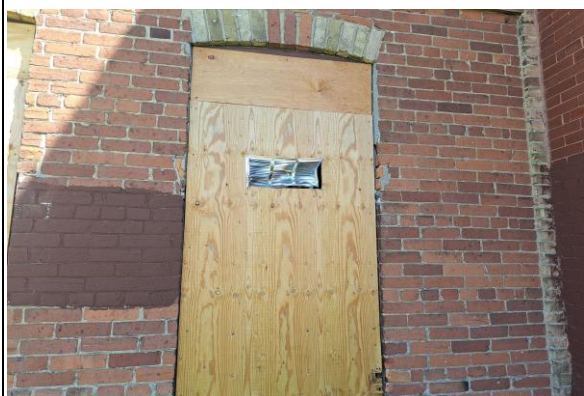
Photo #6- One damaged louvered vent in the plywood on the west side of part 1 building is to be removed and replaced.

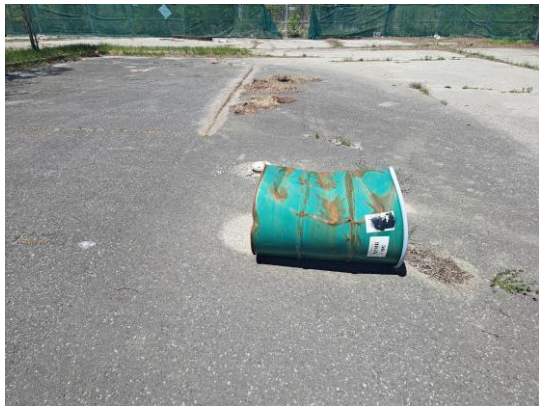
Photo #7- All debris and barrels inside the property are to be removed and disposed.

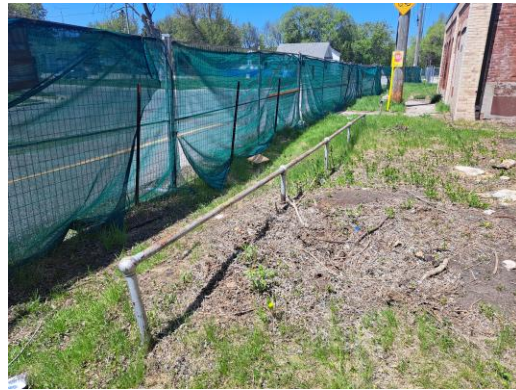
Photo #8- Short railings along the west side of part 1 are to be cut, removed and disposed.

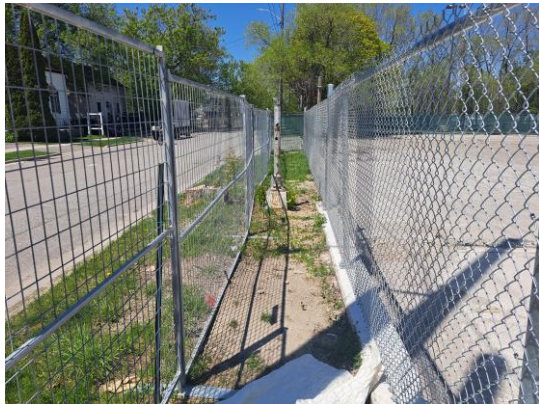
Photo #9- Existing post including footing along the northwest side of entrance gate is to be removed and disposed.

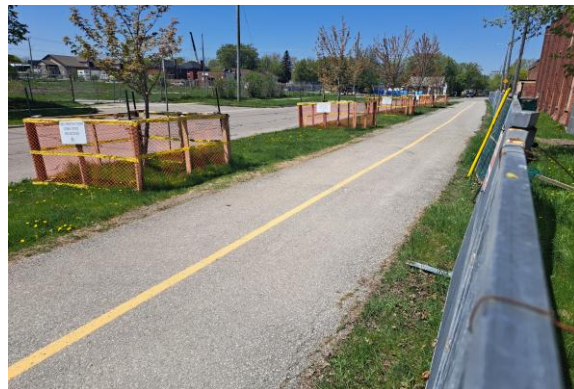
- .6 Tree protection fences along the west side of part 1 building are to be removed and tree protection fences inside the property are to be remained and kept (Refer to photo#10)

Photo #10- Tree protection fences along the west side of part 1 building are to be removed and tree protection fences inside the property are to be remained and kept.

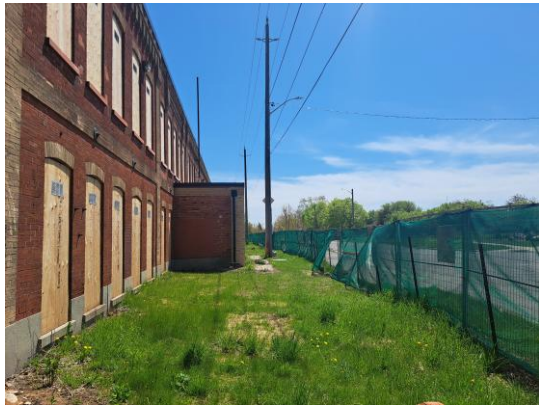
Photo #11- Temporary fast fences and green mesh around the property are to be removed.

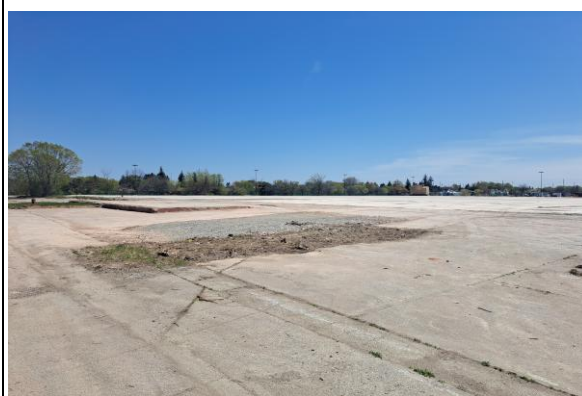
Photo #12- Existing pipe above ground along the north side part 2 building is to be cut and removed.
