SITE VISIT REPORT

Project Name:	TDSB Northlea PS Screen Cladding Replacement	SVR #:	Substantial
Project Number:	1213237	Date of Visit:	September 9, 2022
Project Address:	305 Rumsey Road Toronto, ON	Client:	TDSB
		Contractor:	Duron Ltd.

Stage of Construction: Substantial Completion

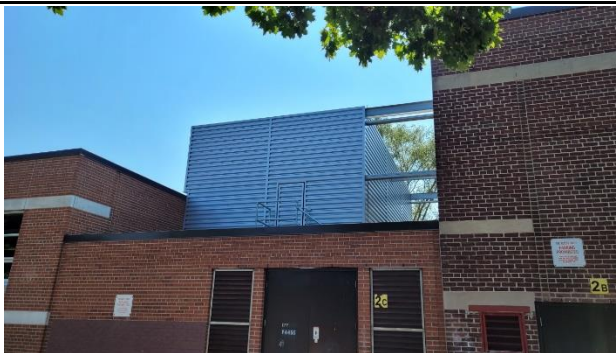
- Contractors were observed to have installed the acoustic screen. The north, west, and south sides of the acoustic screen were found to be installed with insulation. The east side was observed to be installed with the metal screen only. The metal siding were observed to be free of scratches and dents. All corner trim work and flashing were found to be installed in good condition. Work was found to be acceptable.

Photo 1: The acoustic screen was observed to be installed completely. Work was found to be acceptable.

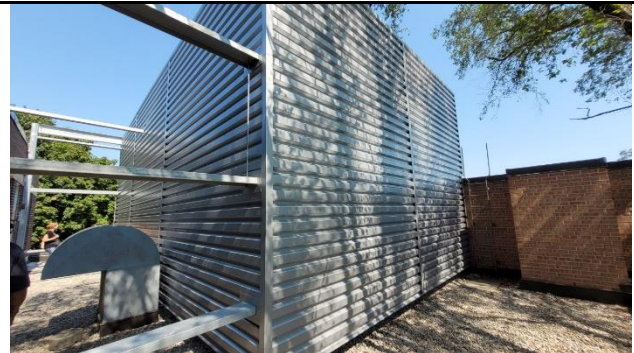
Photo 2: Trim work around corners were found to be installed. Work was found to be acceptable.

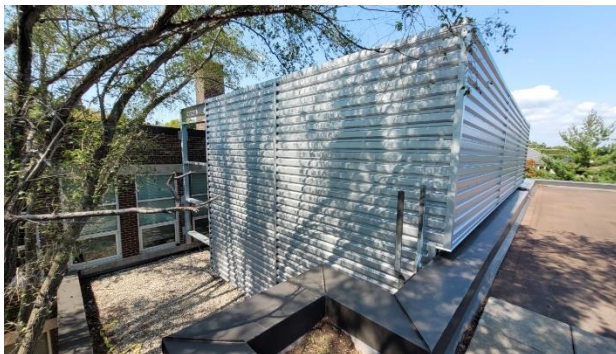
Photo 3: South elevation of the acoustic screen.

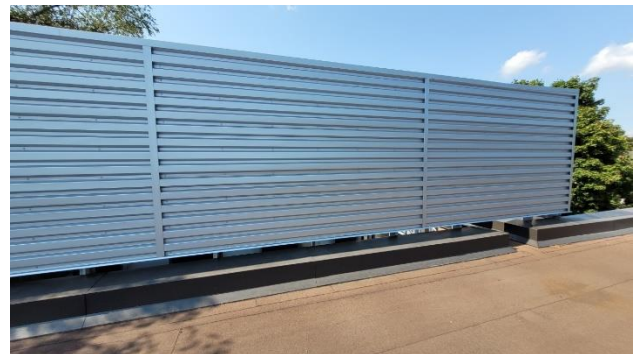
Photo 4: East elevation of the acoustic screen.

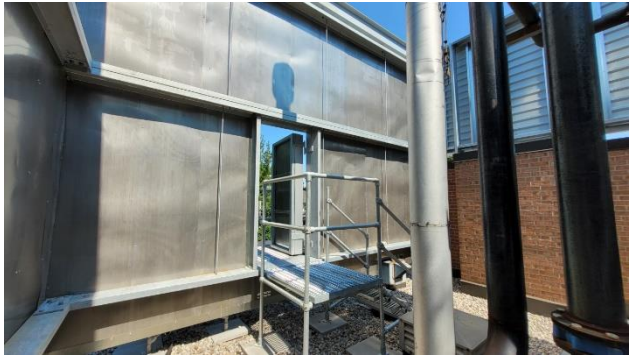
- The ballasted stair and door was observed to be installed. The ballasted stairs were observed to be installed on to pavers. The door was observed to be functional with a bolt lock. Work was found to be acceptable.

Photo 5: The ballasted stair and door were found to be installed. Work was found to be acceptable.

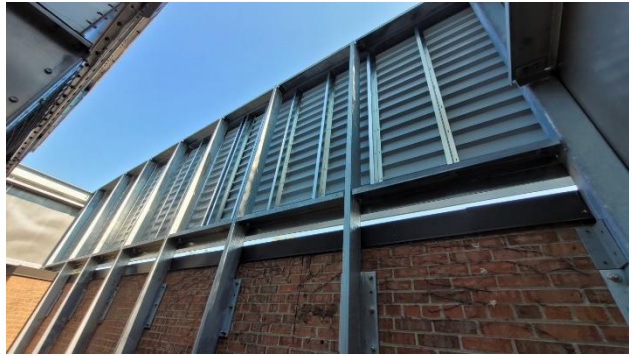
- Contractors were observed to be demobilized from site.
- Contractors were observed to have completed the installation of the steel framing. The steel framing was observed to be securely installed onto the roof and adjacent brick walls. Brick adjacent to the steel framing was found to be in good condition. Work was found to be acceptable.

Photo 6: Steel framing was found to be installed. No brick were found to be damaged. Work was found to be acceptable.

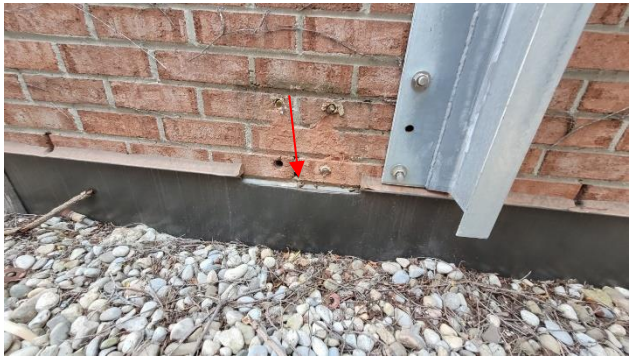
Photo 7: Contractor to caulk the top of the wall upturn metal flashing to ensure watertight seal.

- Contractor to apply sealant at the top of exposed base flashing at the wall upturn locations to prevent water from infiltrating the roof assembly.
- Contractor to infill voids leftover from the removal of the existing steel framing with sealant to prevent water infiltration into the wall assembly.
- Contractor to seal the parapet flashing to steel column junction to prevent water from infiltrating the roof assembly.
- Contractor to grind the ends of the fasteners to create a blunt end to prevent potential injuries from contact with the ends.

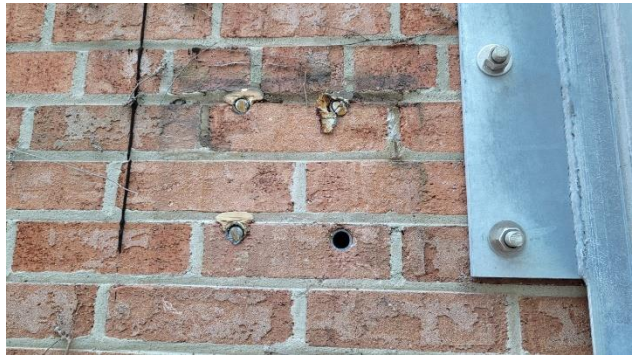
Photo 8: Contractor to infill voids leftover from existing steel framing removal with sealant.

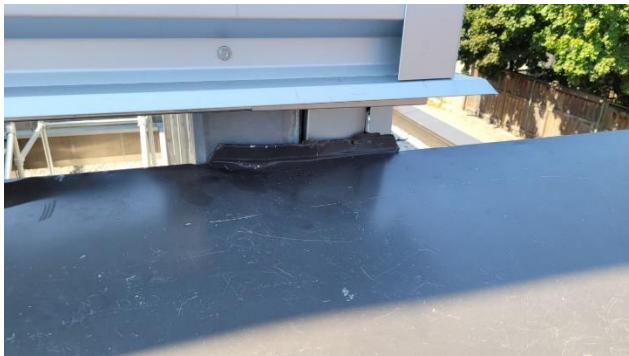
Photo 9: Contractor to apply sealant at parapet cap flashing to steel framing junction.

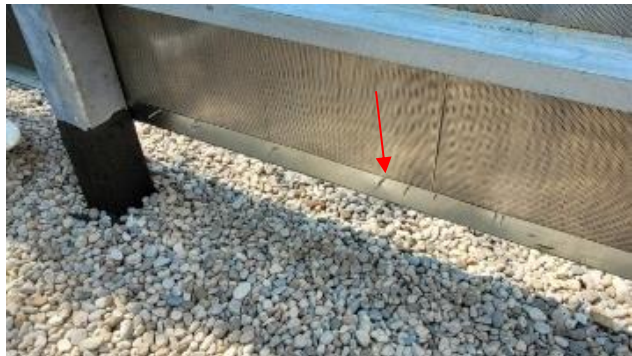
Photo 10: Contractor to grind the ends of the fasteners to create a blunt end.
