**CERTIFICATE OF SUBSTANTIAL PERFORMANCE
OF THE CONTRACT UNDER SECTION 32 OF THE ACT**
Construction Act

Hydro One Remote Communities Inc. Works Compound
Wunnumin Lake, ON

SCHEDULE A REMAINING WORK

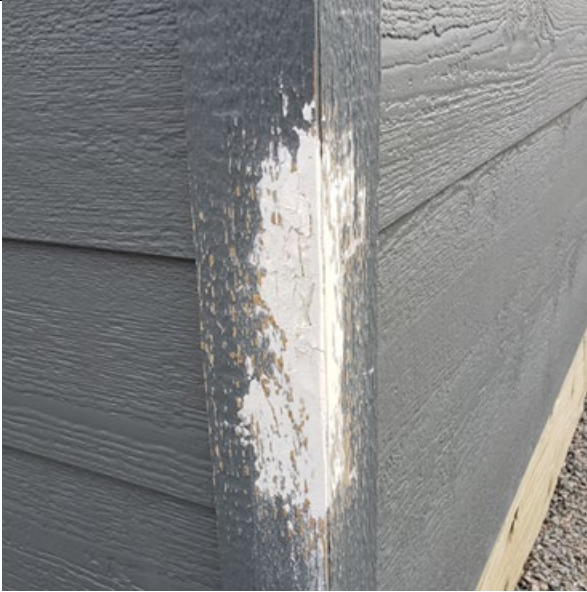
Description	Photo	Deficiency Cost
Mobilization Cost to Correct Deficiencies		\$20,000
High level alarm in holding tank requires new part.		\$1,000
Siding corner trim on staff house requires paint. Various other areas noted as well.

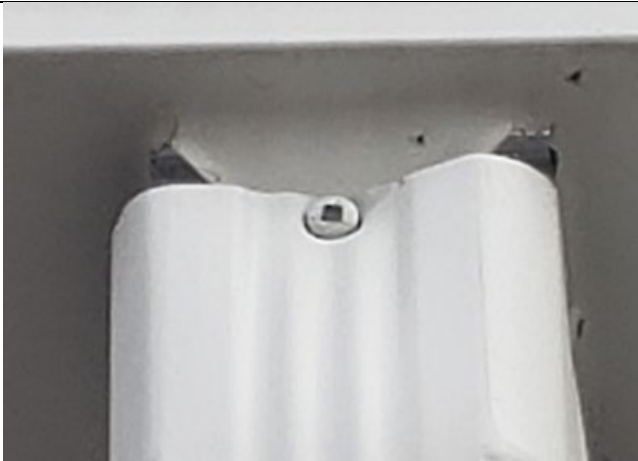
\$200
Downspout has gaps at eavestrough connection.

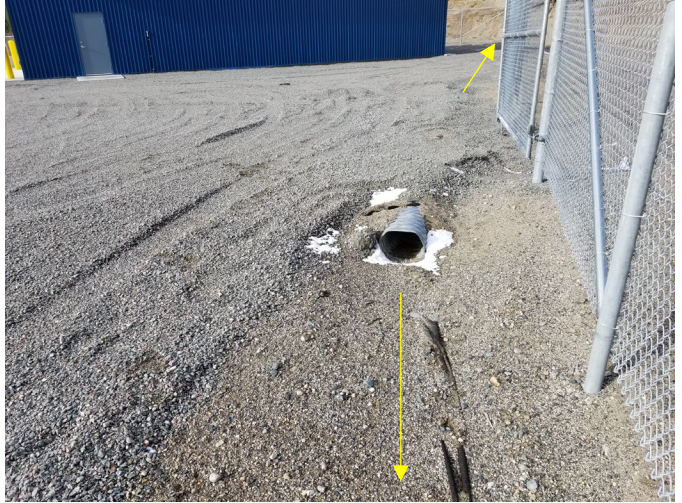
Description	Photo	Deficiency Cost
Perimeter drainage swale not installed. The culvert at east fence line gate.

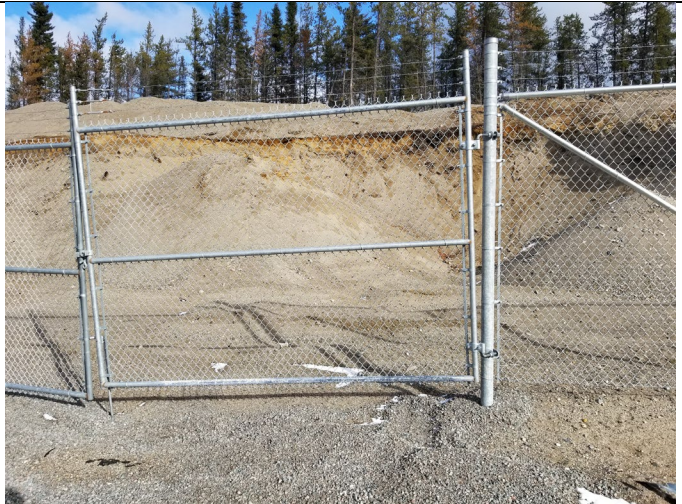
\$2,000
The gate at the east fence line is to be re-aligned.

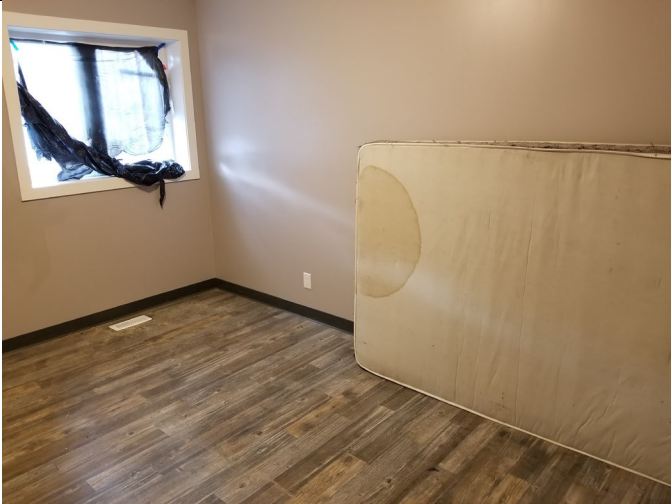
Description	Photo	Deficiency Cost
Complete deep cleaning of all rooms in each building including removal of all unrelated items

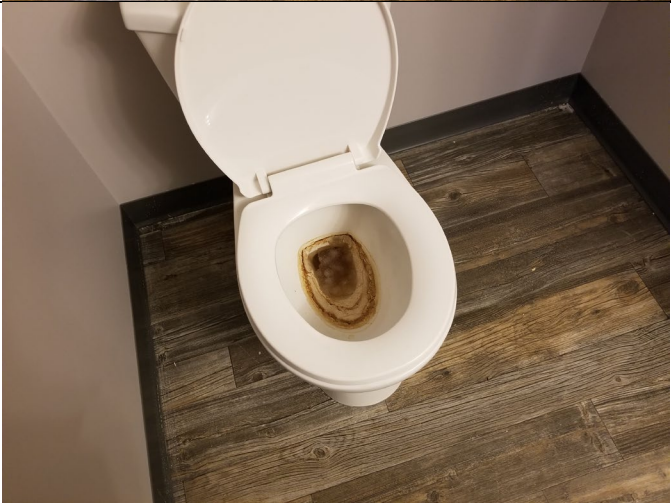
\$2,500
Clean both washrooms, toilet bowls, shower, vanity and floors
