RE: 2105 - 1080474 – ENVELOPE UPGRADES, 135 St. Clair Ave. West, Toronto
CERTIFICATION OF PARTIAL SUBSTANTIAL PERFORMANCE OF THE PROJECT
Ground Floor Interior Space and 2nd Floor Tenant Space

**Re: Envelope Upgrades (MOE Headquarters Ground Floor)
135 St. Clair Avenue West, Toronto**

DEFICIENCY LIST #1
Site Visit: May 25, 2023

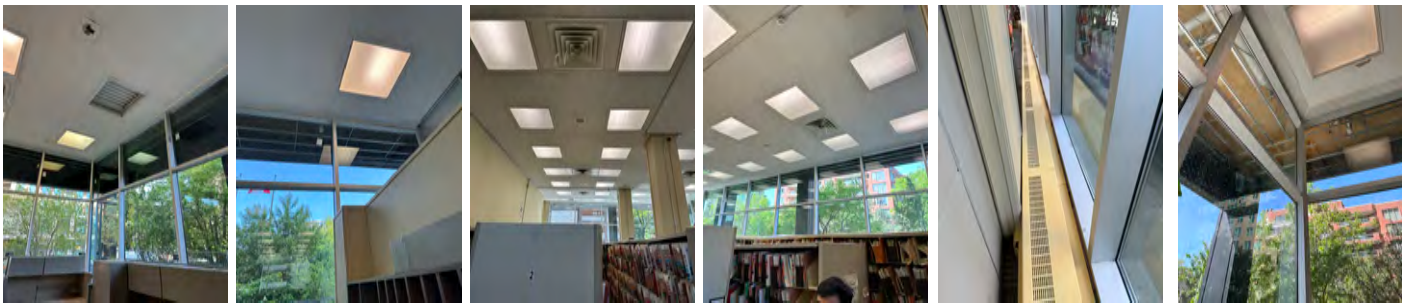
Photo 1-2: Interior flashing covering the 6" gap that was formed to expose access to the curtain wall is now complete.

Photo 3-4: Interior lighting fixtures have been completed.

Photo 5: Gap between Radiator and new curtain wall to be filled. GC has offered to provide a closure strip to fill the irregular gap along the perimeter (typical).

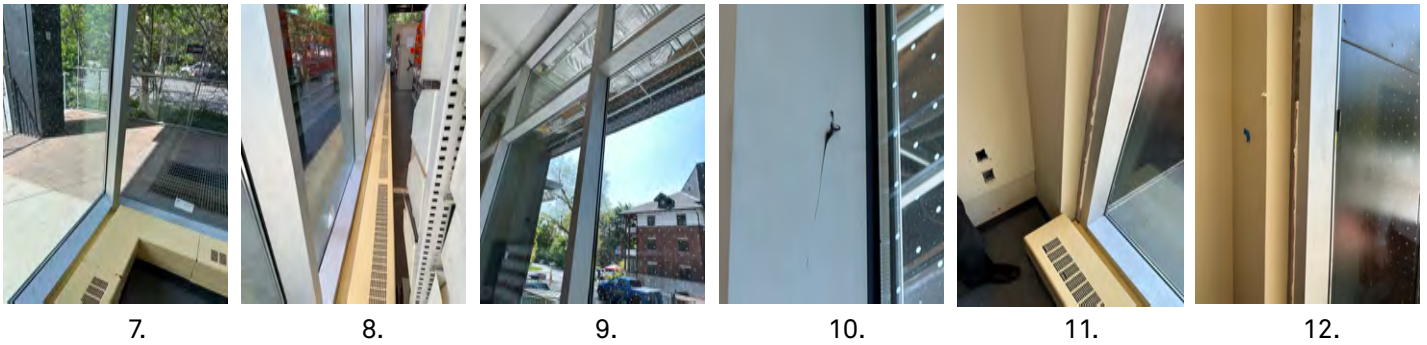
GROUND FLOOR/WEST SIDE/REAR:

Photo 7-10: GC to clean glass and curtain wall frames of all excess glues, caulking, and labels.
Photo 11-12: GC to provide missing wall plate covers. Also, foam insulation to be trimmed and cleaned. Aluminum trim to be provided to cover vertical gap as shown (bottom to top of curtain wall).

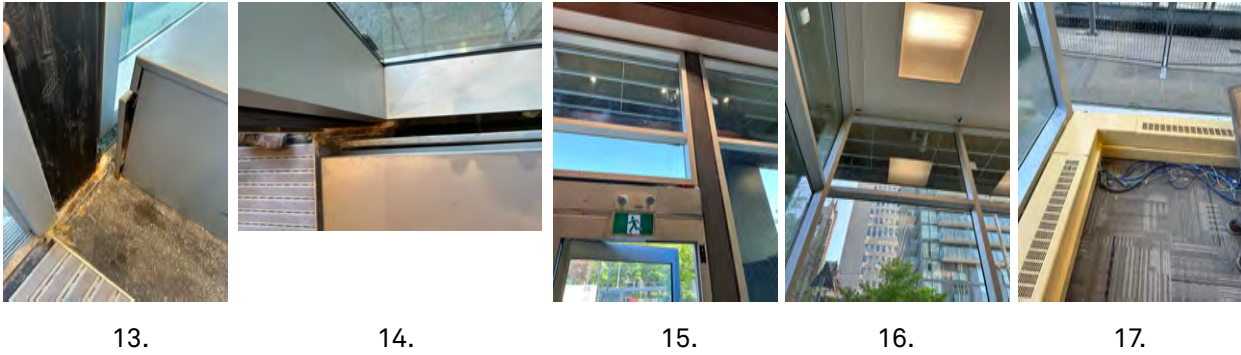
GROUND FLOOR FRONT FOYER:

Photo 13: GC to provide missing interior vertical trim to steel column (black) at Front Foyer.
Photo 14: GC to provide base trim to interior side of curtain wall between curtain wall and floor rads at Front Foyer.
Photo 15: GC to provide missing interior vertical trim to steel column (black) up to ceiling at Front Foyer.

Photo 16: GC to complete installation of power operated window blinds. Various stickers on glass to be cleaned.
Photo 17-18: GC to clean various stickers on glass and general cleaning/vacuuming.

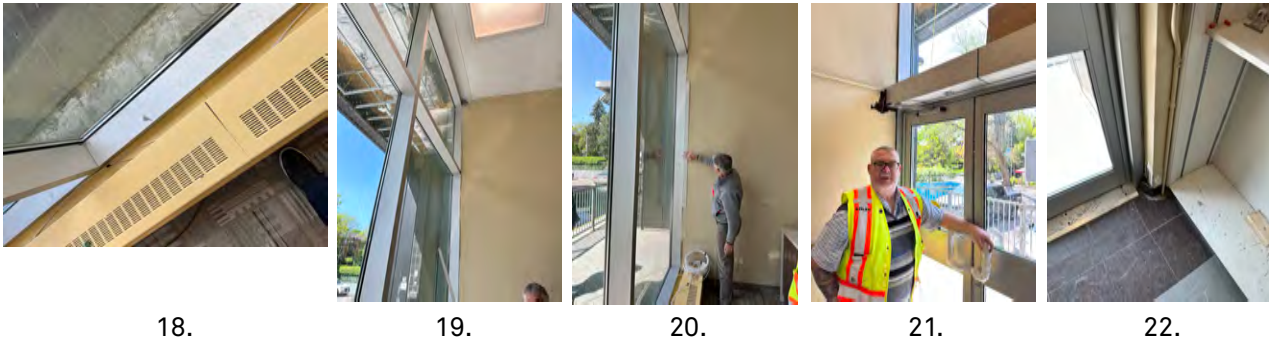
GROUND FLOOR EAST SIDE (REAR):

Photo 19-20: Existing wall, as shown, appears that it got wet and drywall was blemished. GC to cover gap (approx. 3”) with aluminum angle from top to bottom of curtain wall.
Photo 21-22: GC to replace exterior doors as shown with proper sized doors (as per contract). Miscellaneous gypsum board filling and patching to be completed at head of door and door operator and at base of door and floor (photo 22).
