Re. Substantial Performance Application – 3100 Mainway Industrial Building

Contractor's Deficiency List

Deficiency Review Report

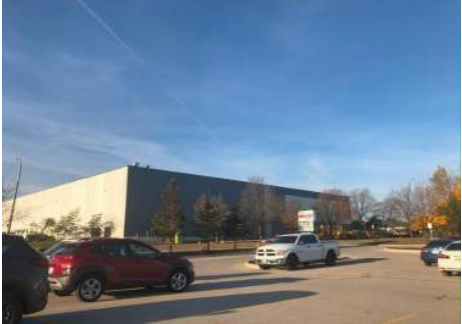
<p>Photo 1 View looking West at East side of site from across street. Pump room HVAC hoods installed & visible from across the street.</p>

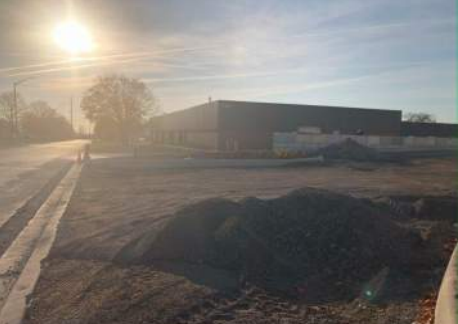
<p>Photo 2 View looking South along East wall. Curbs installed and granular compacted for Base-coat.</p>

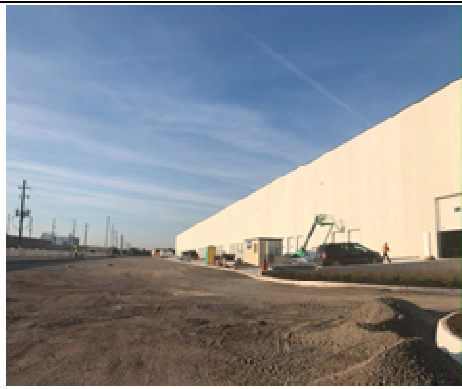
<p>Photo 3 View looking at West into truck court. Apron pour complete. Trailer demobilised and grading has begun prior to asphalt. Complete dock door painting & bollard installation.</p>

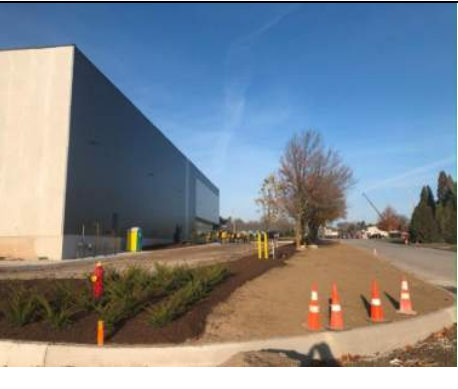
Item #	Deficiencies Noted:	Contractor:	Date Issued:	Estimated Cost	Issued	Status:	Pictures
GPA Deficiency List (Architectural)							
Item 1.0	View of SE corner facing North re status of landscaping, curbs and street connection. Parapet cap flashing & tie-in to be completed.	Alliance	16-Nov-23		20-Nov-23	Closed	Refer to Photo 4

<p>Photo 4 View of SE corner facing North re status of landscaping, curbs and street connection. Parapet cap flashing & tie-in to be completed.</p>

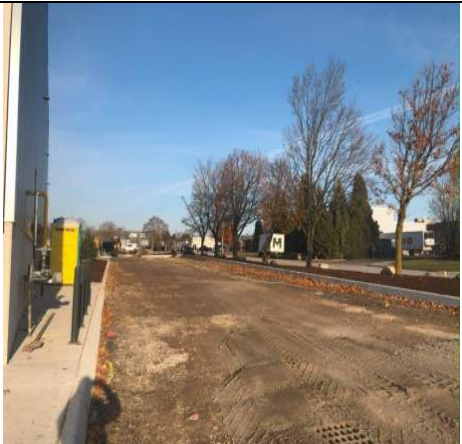
<p>Photo 5 View from SE corner facing North re status of car parking area & of landscaping, curbs etc. Fure route & service room signage to be installed.</p>

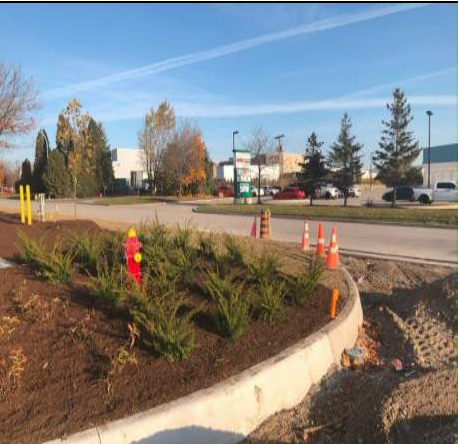
<p>Photo 6 View of SE corner facing East re status of landscaping, curbs and street connection.</p>

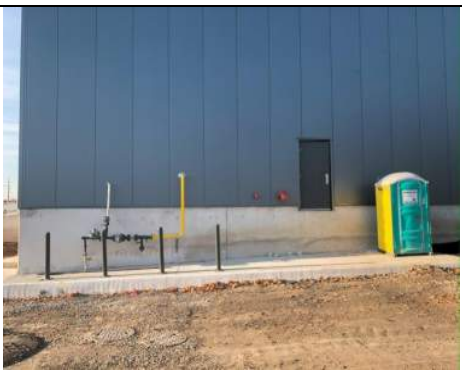
<p>Photo 7 View of SE corner on East side. See notes below regarding stair access, sealant and Unistrut. Bollards to be re-installed vertically.</p>

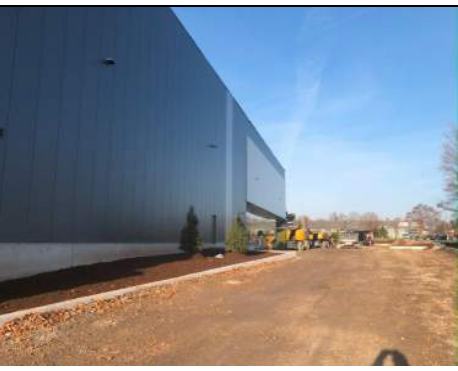
<p>Photo 8 View of NE corner on East side of building. Landscaping, EV chargers, Sidewalk and bollards installed.</p>

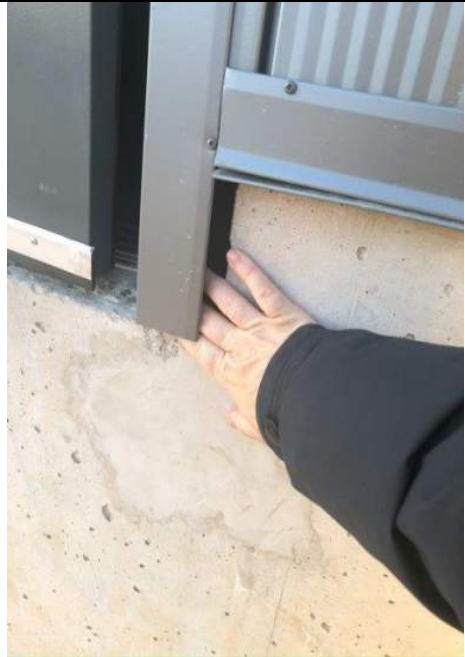
<p>Photo 9 Exit door on East Elevation. Confirm how this will be insulated & sealed weather/rodent tight.</p> <p>Ensure gap is fully insulated, weather tight & foam-in-place insulation is not exposed.</p> <p>See Photo as well for other side of door.</p>

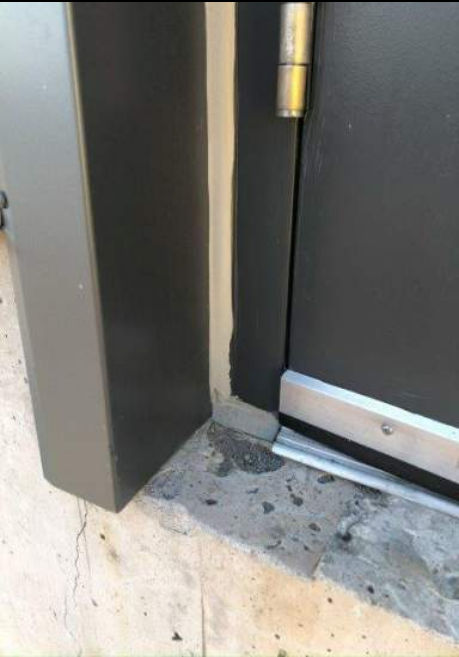
<p>Photo 10 WIP of painting at door on right, sealant & IMP flashing on left.</p> <p>Complete painting. Ensure threshold is set in full bed of sealant and frame, threshold & flashing are caulked weather tight.</p>

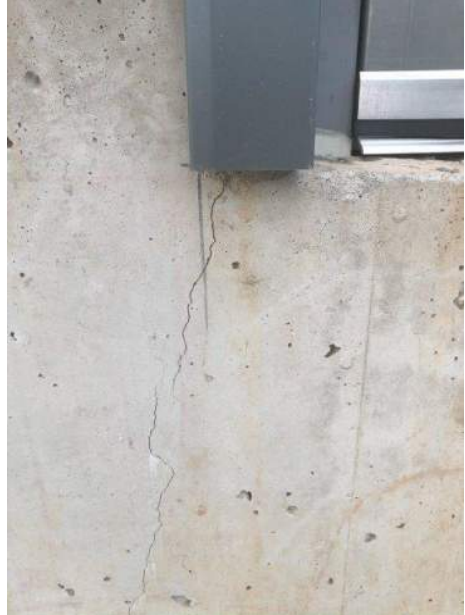
<p>Photo 11 Exit door on East Elevation. Confirm how this will be insulated & sealed weather/rodent tight.</p>

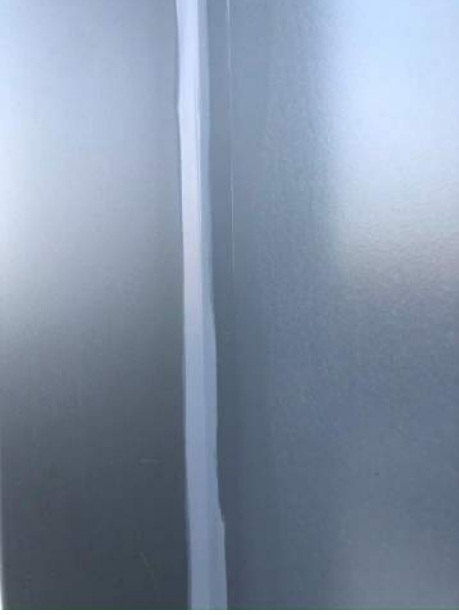
<p>Photo 12 WIP of painting at door on right, sealant & IMP flashing on left.</p> <p>Complete painting.</p>

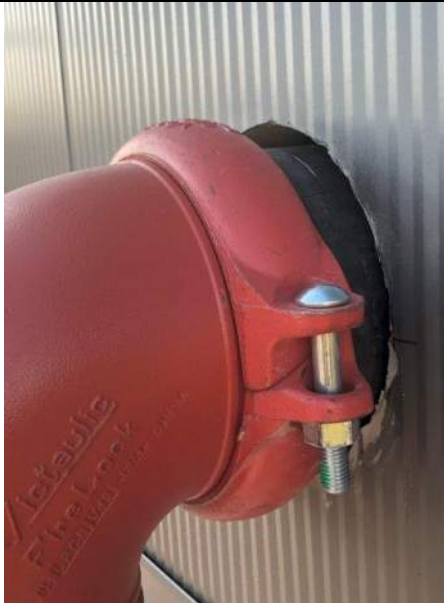
<p>Photo 13 Sprinkler pipe penetration to be fully sealed and insulated from both interior and exterior. Clean IMP of all marks and debris.</p>

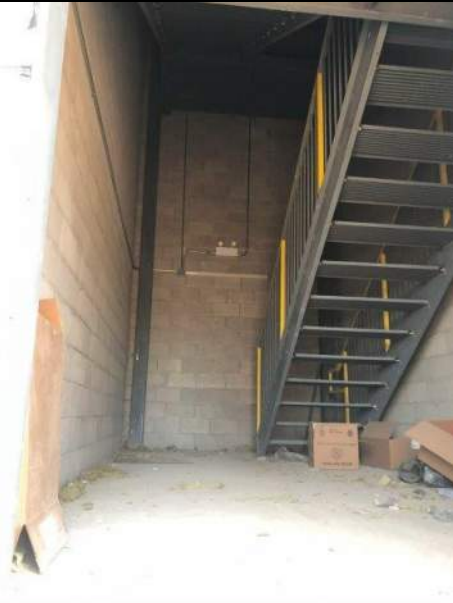
<p>Photo 14 View into roof access stairwell as seen from outside. Provide exterior stari & complete painting, and cleaning within.</p>

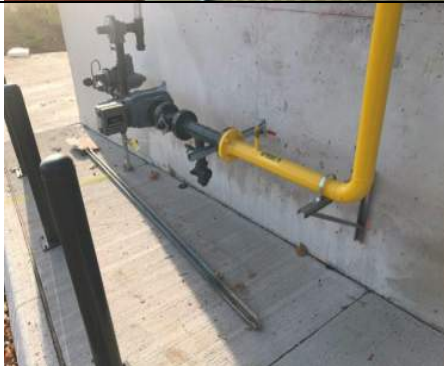
<p>Photo 15 Gas meter & bollards installed at SE corner. Unistrut projecting into walkway is sharp & could be reduced in length.</p>

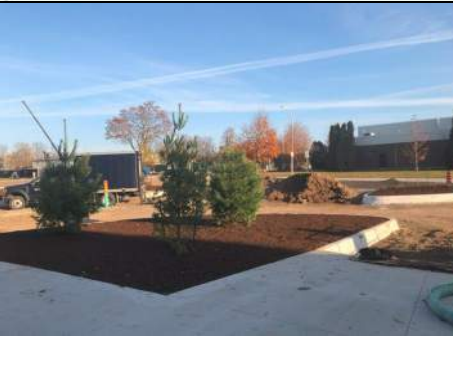
<p>Photo 16 Landscaped island status at NE office corner looking towards street entrance beyond.</p>

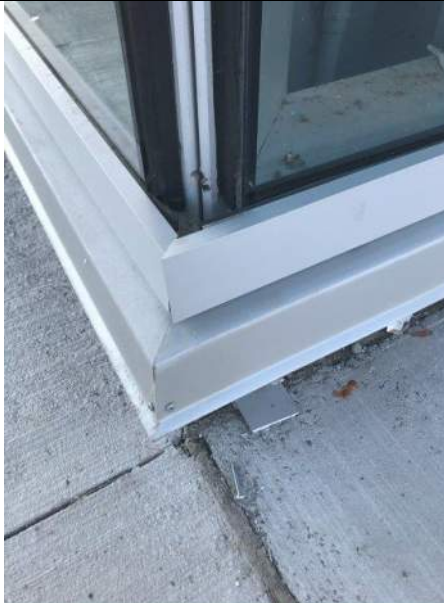
Item 11.0	Loose mullion cap & incomplete sealant application at NE office corner. Ensure mullions are tight & square to envelope.	OGW	16-Nov-23		20-Nov-23	Closed	Refer to Photo 17

<p>Photo 17 Loose mullion cap & incomplete sealant application at NE office corner. Ensure mullions are tight & square to envelope.</p>

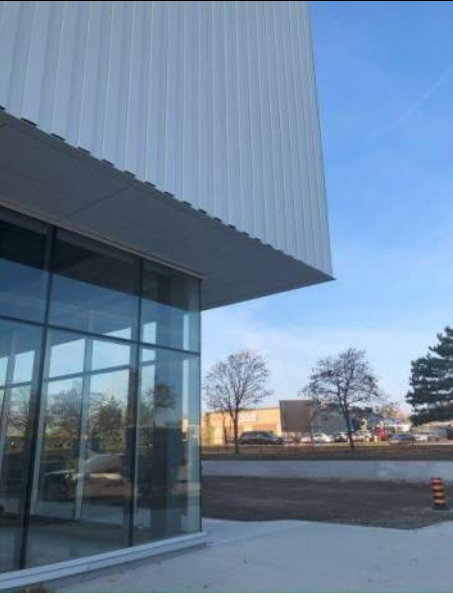
<p>Photo 18 Base of Morin siding in East wall appears to be uneven from panel to panel. Review when final flashing is installed.</p>

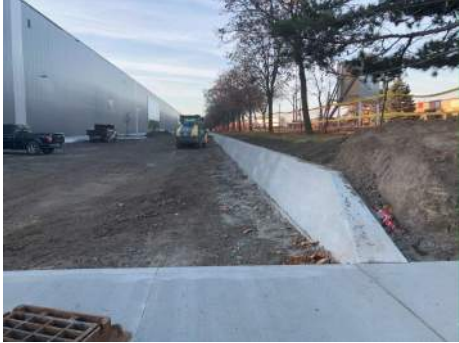
Item 13.0	View at NE corner looking West. Confirm final grades will not exceed 3:1 & civil and install guard where wall exceeds 600mm in height.	Gregor	16-Nov-23		20-Nov-23	Open	Refer to Photo 19 Not a Deficiency as it was not part of the building design and is and extra

<p>Photo 19 View at NE corner looking West. Confirm final grades will not exceed 3:1 & civil and install guard where wall exceeds 600mm in height.</p>

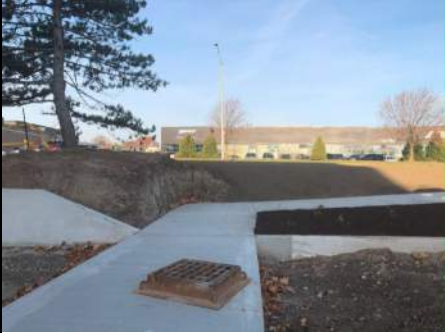
Item 14.0	What is final grading to be? Landscape & Civil consultants to confirm nearby tree has sufficient root for survival & that grades will not drain onto sidewalk.	Gregor	16-Nov-23		20-Nov-23	Open	Refer to Photo 20 Not a Deficiency as it was not part of the building design and is and extra

<p>Photo 20 What is final grading to be? Landscape & Civil consultants to confirm nearby tree has sufficient root for survival & that grades will not drain onto sidewalk.</p>

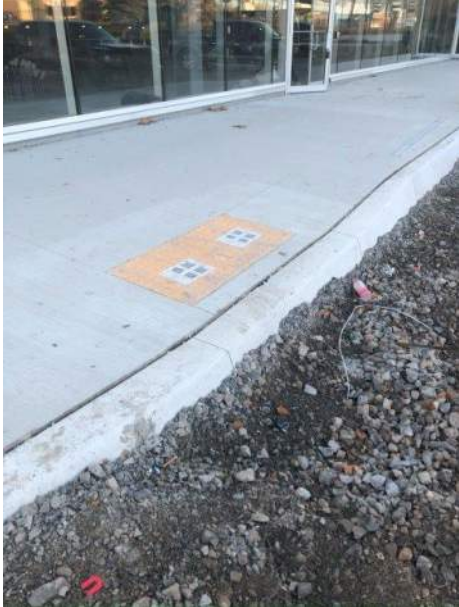
<p>Photo 21 Ensure asphalt meets curb elevation at barrier-free curb cuts & that final grading & compaction are complete and all debris is removed prior to asphalt placement.</p>

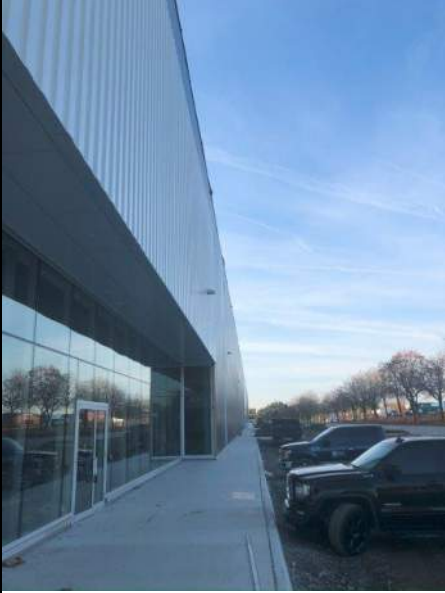
<p>Photo 22 View looking West at NE office area. Soffit & lighting installed.</p>

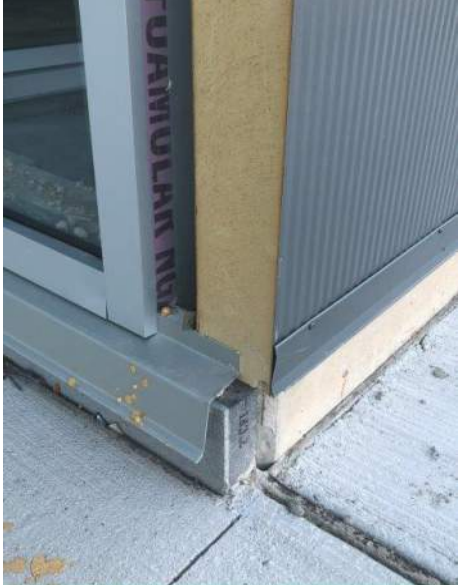
Item 16.0	WIP photo of typical IMP/ glazing corner. See previous months review for additional comments. On finish to insul. board on foundation and gap between glazing & IMP.	OGW/IPS	16-Nov-23		20-Nov-23	Closed	Refer to Photo 23

<p>Photo 23 WIP photo of typical IMP/ glazing corner. See previous months review for additional comments. On finish to insul. board on foundation and gap between glazing & IMP.</p>

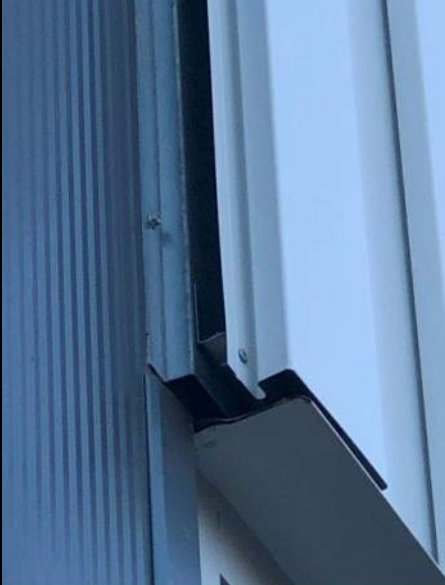
<p>Photo 24 View up from below of head flashing cut short of IMP cap flashing. Ensure this juncture is weather tight when completing flashing installation.</p>

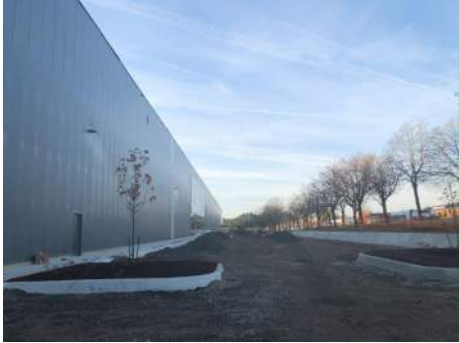
<p>Photo 25 Status View of looking West along North face and car parking area. Confirm IMP installation is per mfg. as there appears to be uneven condensation on IMP near joints and likely fastener locations.</p>

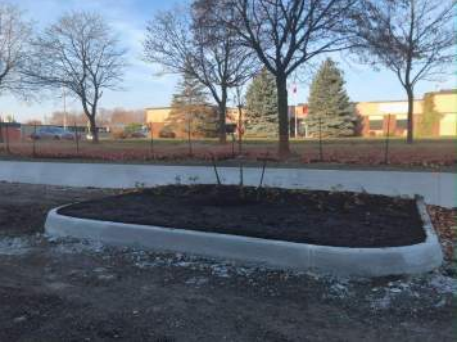
Item 19.0	Typical Northern most parking island and toe wall beyond. Coord with civil for review of extent of guard where finished height exceeds 600mm.	CCN to Be issued to Owner	16-Nov-23		20-Nov-23	Open	Refer to Photo 26 Not a Deficiency as it was not part of the building design and is and extra

<p>Photo 26 Typical Northern most parking island and toe wall beyond. Coord with civil for review of extent of guard where finished height exceeds 600mm.</p>

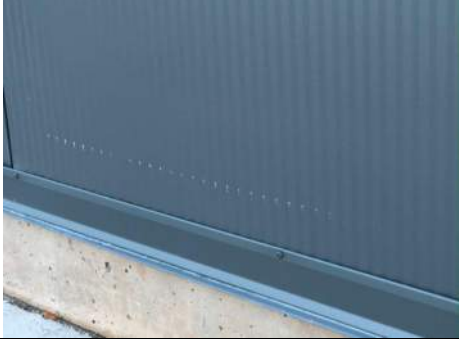
<p>Photo 27 Scratches on North wall. See notes on photo #28.</p>

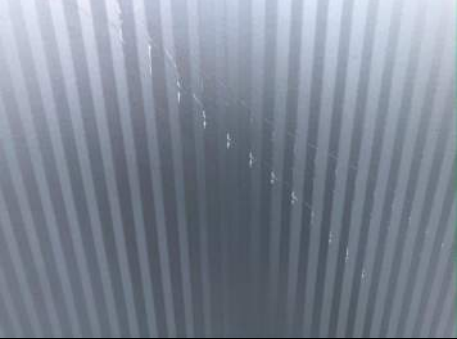
<p>Photo 28 Scratches on North wall above sidewalk to be remediated per mfg. instructions.</p>

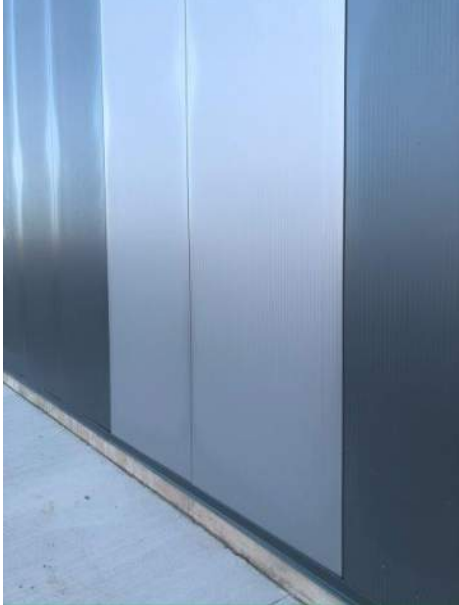
<p>Photo 29 North side looking East at granular placement. Confirm IMP installation per notes on photo #30.</p>

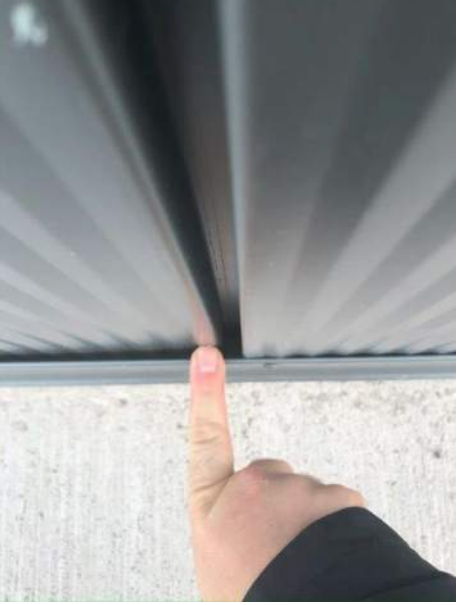
<p>Photo 30 Many IMP panels On North wall appear to have a tapered gap on fastener side. Please have mfg. confirm installation.</p>

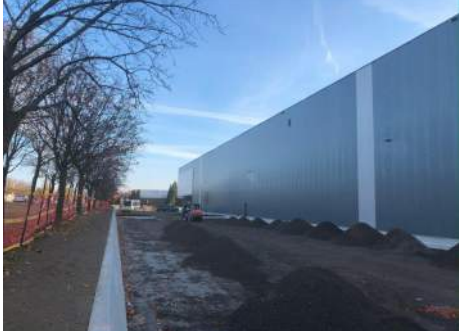
<p>Photo 31 North side looking East at granular placement. Confirm IMP installation per notes on photo #29 & 30.</p>

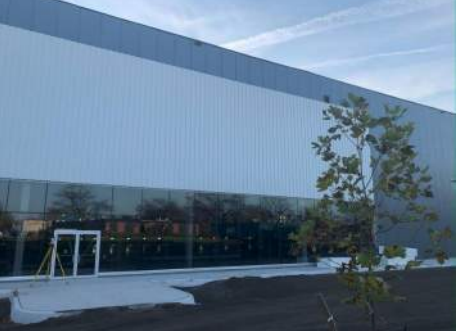
Item 25.0	View looking at central office area. Complete flashing on white siding & verify at louver install to ensure no envelope leaks.		16-Nov-23		20-Nov-23	Closed	Refer to Photo 32

<p>Photo 32 View looking at central office area. Complete flashing on white siding & verify at louver install to ensure no envelope leaks.</p>

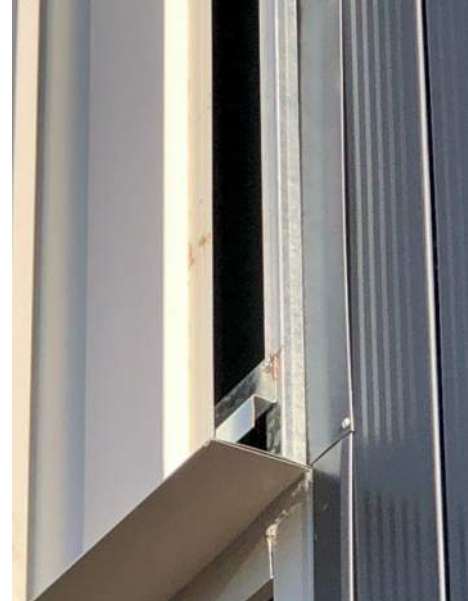
<p>Photo 40 View at typical flashing to be completed on edge of Morin siding. Ensure envelope drains properly. & all hat bars are fully concealed.</p>

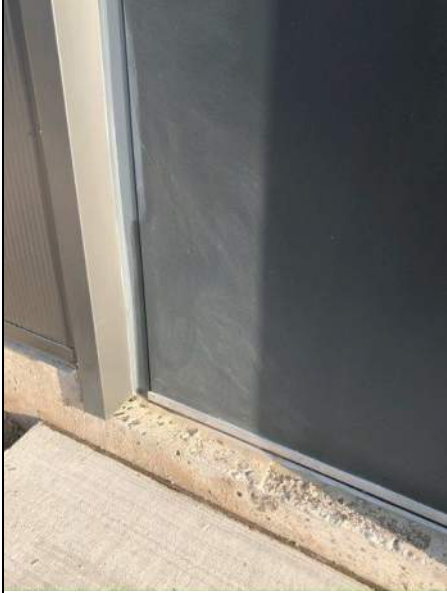
Item 28.0	West exit door painting & priming in progress. Northern-most door appears warped. Replace if damaged. Patch pitted cap wall.		16-Nov-23		20-Nov-23	Closed	Refer to Photo 41

<p>Photo 41 West exit door painting & priming in progress. Northern-most door appears warped. Replace if damaged. Patch pitted cap wall.</p>

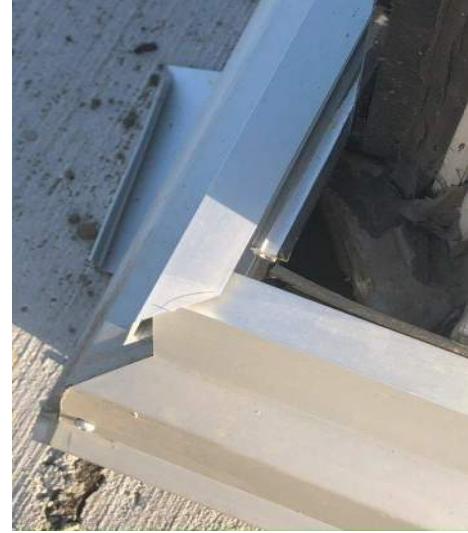
<p>Photo 42 View looking North at NW mullion and sealant installation status. Ensure all corners are tight & caps are installed square.</p>

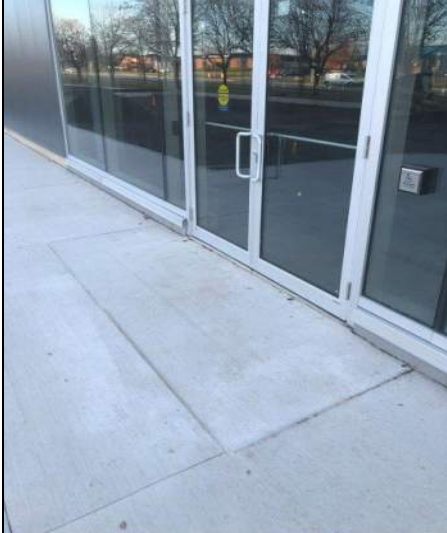
<p>Photo 43 View looking North at NW office entrance. Sidewalk poured around frost slab pad.</p>

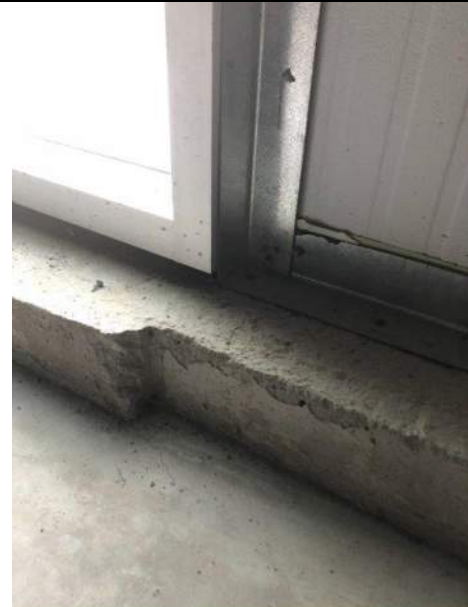
<p>Photo 44 Typical interface between IMP & curtainwall. Remove all excess membrane.</p> <p>There appears to be missing structure here. Confirm with structural & associated trades.</p> <p>Complete installation per details on A7.02.</p>

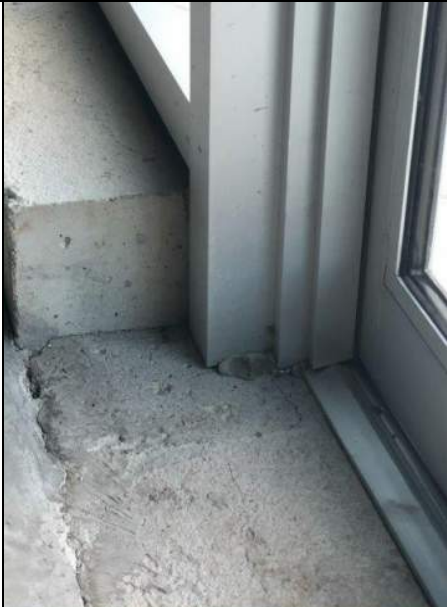
Item 30.0	Typical interface between IMP & curtainwall. Remove all excess membrane. There appears to be missing structure here. Confirm with structural & associated trades. Complete installation per details on A7.02.	OGW/IPS	16-Nov-23		20-Nov-23	Closed	Refer to Photo 45

<p>Photo 45 Typical entrance door, threshold & slab.</p> <p>Grind cap wall smooth to match floor. Ensure sill is set in full bed of sealant & mullions are insulated & sealed to concrete.</p> <p>Complete foam-in-place insulation and sealant around perimeter of curtain wall and entrance.</p>

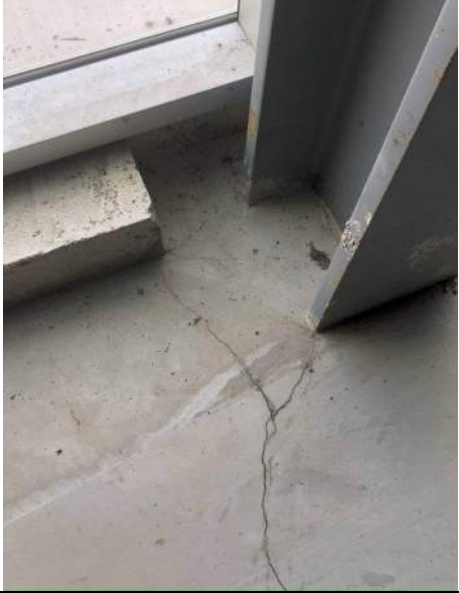
Item 32.0	Floor cracking at center office area to be reviewed by Struct Eng.& installer. Carried from previous review.	Metro	16-Nov-23		20-Nov-23	Closed	Refer to Photo 46

<p>Photo 46 Floor cracking at center office area to be reviewed by Struct Eng. & installer.</p> <p>Carried from previous review.</p>

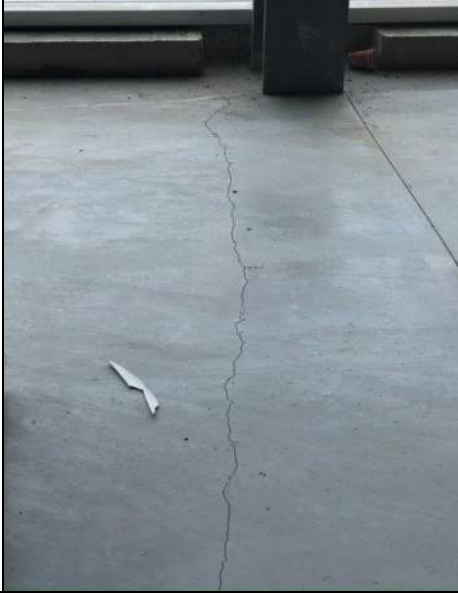
Item 33.0	Floor cracking at center office area telegraphs past first sawcut into building.Carried from previous review.	Metro	16-Nov-23		20-Nov-23	Closed	Refer to Photo 47

<p>Photo 47 Floor cracking at center office area telegraphs past first sawcut into building.</p> <p>Carried from previous review.</p>

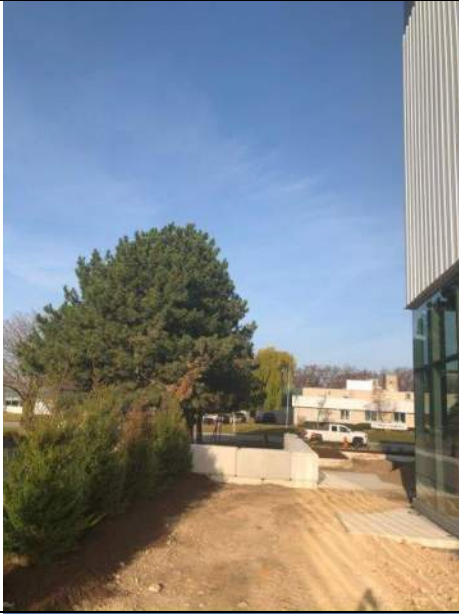
<p>Photo 48 West side status of Landscaping & concrete pads looking North. Complete landscaping & and guardrail.</p>

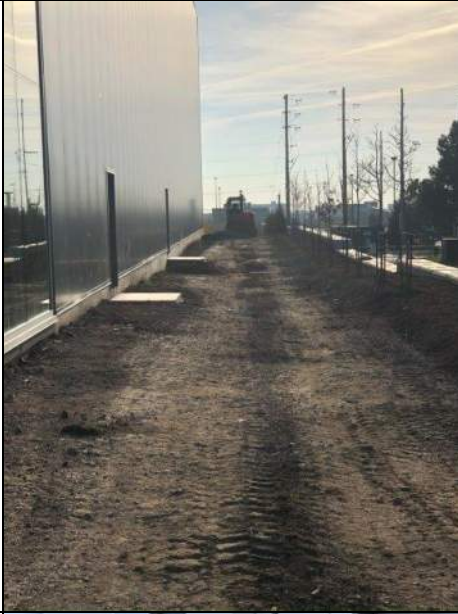
<p>Photo 49 West side status of Landscaping & concrete pads looking South. Complete landscaping & and guardrail.</p>

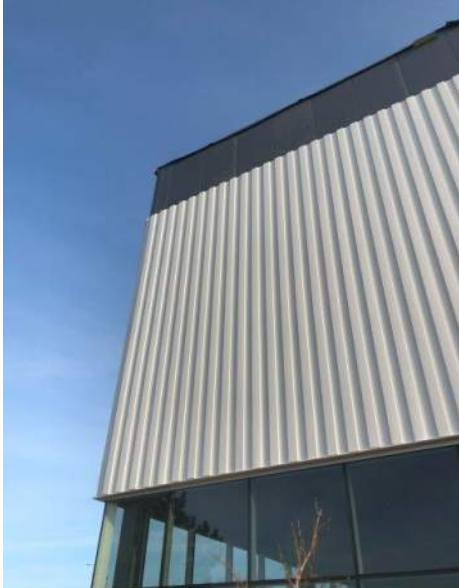
<p>Photo 50 View of NW office area looking East at Morin panel installation progress. Complete flashing and Parapet flashing as well. Clean debris on IMP.</p>

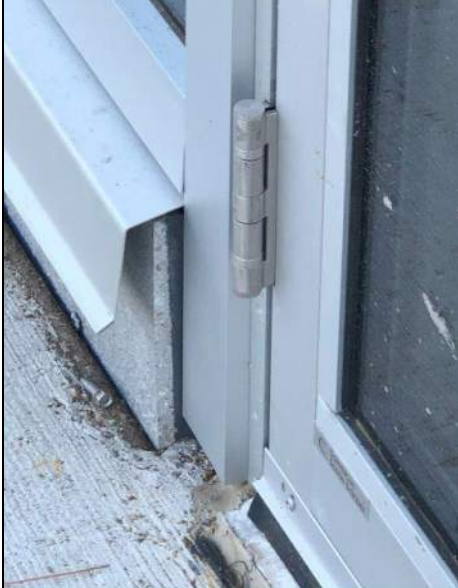
<p>Photo 51 View of NW office entrance looking at sill flashing & mullion-cap installation. Complete sealant and confirm how end of insulation board will be finished.</p>
