T1.New Maintenance Operations Center.Urgent
(Project Name)

Toronto Pearson Airport Terminal 1
(Street address or the location of the premises)

GTAA BMS OFFICE RENOVATION

SUBSTANTIAL COMPLETION SITE VISIT REPORT

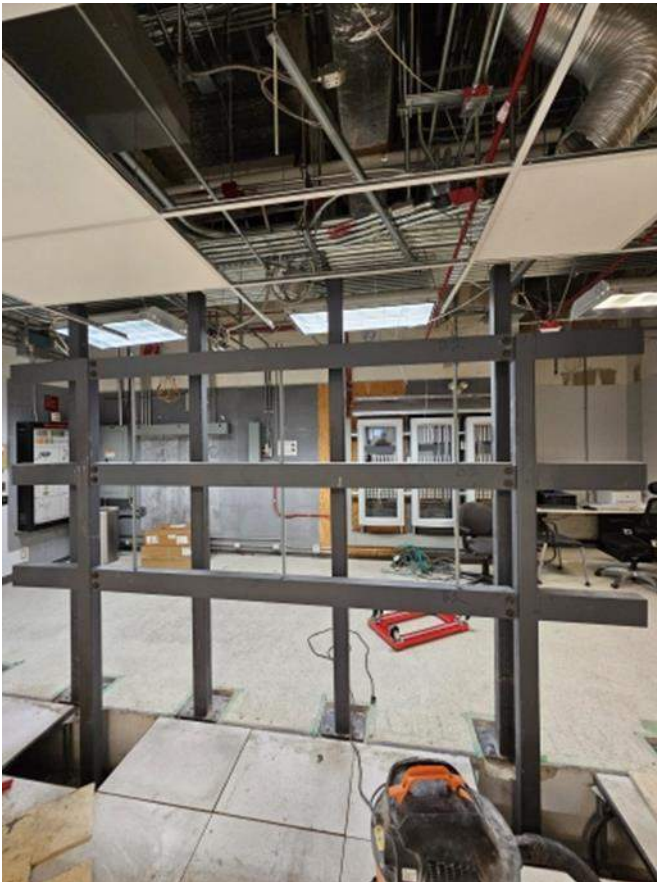
Figure 1 - Framework for Screen Monitor under Construction

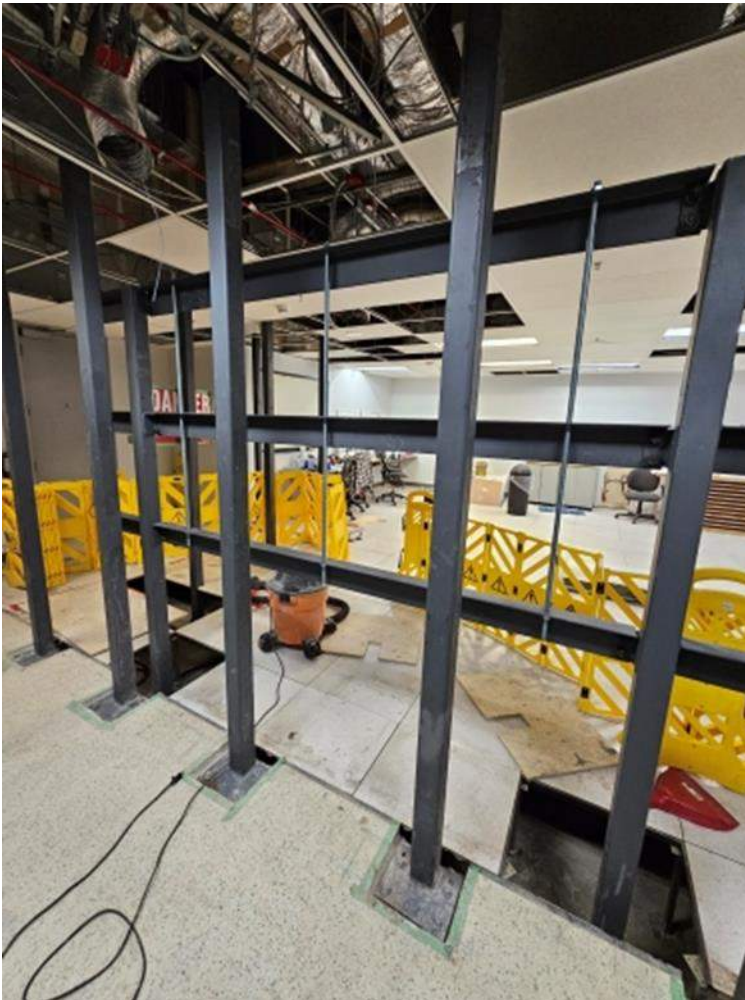
Figure 2 - Column Base Plates of Framework for Screen Monitor

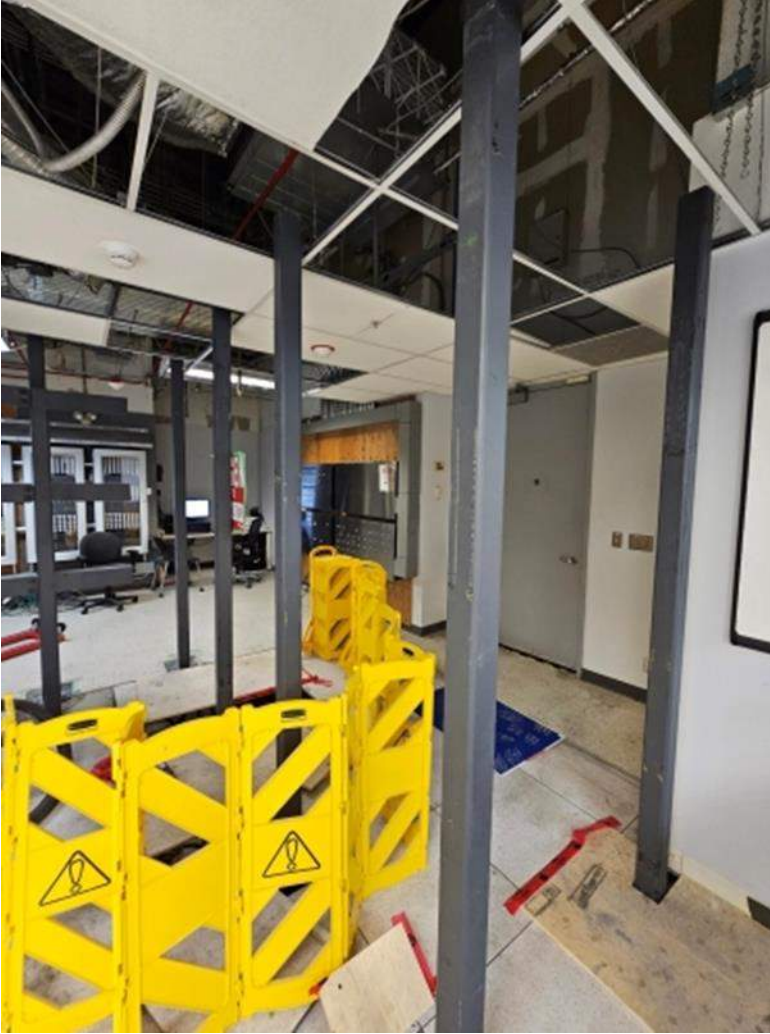
Figure 3 - Typical HSS 89x89x6.4 Columns of Framework for Screen Monitor

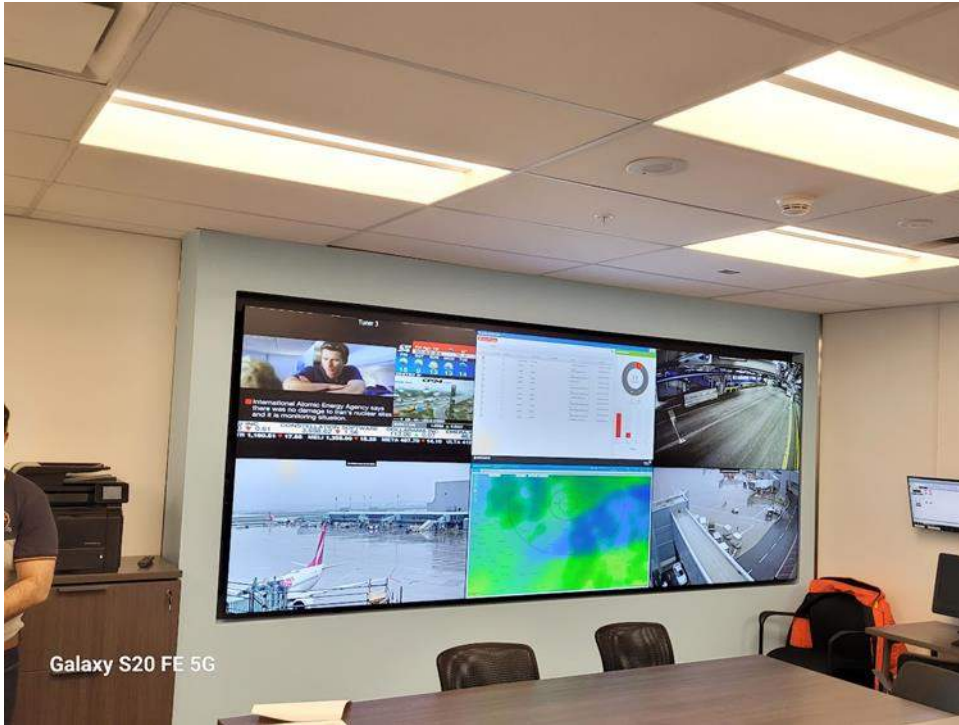
The monitor wall was not in conformance with the design. The CACF room had a missing fire-rated caulking tag/label at the ceiling mounted make-up air mount/threaded rod penetration through ceiling. Refer to site photos in deficiency list.

Figure 4 - Current Condition of Screen Monitor in BMS Office

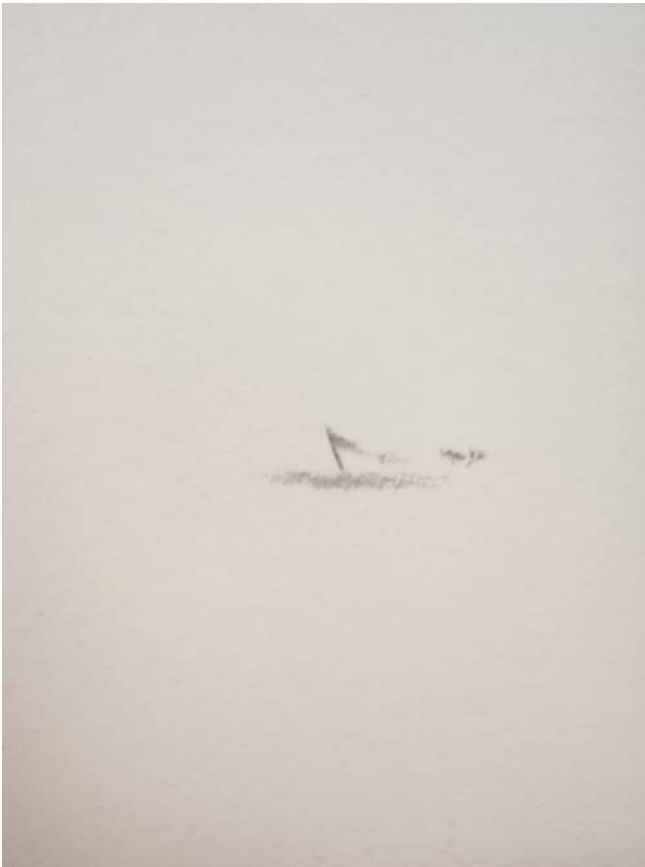
Few areas with scuff marks and slight damage to the GWB walls were noticed. A chair rail/wall trim should have been installed at locations where workstations are located to avoid future damage during use. Particularly, exposed wall corners were damaged; our suggestion is to install protective corner guards of a suitable size and material (N.I.C). Wall areas with scuff marks and other surface imperfections require paint touch-ups.

Figure 5 - Scuff marks / smudges on several walls.

Comments: Touch-up paint or clean marks on wall.

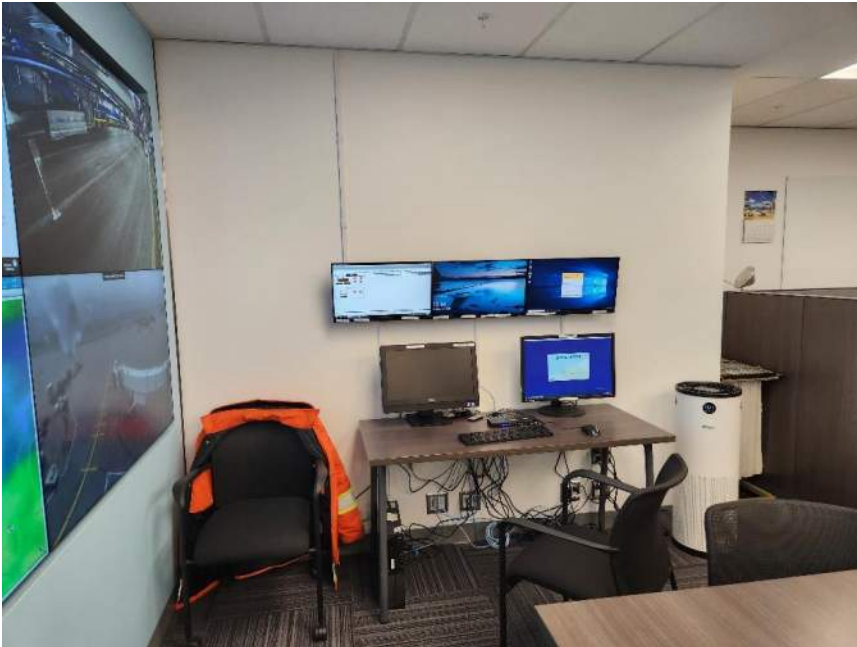
Figure 6 - View of monitor wall as-built condition at site.

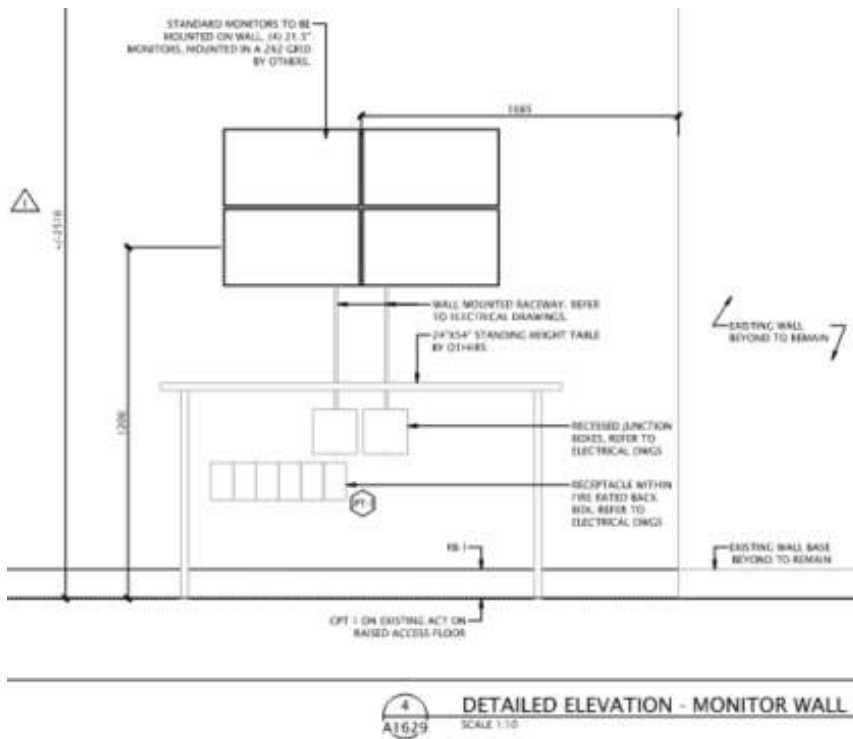
Figure 7 - Layout of monitor wall as designed appears to be different from site installation.

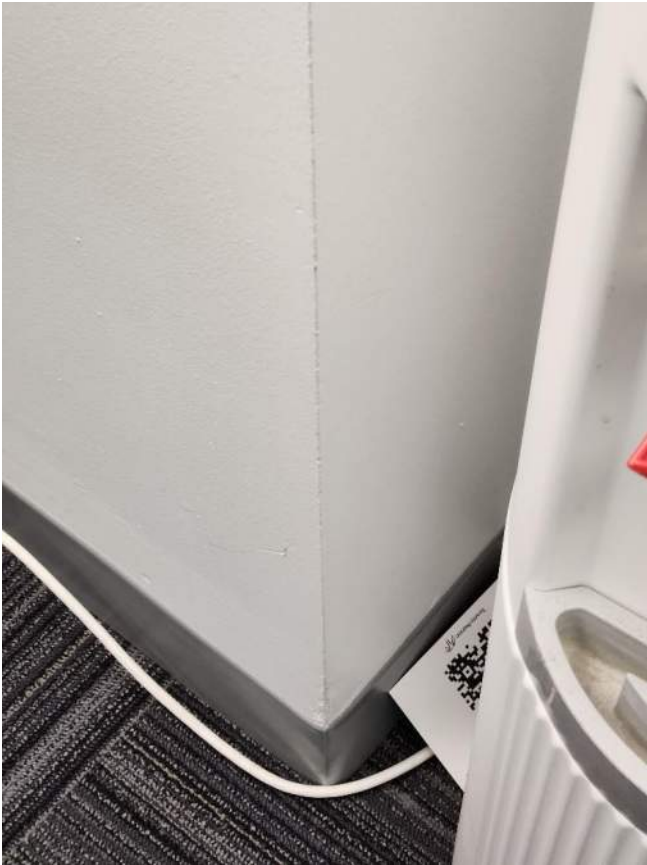
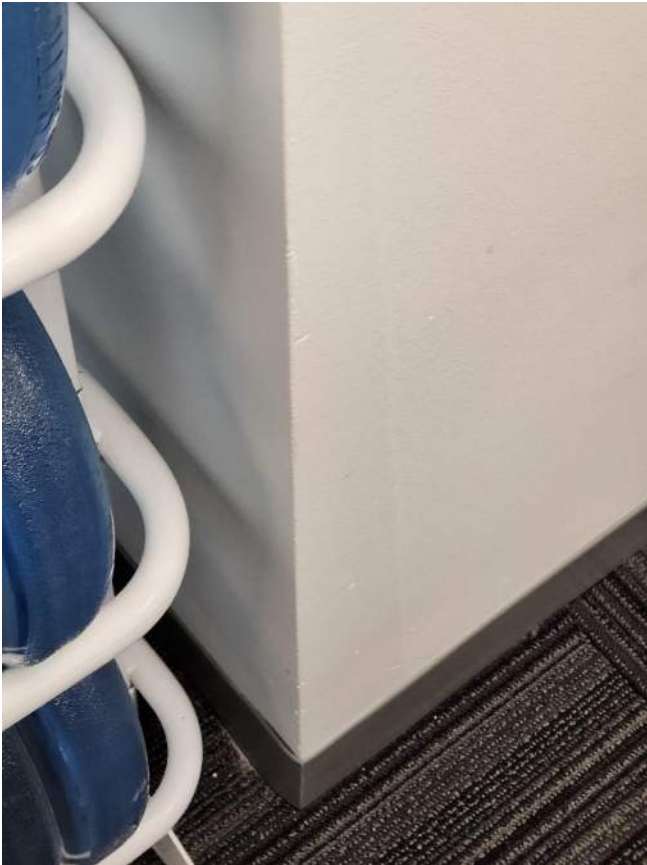
Figure 8 - Minor damage noticed at GWB wall corner edges.

Figure 9 - Minor damage noticed at GWB wall corner edges.

Comments: Consider installing a PVC or stainless-steel corner guard to protect exposed GWB corner from future damage.

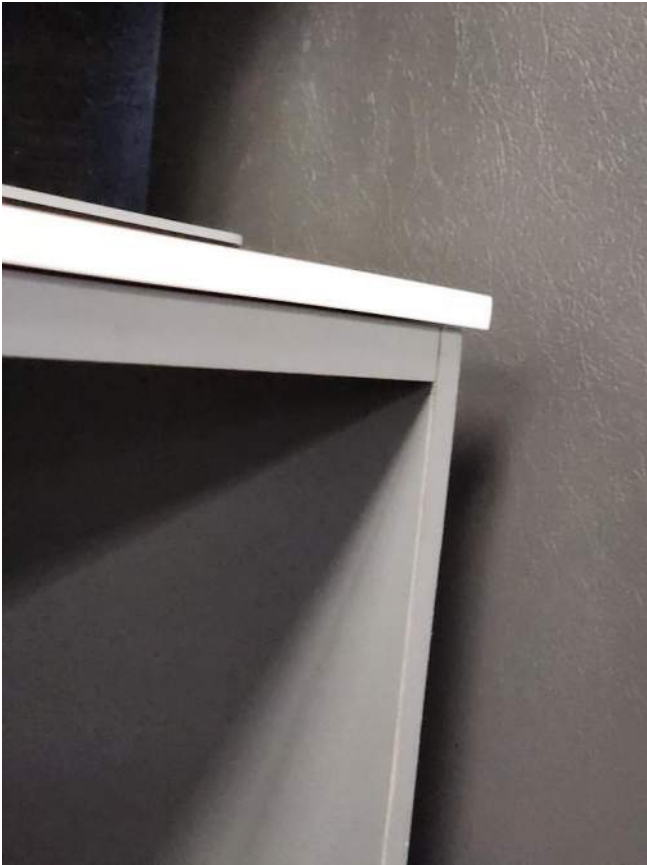
Some minor variances in sizes and details of the kitchenette millwork were observed that have been noted in the deficiency list along with site photos. Countertop edge details did not conform to design / drawings. Solid surface gable/partition was installed but not indicated in the design. Plastic laminate installed at plywood edges had visible gaps and residual adhesive. Stainless-steel base trim was either missed or not installed. Countertop height and height of millwork uppers varied by 10 mm from the design drawings.

Figure 10 - Solid surface countertop edge detail does not appear to conform to kitchenette millwork drawing/detail.

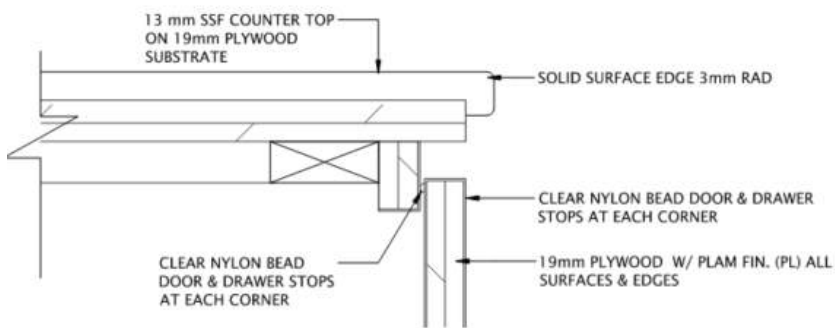
9
A1631

Figure 11 - Solid surface countertop edge detail drops down to cover plywood substrate.

Comments: Solid surface counter front edge does not conform to design intent. There is a chance for moisture penetration between the plywood substrate under the solid surface material. Visible gap at this location needs to be caulked with suitable type of caulking.

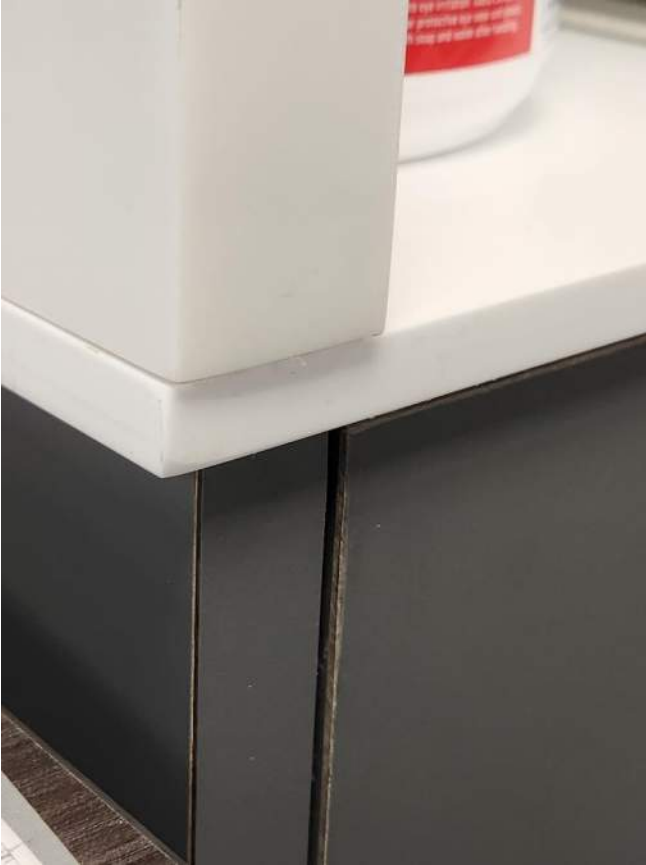
Figure 12 - Quality of workmanship of plastic laminate installed at sides of plywood substrate seems below average. Residual adhesive is visible.

Comments: Plastic laminate edges require thorough clean-up.

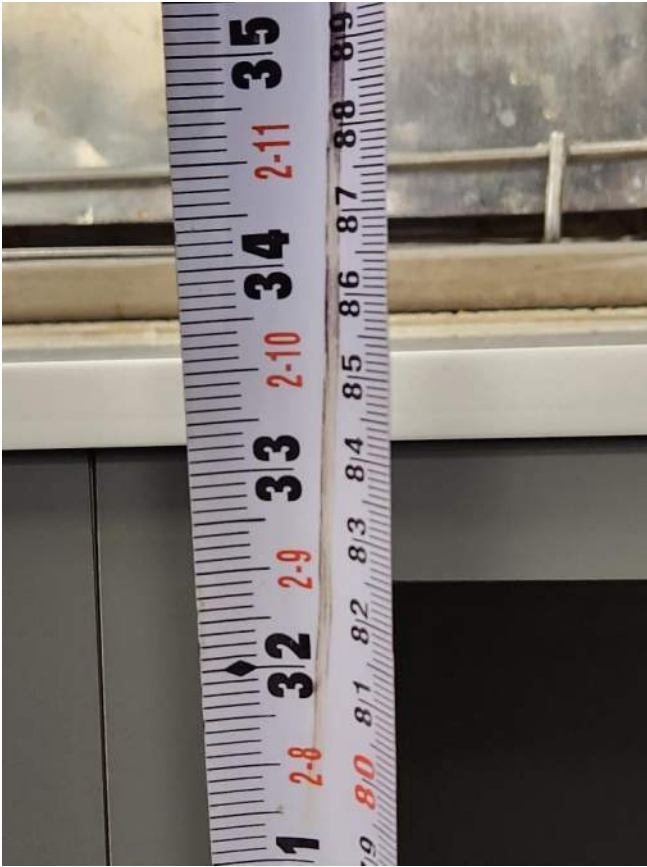
Figure 13 - Height of countertop from floor finish level was measured at: 850 mm, drawing shows height as: 860 mm.

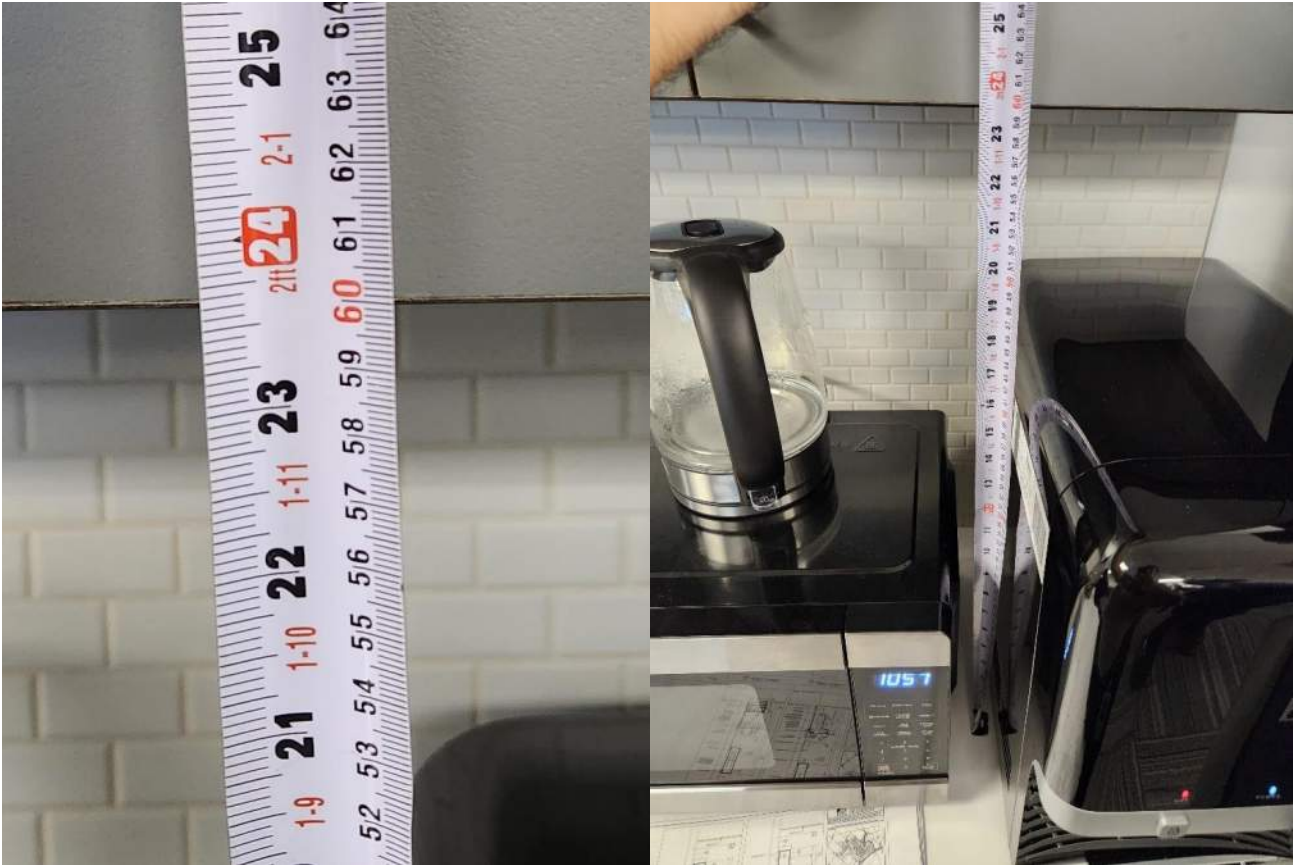
Figure 14 - Heigh of millwork cabinet uppers from countertop was measured at: 600 mm, drawing shows: 590 mm.

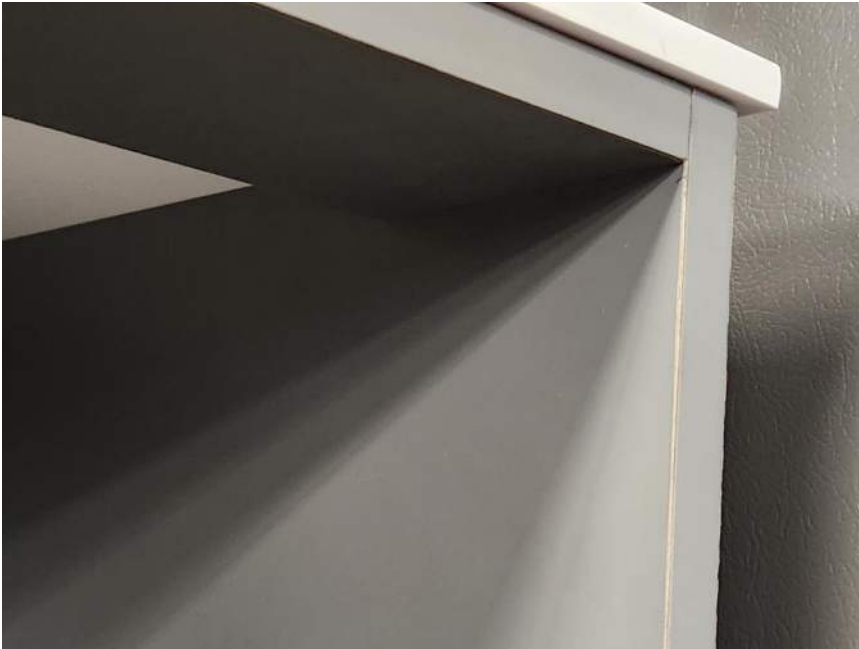
Figure 15 - Solid surface countertop protrudes beyond edge of kitchenette millwork.

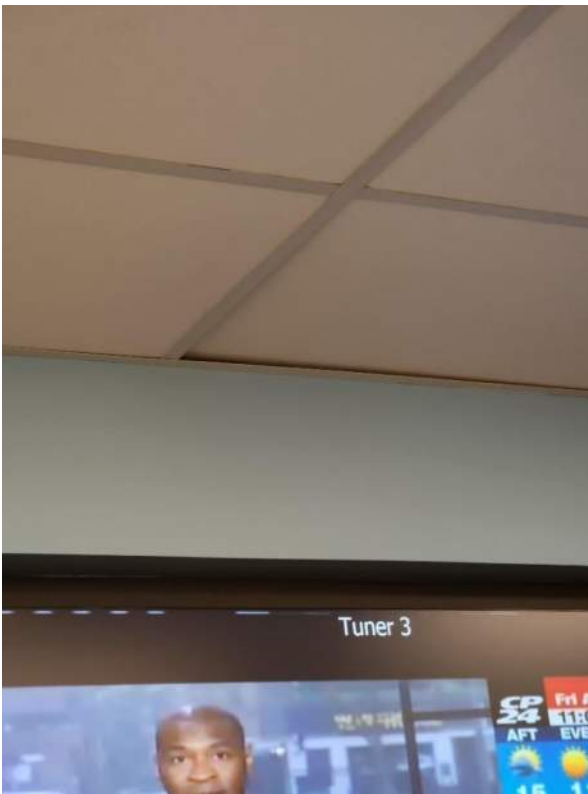
Suspended ceiling tiles and grid did not appear to conform to the contract documents. Details of non-conformance are noted in the deficiency list, tegular edge ceiling tiles indicated on drawings and square edge tiles installed. Shadow mold edge trim was not installed and replaced by a regular ceiling edge trim. Overall workmanship of the ceiling appeared to be below

acceptable industry standard. Several instances were observed where the ceiling grid was damaged, ceiling tiles did not sit tight within the ceiling grid, and there were visible gaps between the ceiling edge trim and GWB walls.

Figure 16 - Ceiling tile does not seem to sit tightly in ceiling frame above video wall.

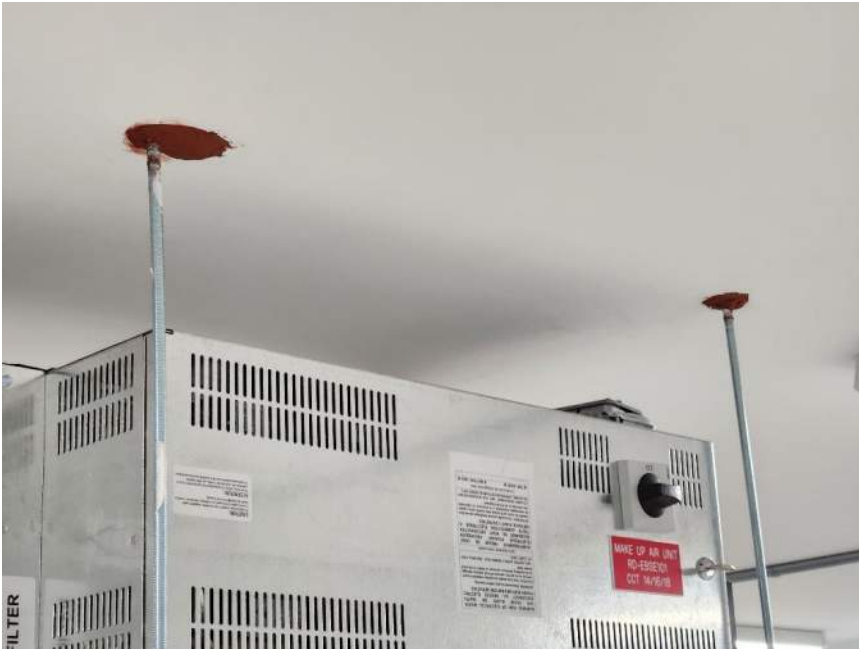
Figure 17 - Existing C.A.C.F. Room (EBS013) Ceiling mounted make-up air unit is missing fire-rating labels at threaded-rod ceiling penetrations.

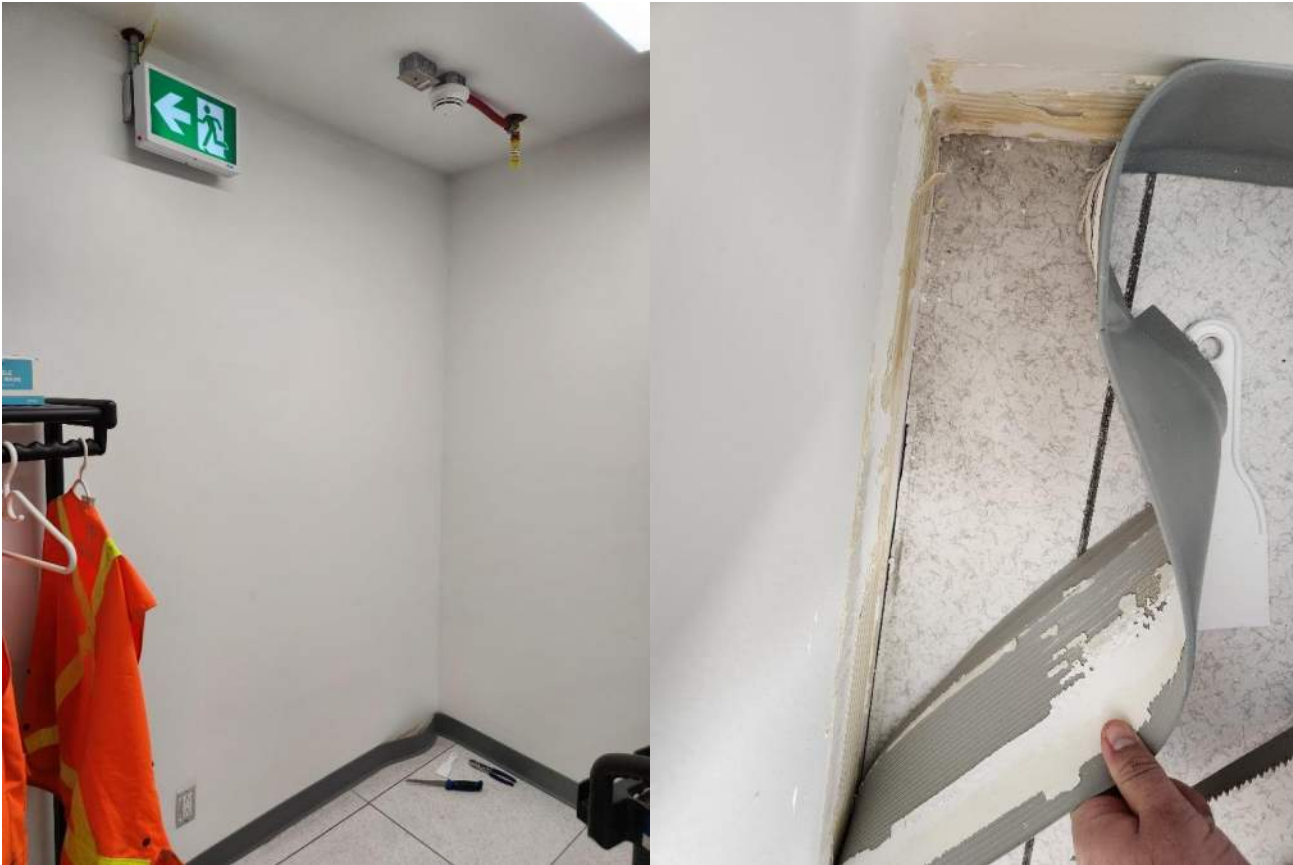
Figure 18 - Existing C.A.C.F. Room (EBS013) fire rated (red) caulking was not visible below fire rated GWB partition wall. Concern about installation of firestopping around new fire rated walls. This is to be verified as it is an occupant life-safety requirement according to the building code.

Based on the relatively minor status of the above deficiencies with the exception of the architectural deficiency noted in Figure 18, WSP recommends that the Certificate of Substantial Completion be issued. It is strongly recommended that GTAA, their code consultant LMDG, and the contractor and designer team confirm there is no life-safety code violation in regards to the deficiency noted in Figure 18 before issuing the Total Performance Certificate to the contractor. Once all deficiencies have either been rectified by the contractor or designated as accepted by GTAA, WSP will conduct a final site investigation to confirm completion and issue the Total Performance Certificate.

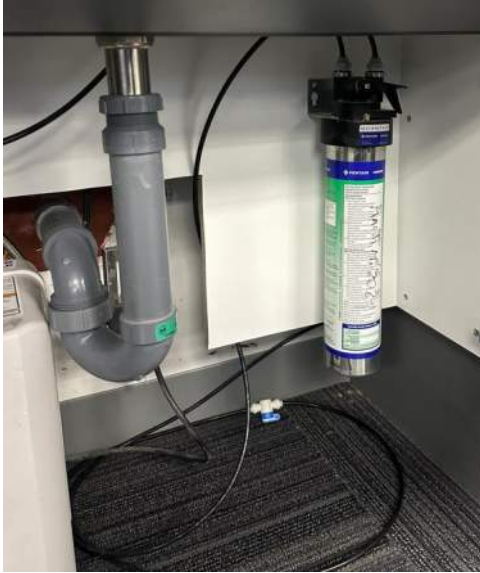
- ❖ Due to the closed ceiling and occupancy of the room, we were unable to inspect the HVAC ductwork. Kindly furnish any construction photos available for review.
- ❖ Confirmation of the fire sprinkler and its connections was not feasible due to the sealed ceiling. Please submit any relevant construction photographs for examination.
- ❖ Secure and neatly arrange the connections to the water filter (refer to **Figure 19 - Under-sink water** below).

Figure 19 - Under-sink water filter.

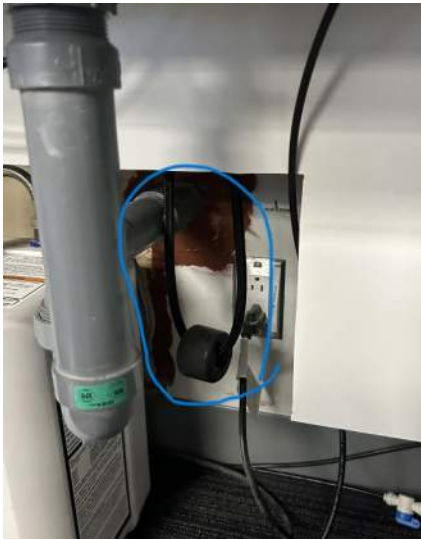
- ❖ To ensure proper functionality, it is imperative that the faucet sink pullout weight moves freely and does not become lodged against the false wall (refer to **Figure 20 - Faucet Sink Pullout Weight** below).

Figure 20 - Faucet Sink Pullout Weight

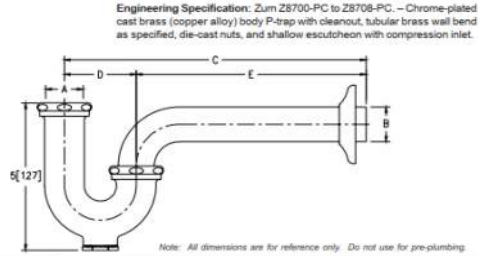
- ❖ The P-trap supplied for the sink deviates from the specifications delineated in the approved submittal (refer to **Figure 21 - Specified P-Trap Approved Submittal** and **Figure 22 - Installed P-Trap** below).

Figure 21 - Specified P-Trap Approved Submittal

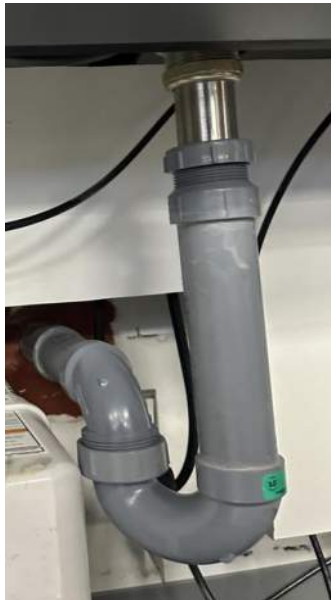
Figure 22 - Installed P-Trap

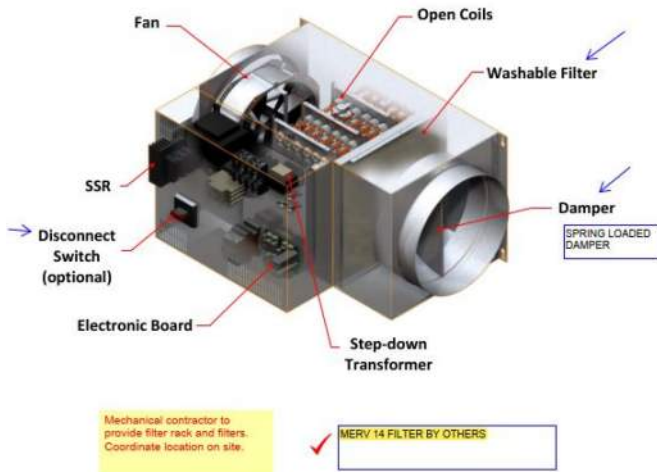
- ❖ The filter and its corresponding rating for the Makeup Air Unit (MAU-1) could not be located and verified. Please provide clarification (refer to **Figure 23 - Approved submittal for MAU stating filter to be provided by contractor** below).

Figure 23 - Approved submittal for MAU staging filter to be provided by contractor

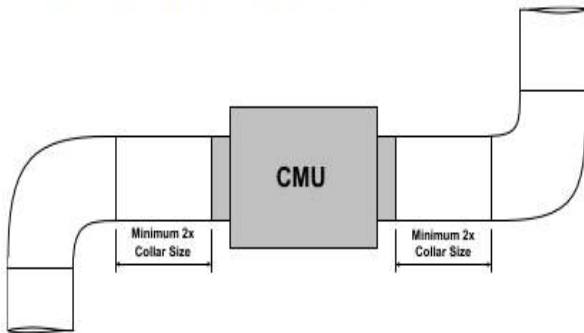
- For proper air flow, a minimum straight duct distance of 2x the collar size/duct diameter must be maintained upstream and downstream the CMU, between the unit and any obstacle, such as dampers, louvers and elbows.
- Use round insulated ducts for the inlet connection and uninsulated ducts for the outlet, while ensuring to minimize the use of elbows.
- When taking air directly from outside, install the inlet duct at an incline, in order to prevent condensation or melted snow from flowing into the unit.
- It is recommended to have a secondary damper before the inlet of the make-up air unit, in order to prevent a strong draft of wind from opening the damper in the unit. The secondary damper can be a gravity damper or a damper with an actuator.
- A louver with a bird protection grille must be installed on the air inlet.

Figure 24 - Manufacturer's Installation Requirements for MAU-1

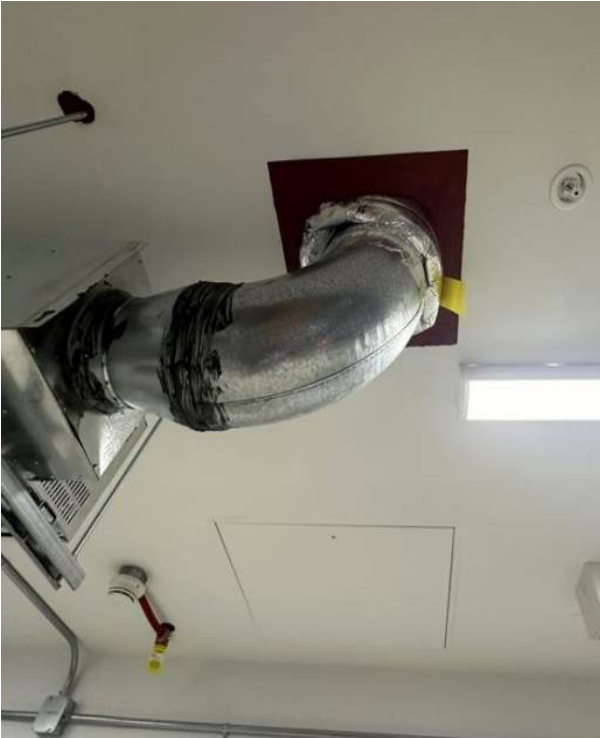
- ❖ Confirmation of the connection between the fresh air ductworks and the new MAU-1 was impeded by the sealed ceiling. Kindly provide relevant construction photographs.
- ❖ Verification of the fire smoke damper and its associated connections was hindered by the inaccessible ceiling. Please supply any pertinent construction images for assessment
- ❖ It appears that the installation of the Makeup Air Unit (MAU-1) does not conform to the manufacturer's installation requirements (refer to **Figure 24 - Manufacturer's Installation Requirements for MAU-1-1** and **Figure 25 - Site Installation of MAU Ductwork Not Conforming to Manufacturer's Instructions** below).

Figure 25 - Site Installation of MAU Ductwork Not Conforming to Manufacturer's Instructions

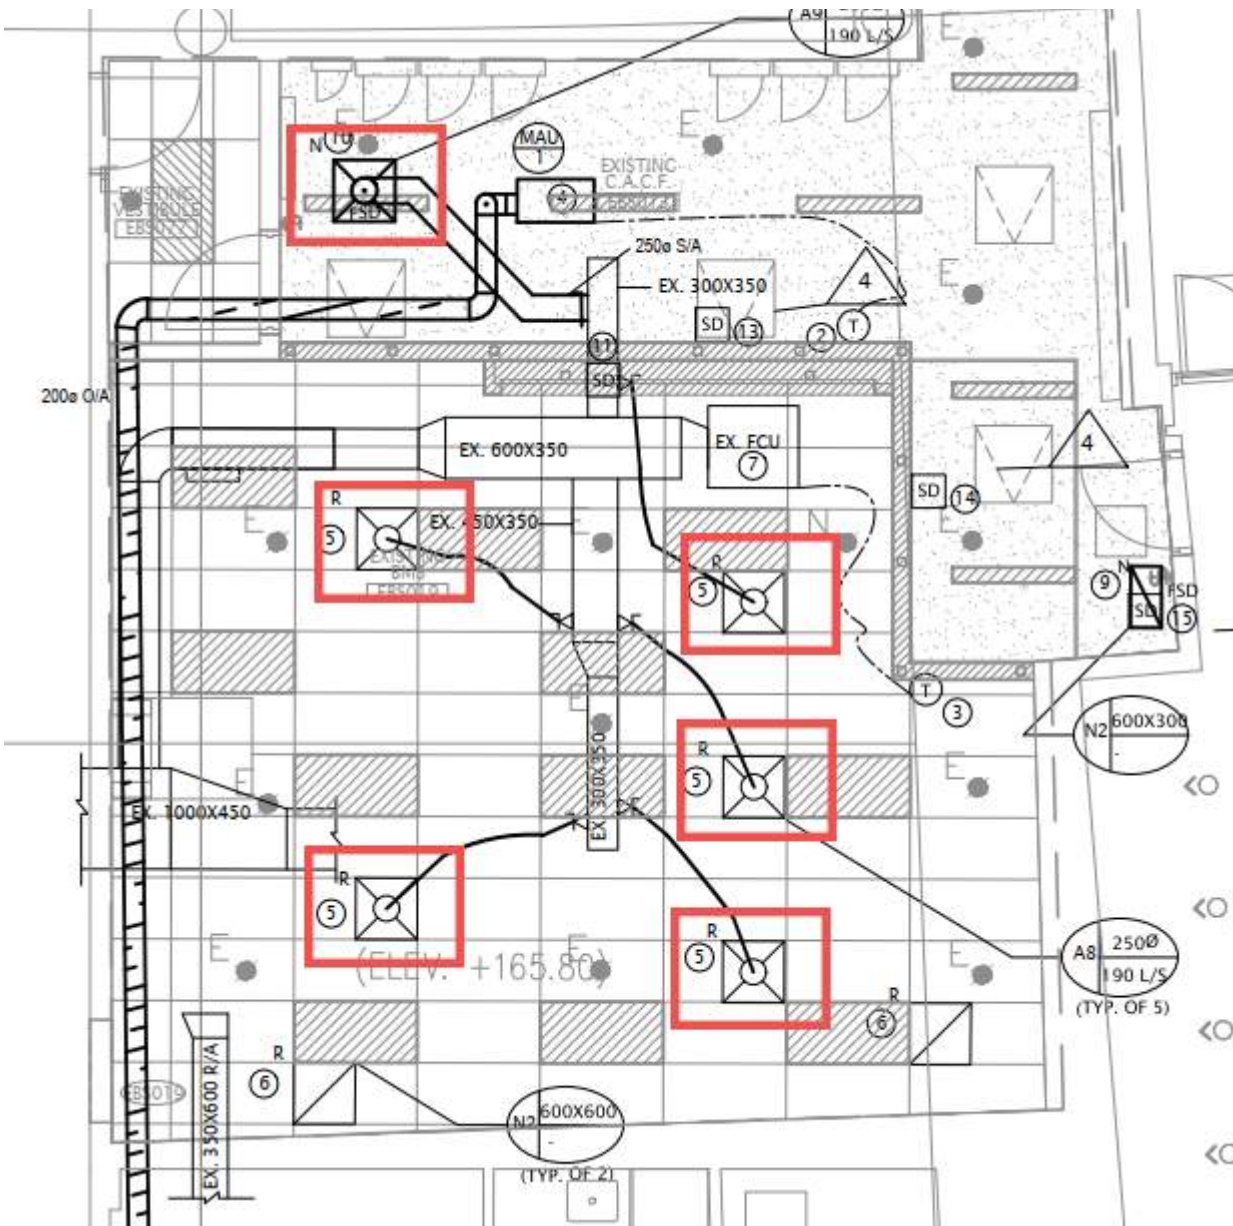
- ❖ Verification of the damper and bird screens on the supply side of the Makeup Air Unit (MAU-1) was not possible due to access limitations. Please submit any relevant construction photographs for examination.
- ❖ Provide the testing and commissioning report for MAU-1. Also, confirm if the MAU has been configured with the BAS.
- ❖ Provide the testing and balancing report for modified duct work. Refer to figure 35 below.

Figure 26 : Modified duct and terminals arrangement

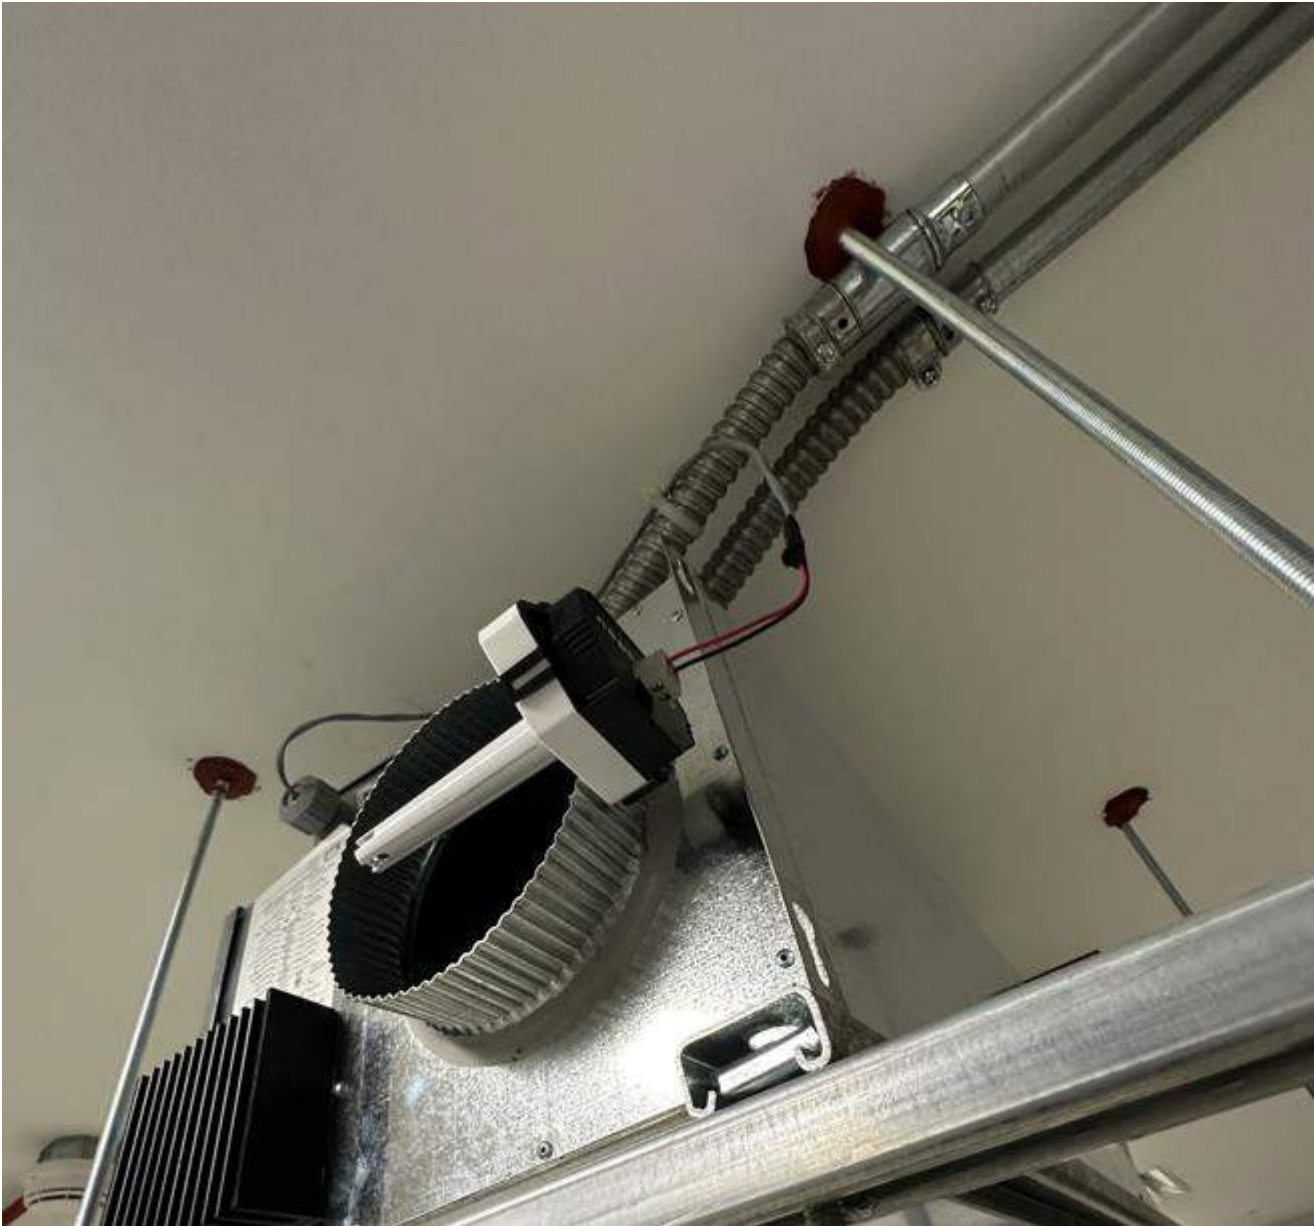
❖ Cannot find the fire rating labels on the threaded rods for the MAU-1. Please refer to Figure 36 below.

Figure 27: Thread rods do not have fire rating labels.

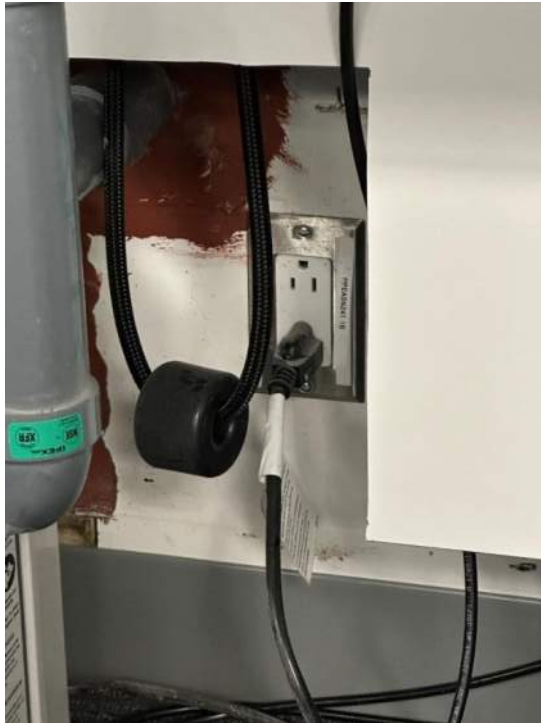
refers to a panel PPEASN241 circuit 16, but the facilities escort was not aware of a panel by this name. To rectify this issue, the contractor shall either.

Figure 28 - Receptacle below sink in BMS Office EBS019

- Replace the existing duplex receptacle with a GFCI-type receptacle, or
- Trace the branch circuit back to the source panel, confirm the breaker is a GFCI-type, and update the circuit tag on the receptacle.
