Re: Driveway Repaving & Releveling for Fire Station 106
1355 Winding Trail, Mississauga, Ontario L4Y 2V1
Substantial Performance
Procurement No.: PRC004168

FIELD REVIEW REPORT #1

Project Name: Driveway Repaving & Releveling for Fire Station 106

Date of Review: June 17, 2024

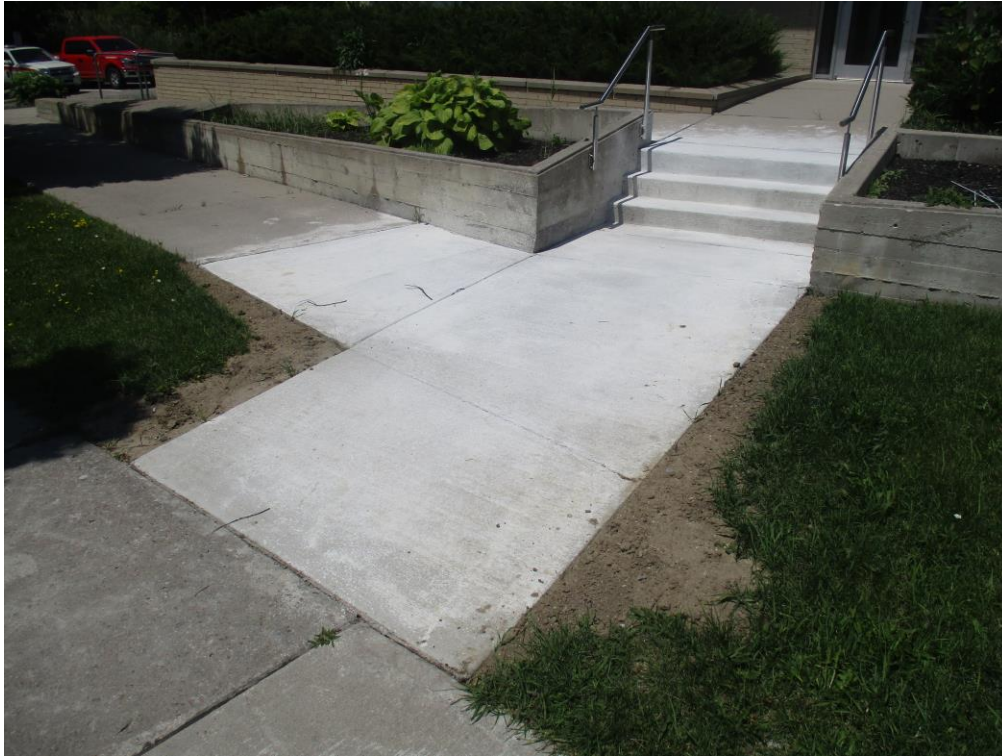
1. Damaged concrete sidewalk for area #4 has been removed and replaced (Refer to photo #1).

Photo 1: Damaged concrete sidewalk for area#4 has been removed and replaced.

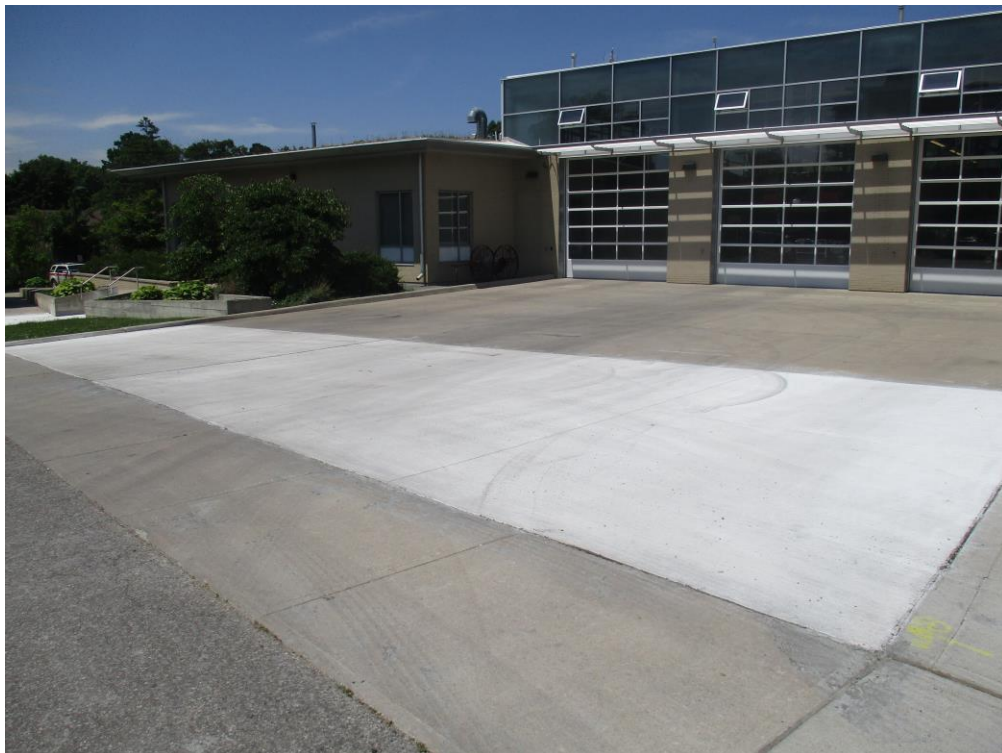
2. Interlock pavers and granular materials for area #3 has been removed and replaced with reinforced concrete slab (Refer to photo #2).
3. Interlock pavers and granular materials for areas#1 &2 have been removed, granular materials was replaced, compacted and interlock pavers have been reinstated (Refer to photo#3).
4. Joint fill material was in place between the interlock gaps at the whole areas not being releveled and reinstated (Refer to photo#4).

Photo 2: Interlock pavers and granular materials for area #3 has been removed and replaced with reinforced concrete slab.

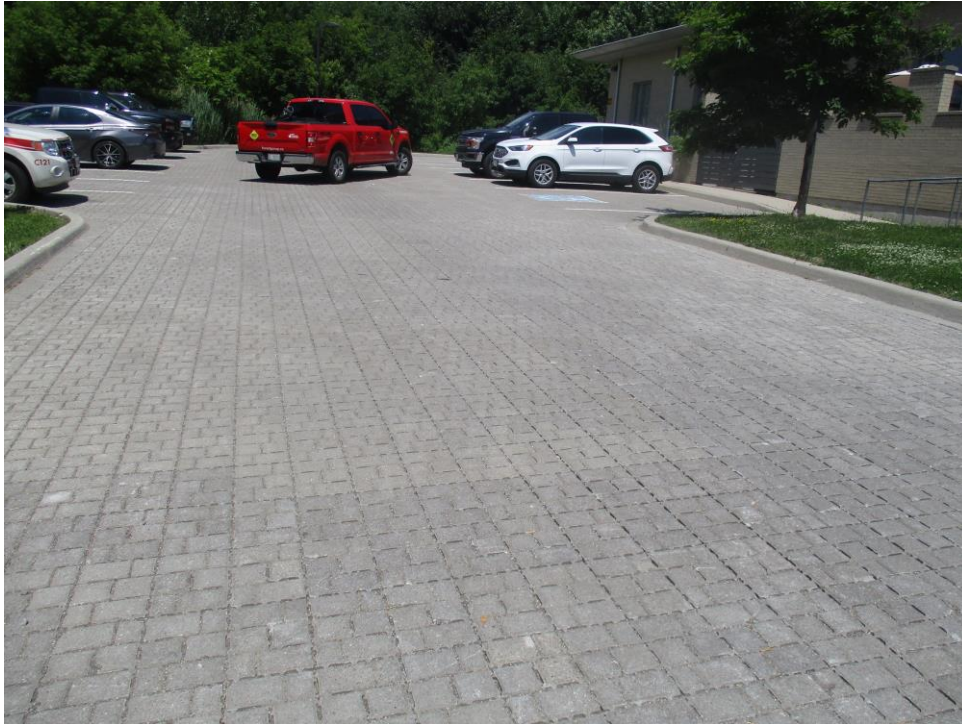
Photo 3: Interlock pavers and granular materials for areas#1 &2 have been removed, granular materials was replaced, compacted and interlock pavers have been reinstated.

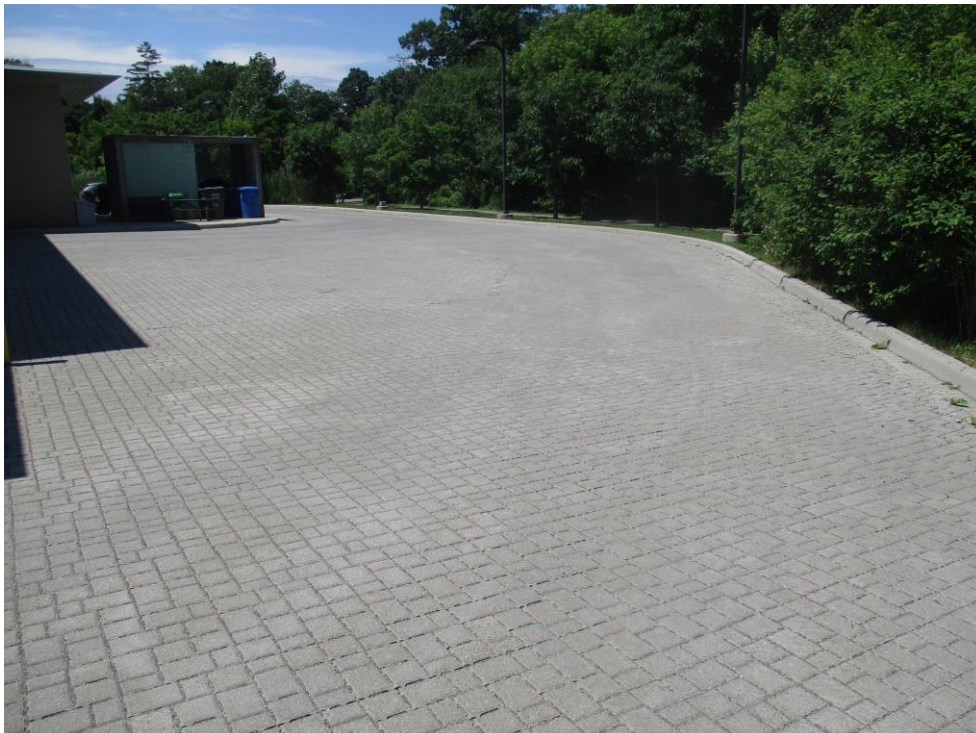
Photo 4: Joint fill material was in place between the interlock gaps at the whole areas not being releveled and reinstated.

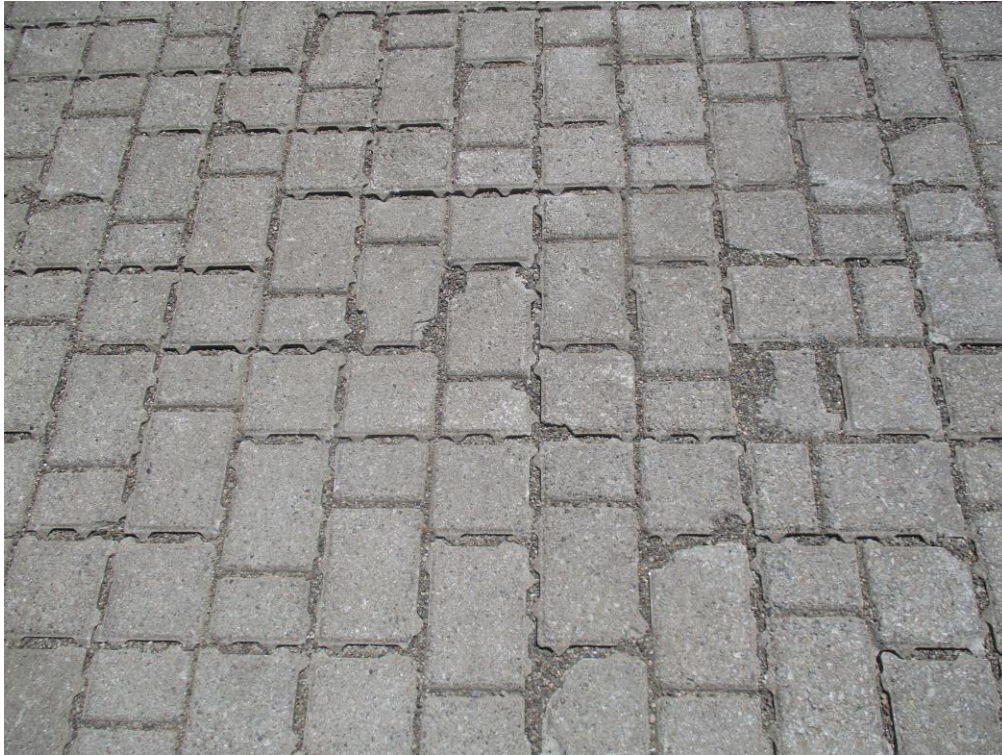
Photo 5: Chipped interlock pavers for areas# 1 & 2 are to be replaced with new interlock pavers as per the contract document, the contractor was instructed to send photo to our office for review and record after completion of work.

1. Chipped interlock pavers for areas# 1 & 2 are to be replaced with new interlock pavers as per the contract document, the contractor was instructed to send photo to our office for review and record after completion of work (Refer to photo#5).

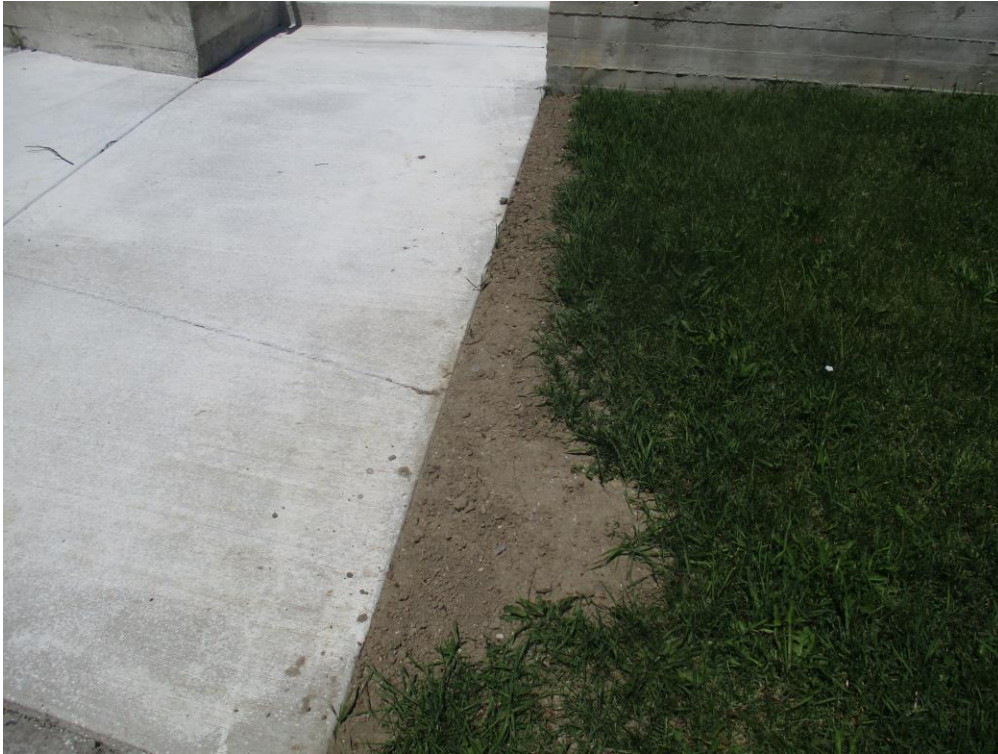
Photo 6: All areas disturbed by construction and adjacent concrete sidewalk shall be restored to the original condition by providing local fill, a minimum 100mm topsoil and 50mm sod, the contractor was advised to send photos to our office for review and record after completion of work.

2. All areas disturbed by construction and adjacent concrete sidewalk shall be restored to the original condition by providing local fill, a minimum 100mm topsoil and 50mm sod, the contractor was advised to send photos to our office for review and record after completion of work (Refer to photos#6).

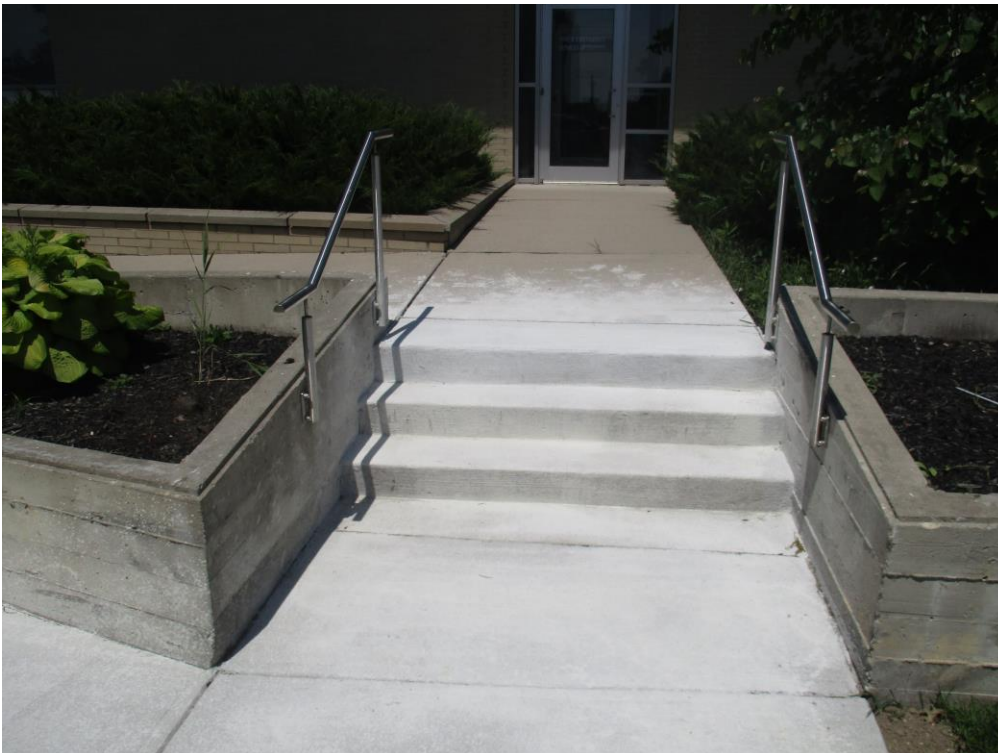
Photo 7: The contractor was informed to wash and clean adjacent the repaired concrete areas# 3 & 4 and send photo to our office for review and record after completion of work.

3. The contractor was informed to wash and clean adjacent the repaired concrete areas# 3 & 4 and send photo to our office for review and record after completion of work (Refer to photo#7).

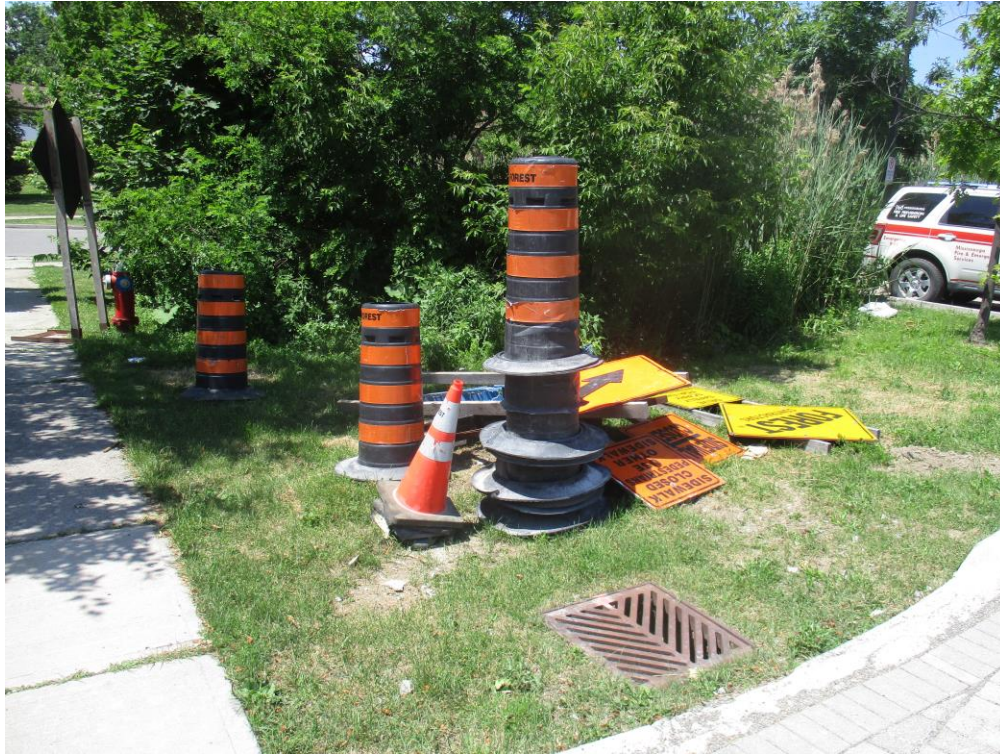
Photo 8: The contractor was instructed to remove all the signs and construction cones on the green zone area adjacent to area#2 and all areas disturbed by construction shall be restored to the original condition by providing local fill, a minimum 100mm topsoil and 50mm sod.

4. The contractor was instructed to remove all the signs and construction cones on the green zone area adjacent to area#2 and all areas disturbed by construction shall be restored to the original condition by providing local fill, a minimum 100mm topsoil and 50mm sod (Refer to photo#8).
