FORM 9
CERTIFICATE OF SUBSTANTIAL PERFORMANCE OF THE
CONTRACT UNDER SECTION 32 OF THE ACT
Construction Act

DEFICIENCIES REPORT

Project No.
ONBL20-0211

Project Name
Granite REIT – 555 Beck Lighting Manufacturing Expansion

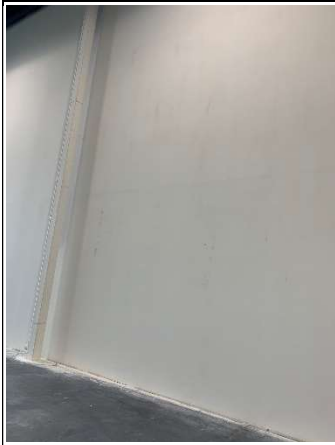
1. Missing rubber base.

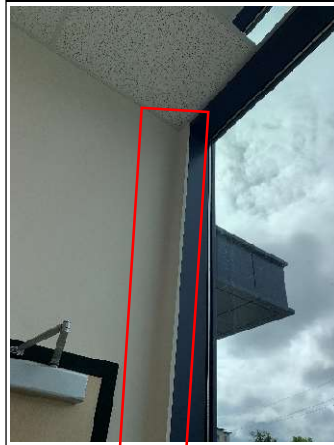
18. Unit 2 - trim needs to extend fully

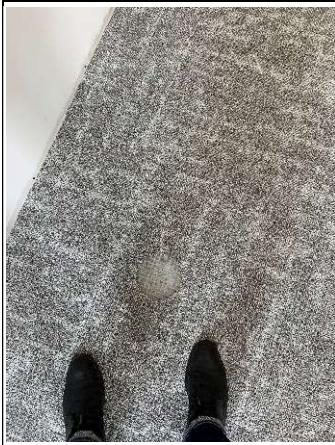
21. An access cover was observed on the carpet

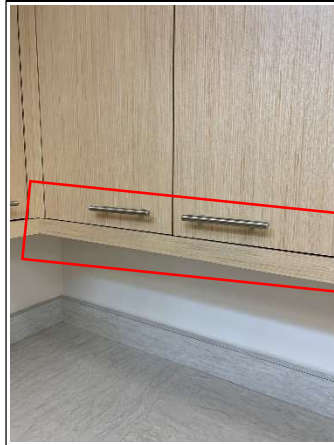
23. Cabinets are misaligned

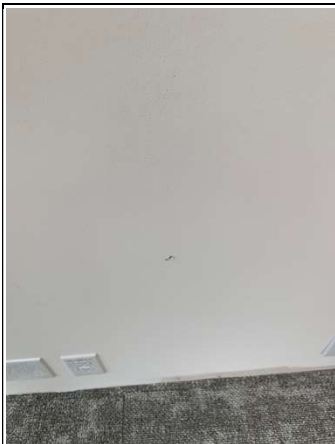
25. Drywall needs patching.

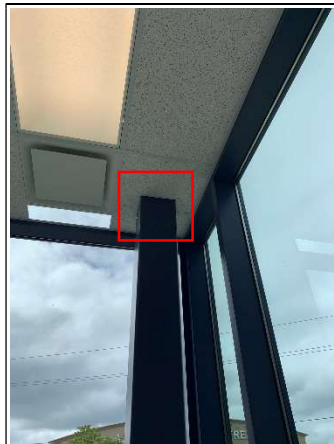
26. ACT trim around column needs proper cutting

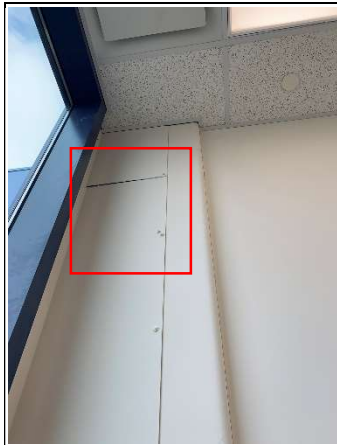
29. IT Room - Installed aluminum beside the mullions needs adjustment

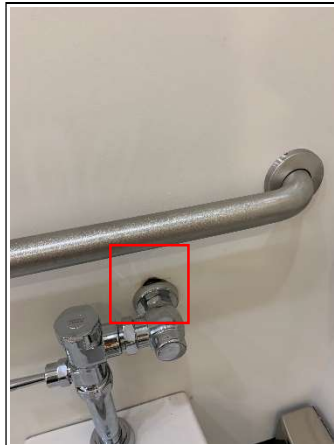
30. Patching needed around the toilet

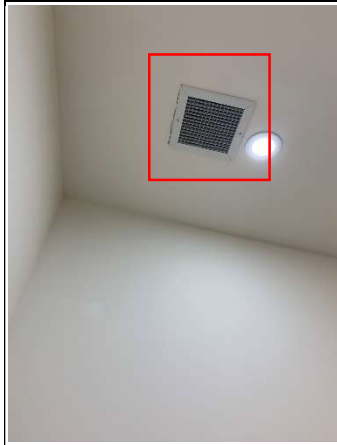
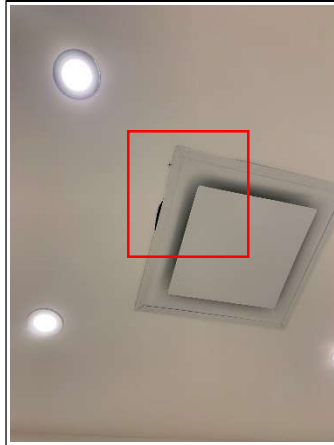
34. Patching needed around washroom grill

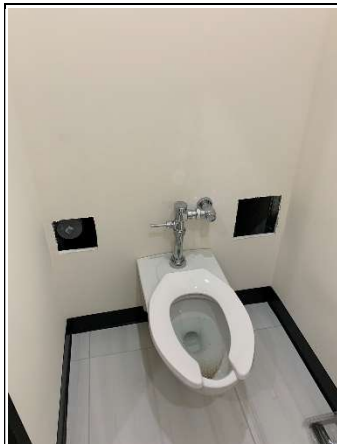
35. Missing access panel

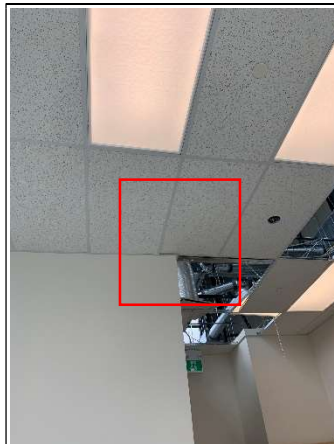
37. ACT trim needs adjustment

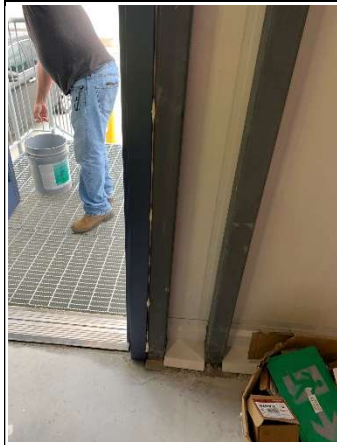
40. Caulking needed around the doors.

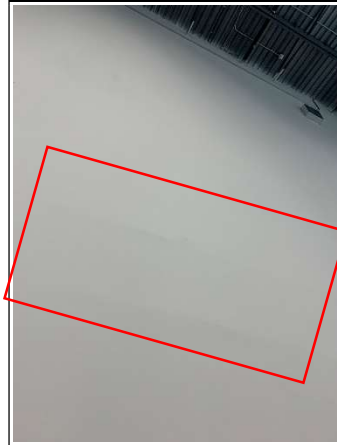
41. Drywall joints are visible and need sanding

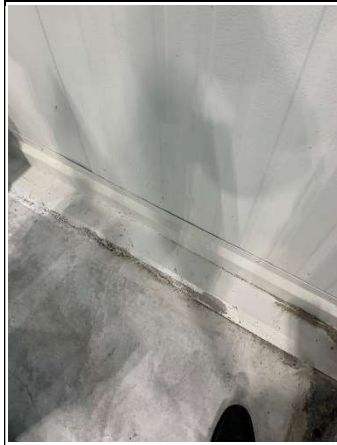
43. Deep cleaning of transition trims needed

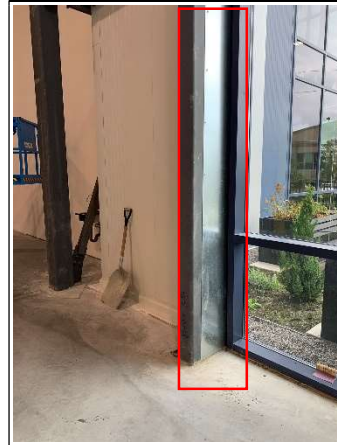
44. Installed aluminum panel between column and mullions needs to be painted to match

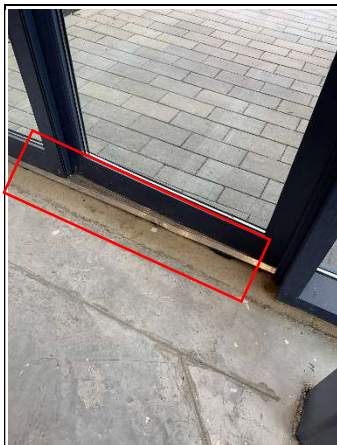
45. South door transition needs replacement

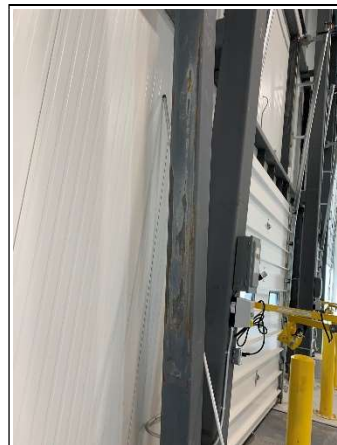
48. Structural columns need painting

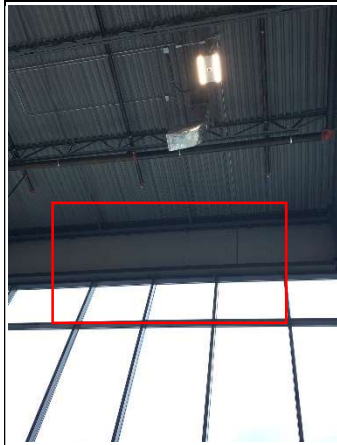
49. Scratches observed on the IMP panel on top of the mullion

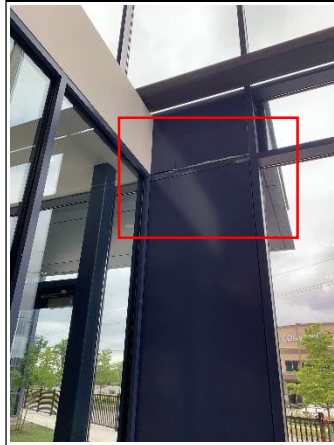
50. Vapor barrier needs to be cut and the mullions need cleaning

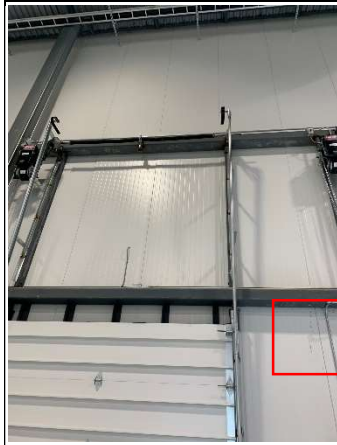
54. Marks observed on IMP panel need cleaning

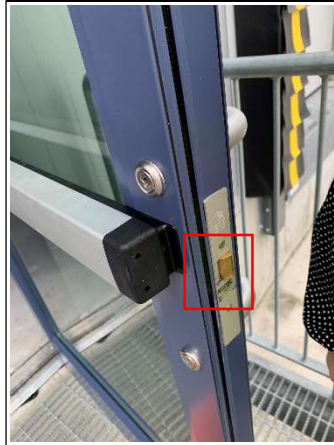
56. Door latch needs adjustment

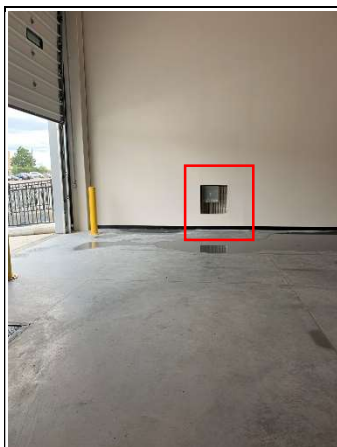
57. Access panel needed to cover the pole lighting junction

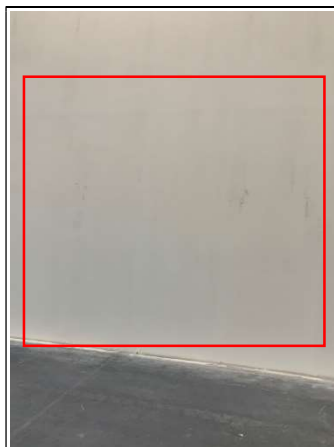
51. Partition drywall chipped between Unit 2 and 1, needs repainting.

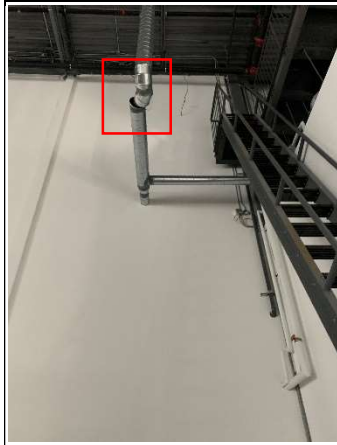
61.Duct leading to office space needs adjustment

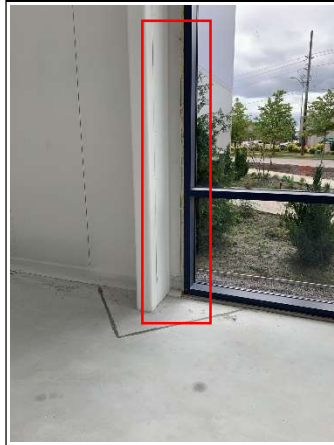
68.Foam around the mullion needs to be cut properly

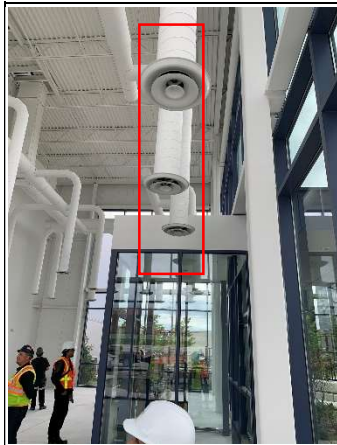
70.Ducts in the office area need alignment

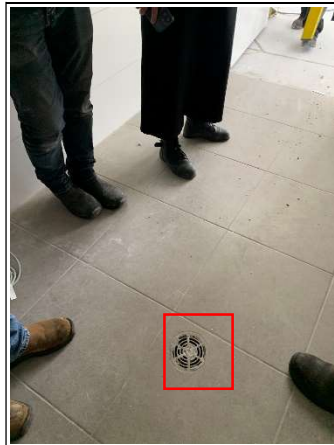
74.Washroom drain cover needs deep cleaning

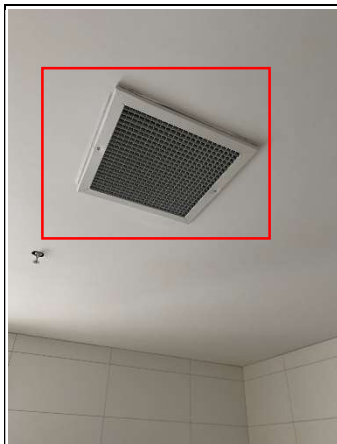
73.Caulking needed around the washroom exhaust

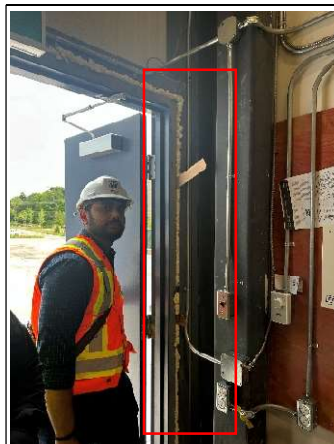
75.Foam around the electrical room door needs to be cut and caulked properly

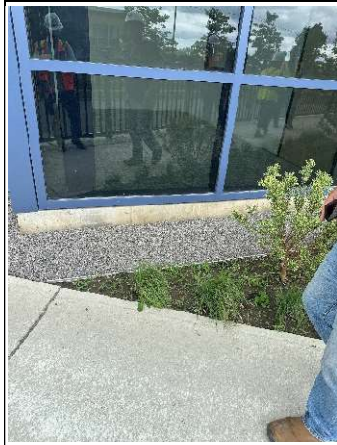
77.Missing flashing beneath the mullions

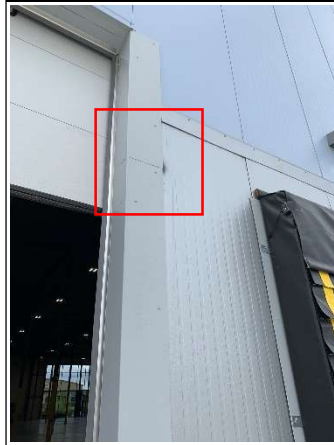
78.Paint observed on some outside panels; cleaning needed

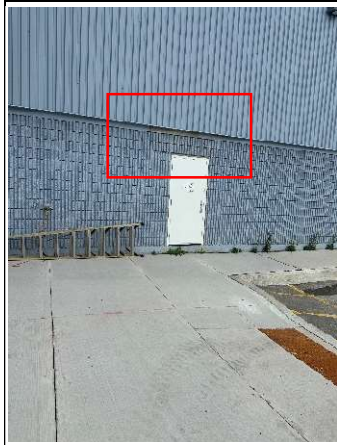
79.Paint required for the exit doors and top part

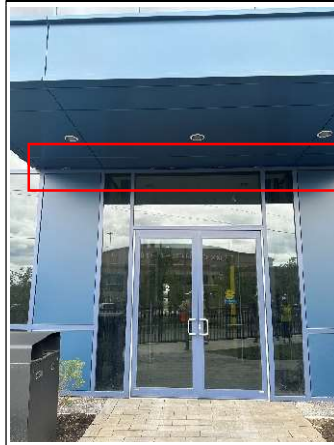
82.Gap observed between the office entrance canopies and mullions

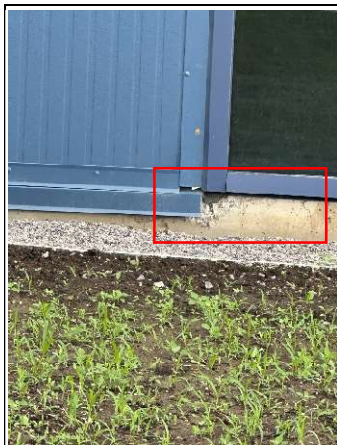
83.The outside concrete curb was damaged and needs repair work

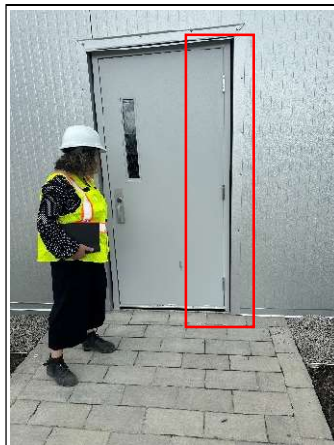
84.Caulking needed around the exit doors

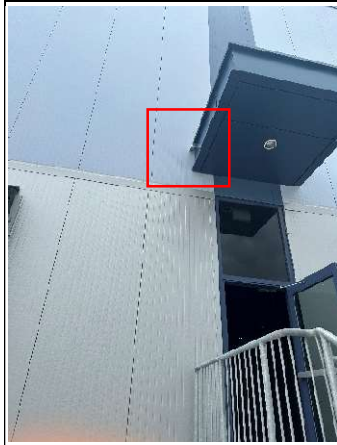
86.Canopies in manufacturing entrance area need scupper painted

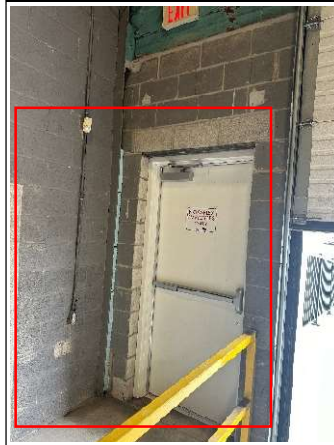
88.Existing building wall (existing Tenant side) needs painting

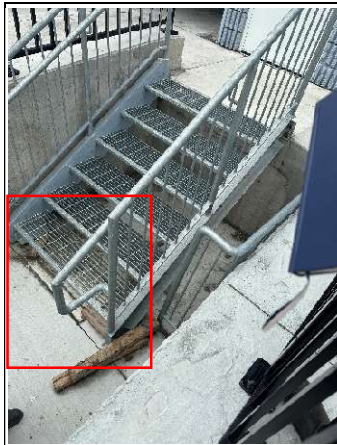
89.Stairs leading to existing building need safe installation

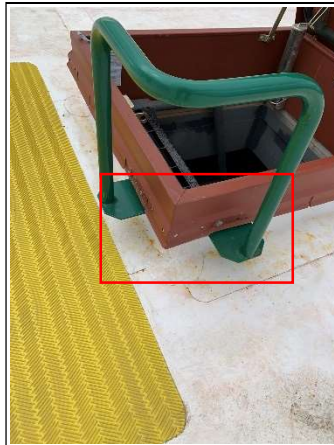
91.Access hatch grab bar needs fixing; it is missing screws and is loose

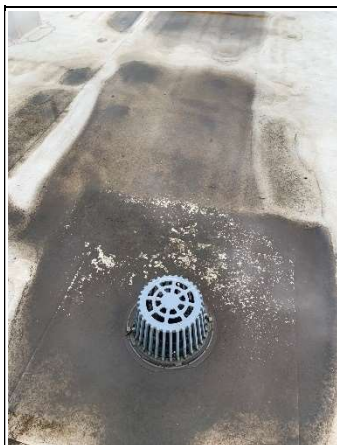
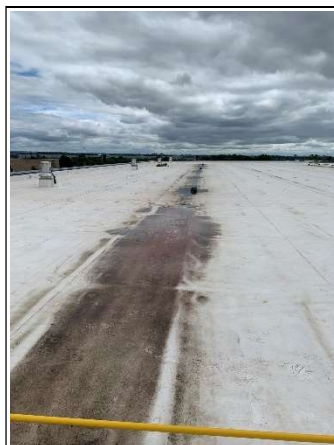
5.0	Roof	Status	GC	Cost	GR
Arch	91. Access hatch grab bar needs fixing; it is missing screws and is loose (See photo) 92. Water puddle observed in multiple areas; General Contractor to confirm proper sloping of the roof. 93. Safety post is missing. 94. Air buildup observed in roofing membrane (See photo) 95. Rust observed in some pipes and elbows (See photo)			\$800

92.Water puddle observed in multiple areas

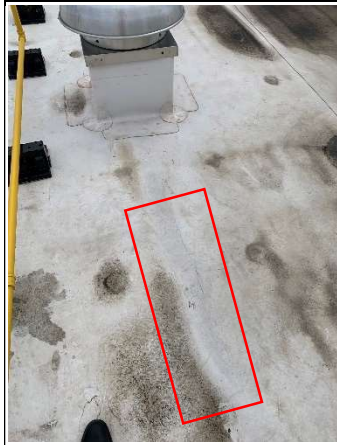
94. Air buildup observed in roofing membrane

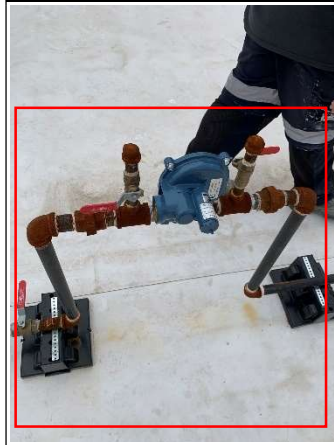
95. Rust observed in some pipes and elbows

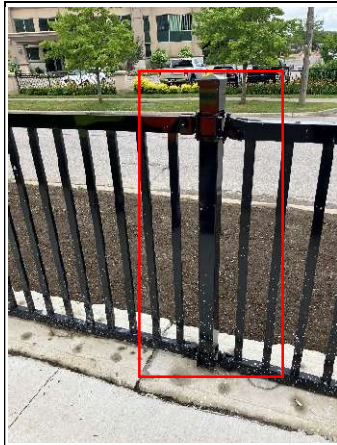
96. Handrail damaged/cleaning needed

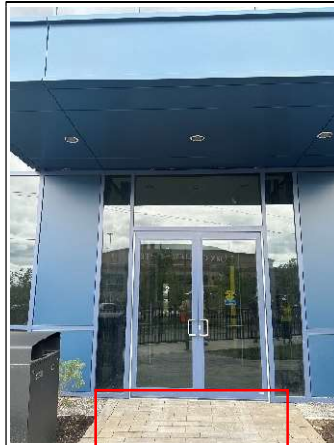
99. Marks observed on outside pavers

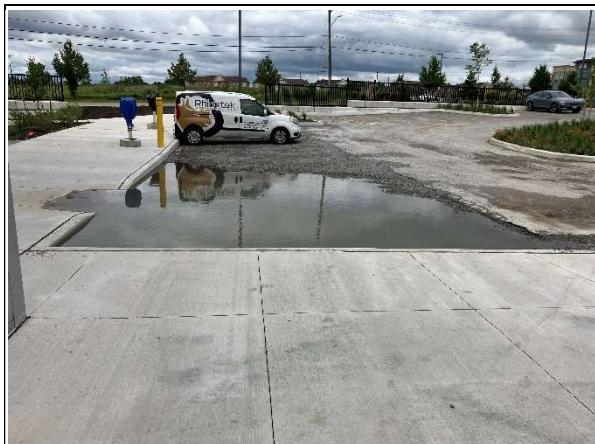
98. Water puddle observed near Unit 1 Office area

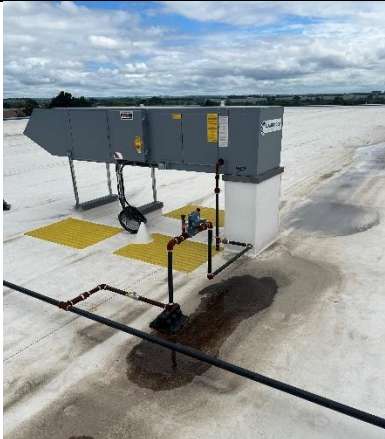
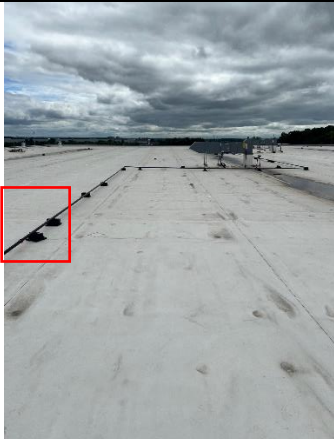
3.2	<u>Office Space</u>				
Mech	16. Thermostats have not been installed yet				
5.0	<u>Roof</u>	Status	GC	Cost	GR
Mech	17. Gas piping on roof was observed to have been installed but not fully painted. 18. The non-painted gas piping elbows were observed to have rust. 19. Gas piping on roof was observed to not be fully supported. Some of the supports appeared to be loose and have inconsistent spacing. 20. Water was seen pooling on the roof in areas besides by the roof drains.			\$200 \$200 \$200

1. Unpainted gas piping with rusted elbows		2. Unevenly spaced and loose gas piping supports

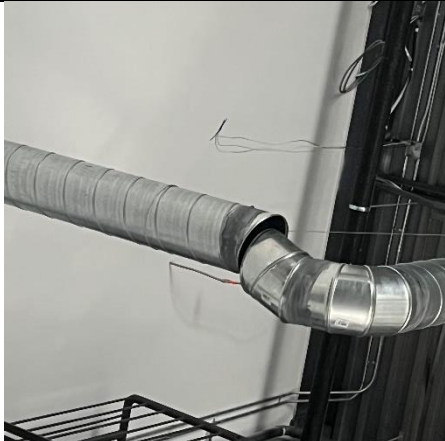
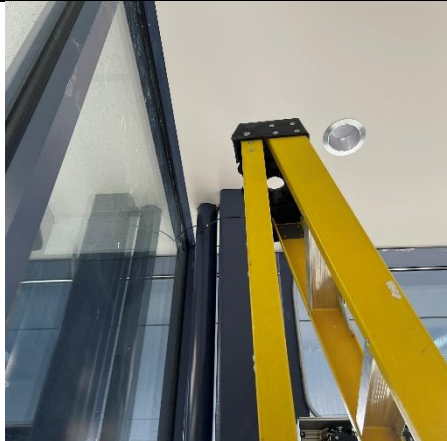
3. Disconnected washroom exhaust		4. Vestibule storm piping zip tied to column

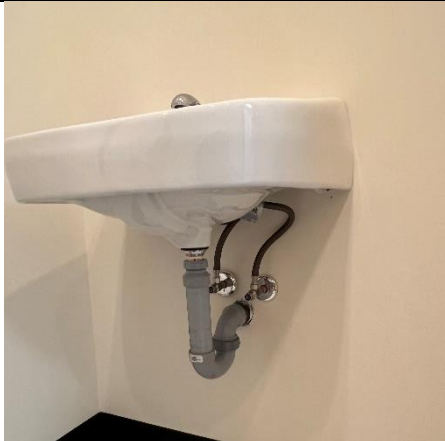
5. Plumbing fixture without piping insulation
