**Re: Denne Public School,
330 Burford Street, Newmarket, Ontario, L3Y 6L1
Site Improvement Works for Replacement of Exterior Steps, Railings and Pathways for
Locations 3 and 4
Substantial Performance
Project No.: 20231670**

FIELD REVIEW REPORT #4

Project Name: Denne Public School, Newmarket,
Site Improvement Works for Replacement of exterior steps,
retaining walls, railings, and pathways for locations 3 and 4
Location: 330 Burford Street, Newmarket, Ontario, L3Y 6L1
Project #: 20231670
Tender#24T56

Date of Review: October 07, 2024

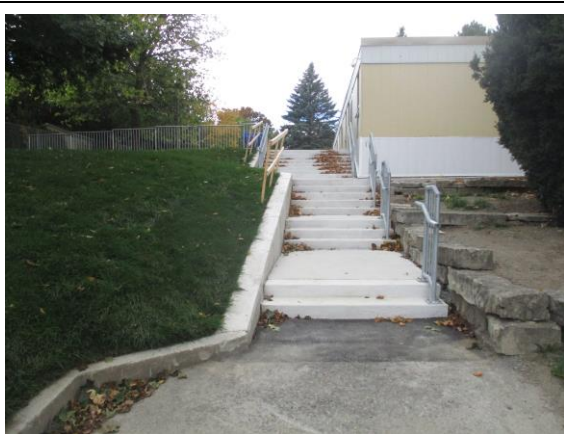
- .1 Substantial completion walkthrough was performed (Refer to Photo#1).

Photo #1- Substantial completion walkthrough was performed.

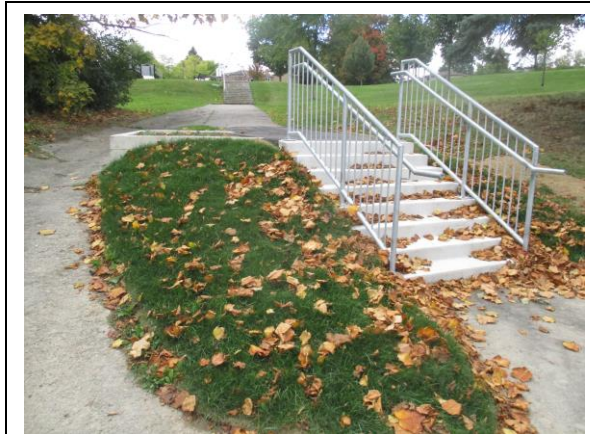
- .1 Railings have been installed (Refer to photo#2)
- .2 New metal cladding has been installed (Refer to photo#3).
- .3 Topsoil and sod for green zone areas adjacent to the stairs were in place (Refer to photo#4).
- .4 The contractor was instructed to submit 28 day concrete test result reports to our office for review and record.

Photo #2- Railings have been installed.

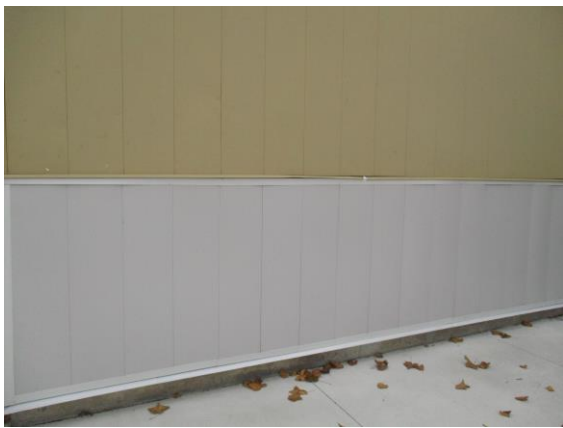
Photo #3- New metal cladding has been installed.

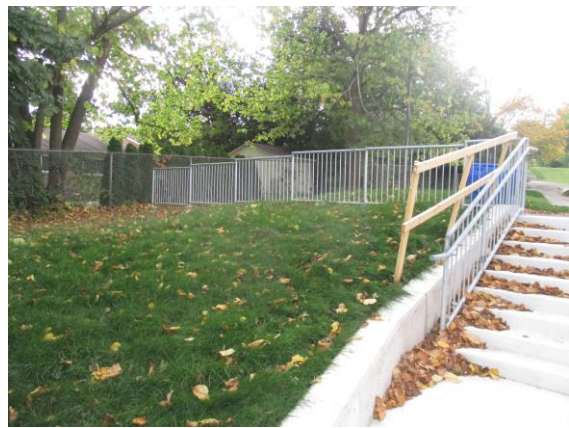
Photo #4- Topsoil and sod for green zone areas adjacent to the stairs were in place.

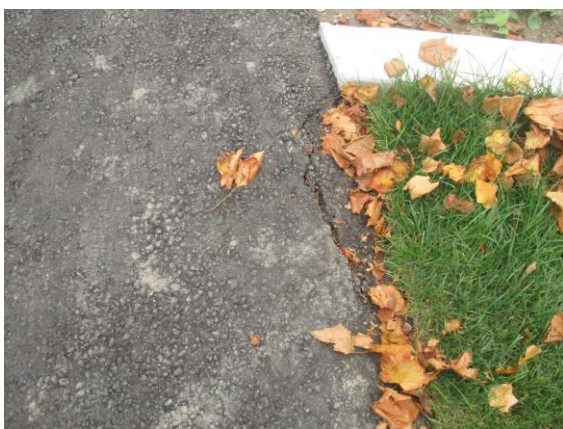
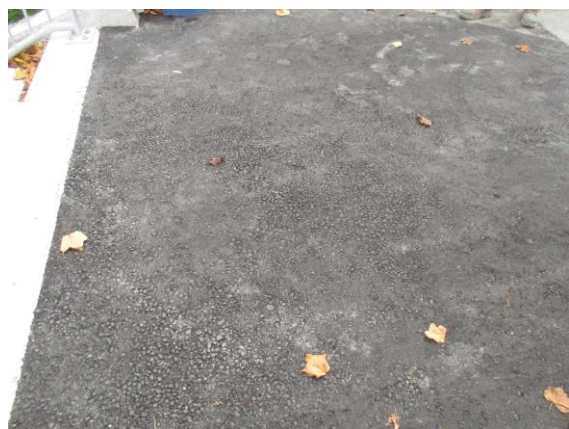
- .1 Asphalt surface segregation and cracked/settlement was noted at locations 3 and 4, asphalt areas are to be repaired, photos are to be submitted to our office after repair of asphalt at both locations (Refer to photos#5, #6).
- .2 Temporary wooden railing along stairs are to be removed and disposed off site and photo is to be submitted to our office for review (Refer to photo#7).
- .3 Damaged sods adjacent to stairs at location 4 are to be replaced and photos are to be submitted to our office after repair of sods (Refer to photo#8).
- .4 The contractor was advised to wash and clean all the work areas and send photo to our office for review (Refer to photo #9).

- 3.4.1 Asphalt surface segregation was noted at locations 3 and 4, asphalt areas are to be Repaired (**OUTSTANDING**)

Photo #5- Asphalt surface segregation and cracked/settlement was noted at locations 3 and 4, asphalt areas are to be repaired, photos are to be submitted to our office after repair of asphalt at both locations.

Photo #6- Asphalt surface segregation and cracked/settlement was noted at locations 3 and 4, asphalt areas are to be repaired, photos are to be submitted to our office after repair of asphalt at both locations.

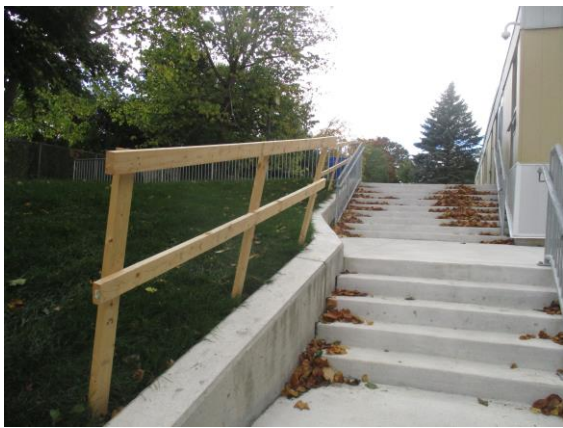
Photo #7- Temporary wooden railing along stairs are to be removed and disposed off site and photo is to be submitted to our office for review.

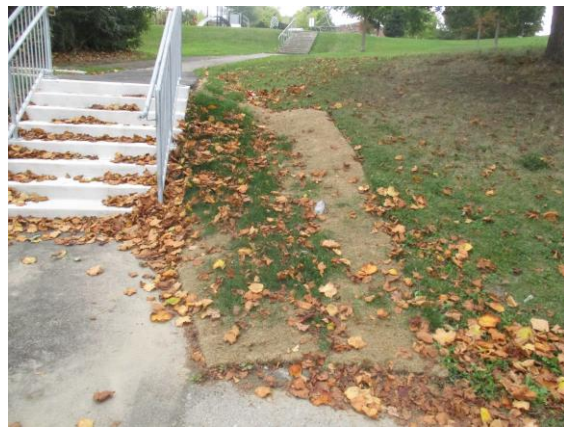
Photo #8- Damaged sods adjacent to stairs at location 4 are to be replaced and photos are to be submitted to our office after repair of sods.

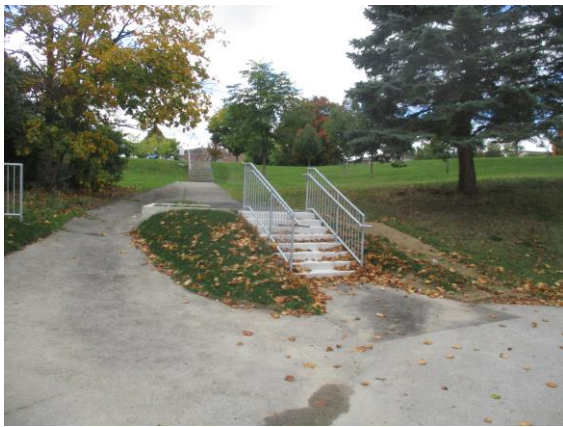
Photo #9- The contractor was advised to wash and clean all the work areas and send photo to our office for review.
