Re: Shops at Don Mills System Upgrades Maintenance and Equipment Testing 1090 Don Mills, RBC Tower Toronto, Ontario Our Reference #21-061-001

ELECTRICAL FIELD REVIEW REPORT

Re: 1090 Don Mills Road Substation Maintenance Report

Re: 1090 Don Mills Road IR Scanning Report

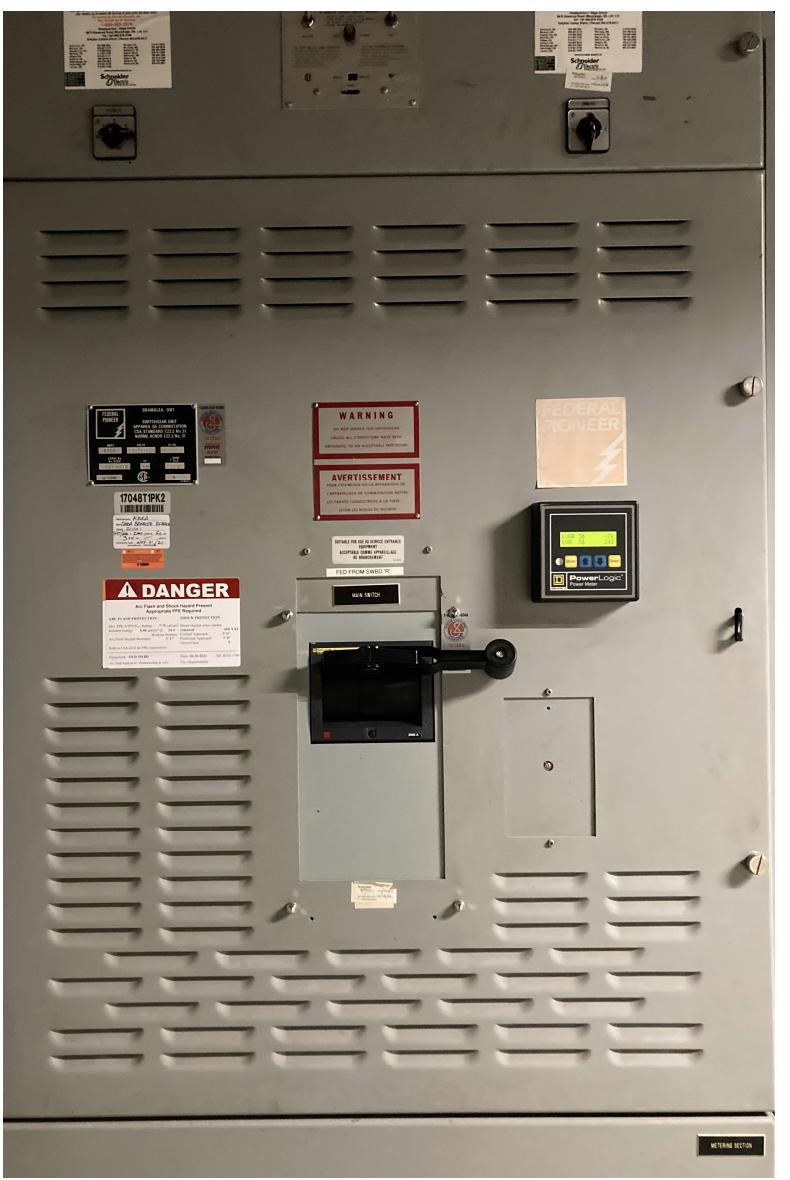
Photo Records:

- 1. H&J went on site to confirm new breaker install and electrical equipment in good order.
- 2. We reviewed the newly installed equipment that is to replace the original one and found the installation in order.
- 3. At the time of our review H&J delivered and applied new arc flash labels for the main electrical equipment.
- 1. Items requiring contractor's attention:
 - 1.1. Final document submission one package to include all documents 2021-11-20

Picture 1: New sub-main breaker switch installed in the original Federal Pioneer equipment.

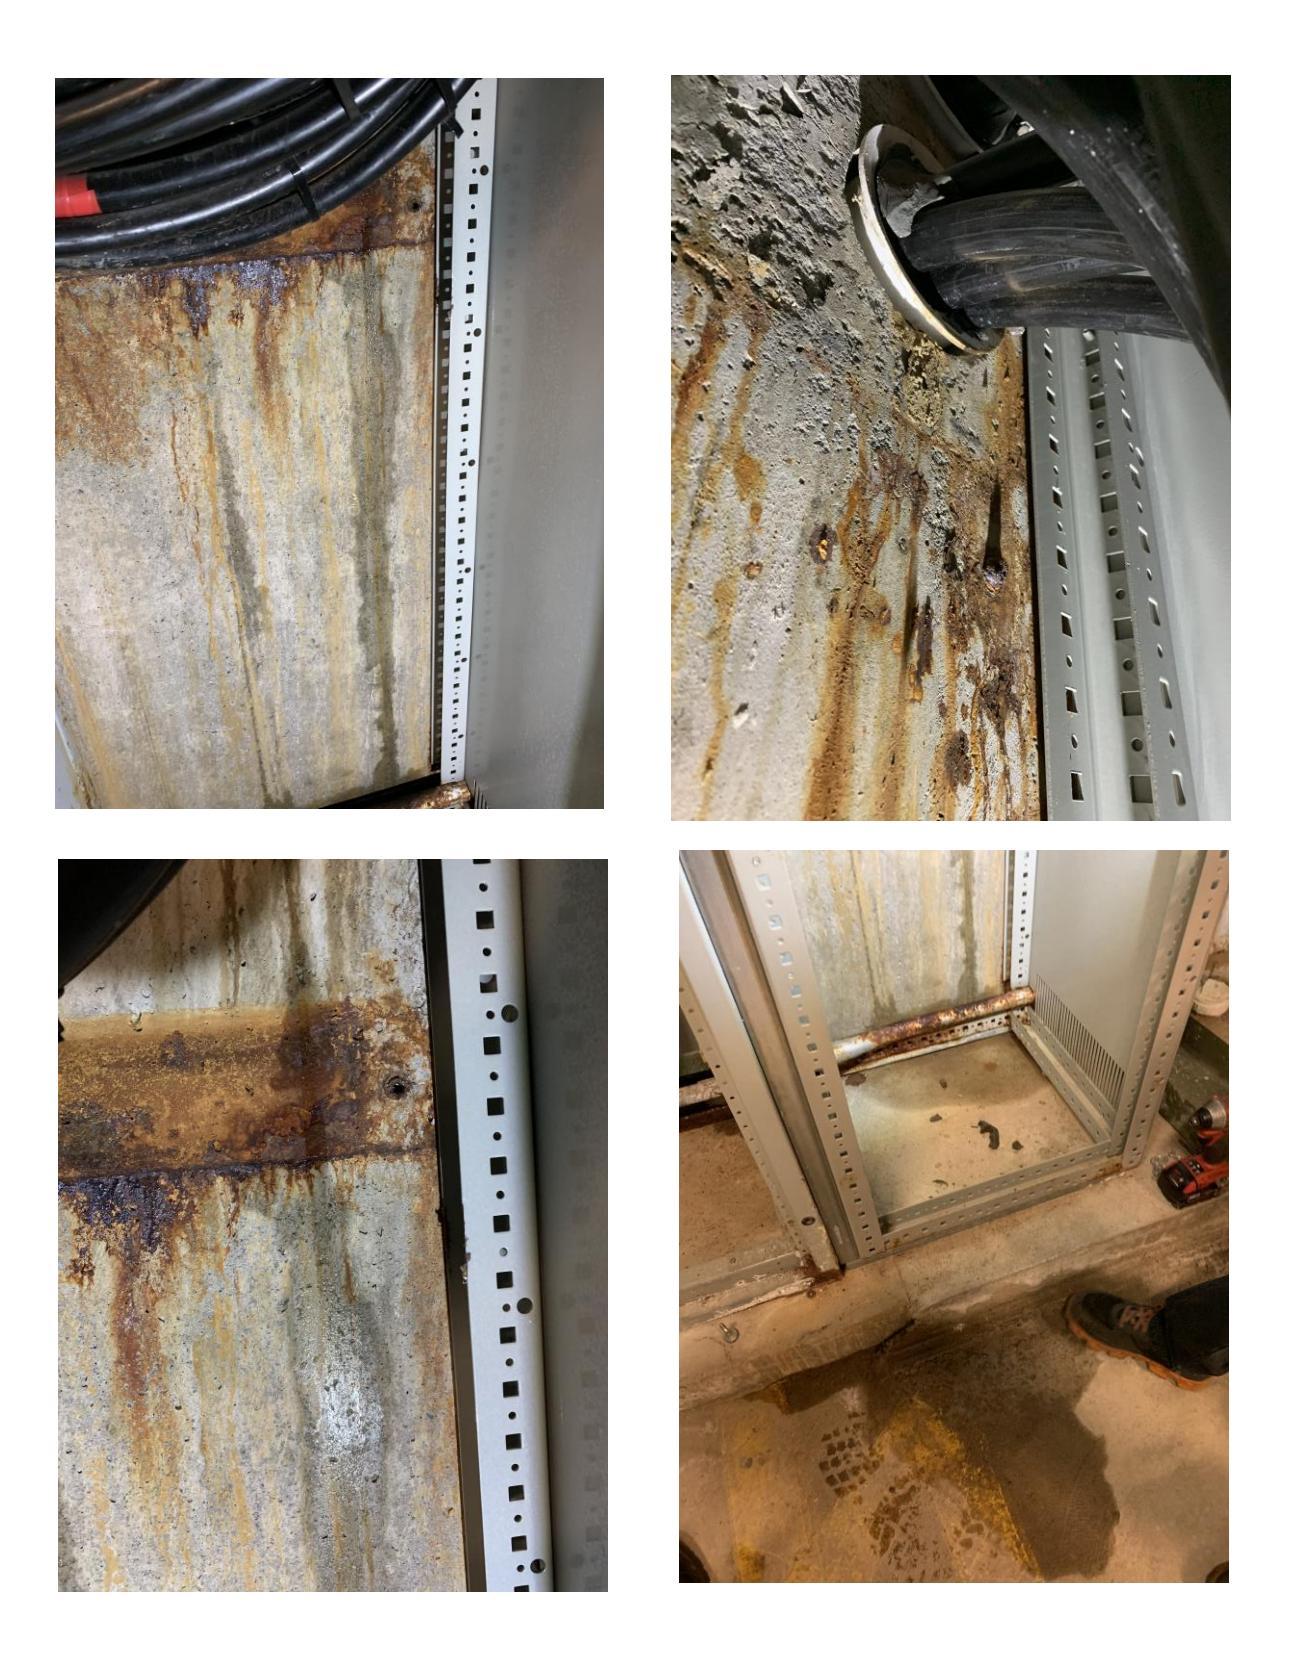
SWITCHBOARD 'R'

- i. Regarding Switchboard R
 - i. Presence of rust found at the bottom part of switchboard during visual inspection
 - ii. Presence of water dripping at the back of switchboard and main incoming conduit

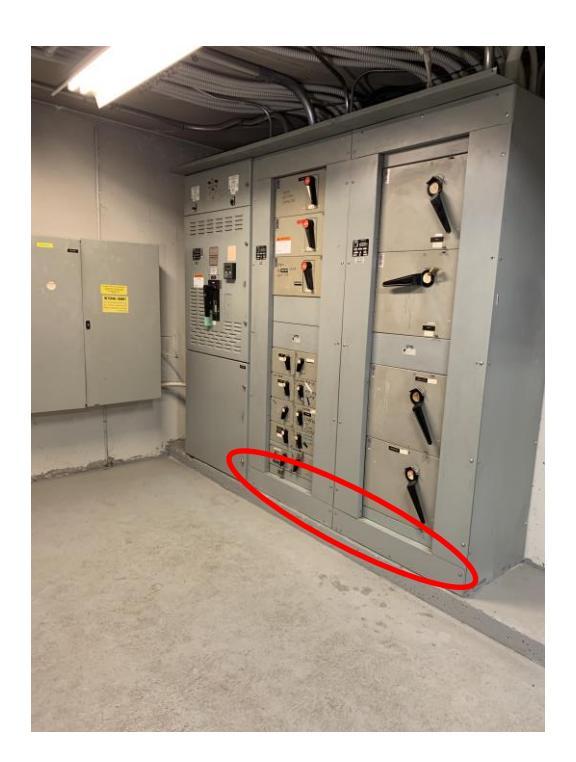
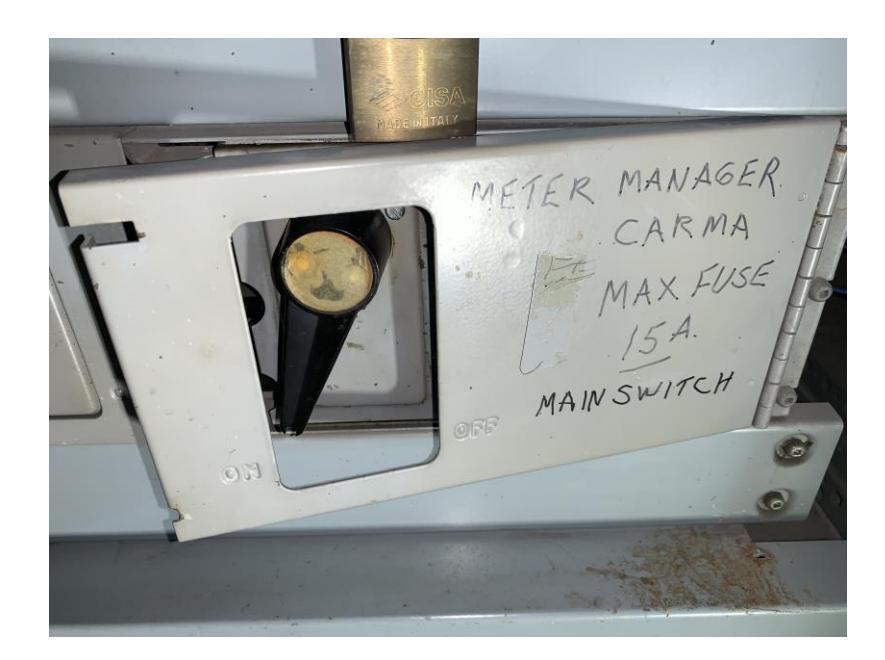
OLD ELECTRICAL ROOM SWITCHBOARD

- ii. Regarding Old Electrical Room Switchboard
 - i. Presence of rust found at the bottom part of switchboard during visual inspection
 - ii. Associated disconnect and its compartment too dirty and dusty

2) SWBD too dirty.

3) Rust found on the bottom side of SWBD.

- i. Old electrical room switchboard and disconnects are in very poor condition. It is strongly recommended that the existing switchboard to be replaced/modified to be updated with breakers instead of disconnects to increase facility reliability, as well as improved arc flash protection of equipment and personnel.
- ii. Regarding Switchboard R
 - i. Switchboard needs to be replaced due to high amounts of rusting and water leakage (see pictures)
- iii. Regarding 'RP-2C' in 'PP-2HH' Level 2
 - i. No access to tenant space to allow for further investigation as to what caused damage to cable prior to correction.
- iv. Thermal re-scanning of equipment noted with issues was based on its available load.

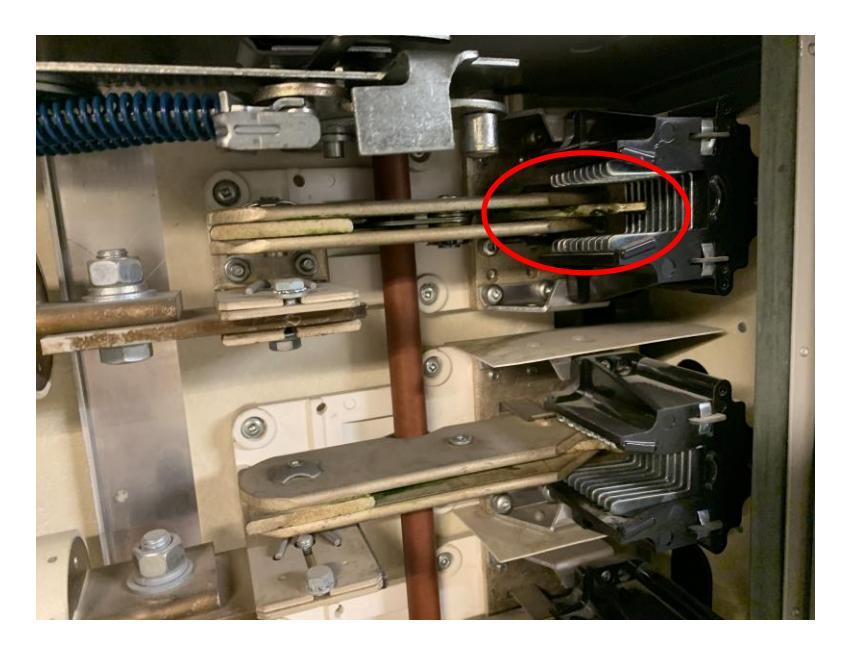
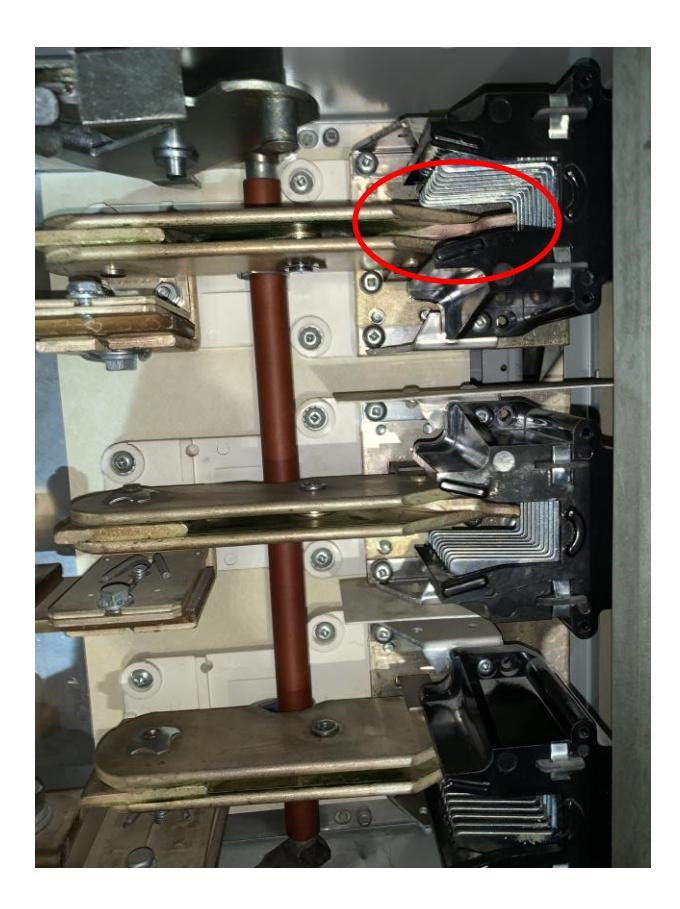
<u>'CHILLER' DISCONNECT</u>

- 1) Regarding 'Chiller' Disconnect Sub Main Electrical Room
 - a. Sign of pitting observed in one of the disconnect blades
 - b. Hot spot found at the point of pitting

- c. Recommend isolation of disconnect for detailed inspection and cleaning and then re-scanning
- 2) Regarding 'RP Busduct' Disconnect Level 2
 - a. Amperage recordings of:

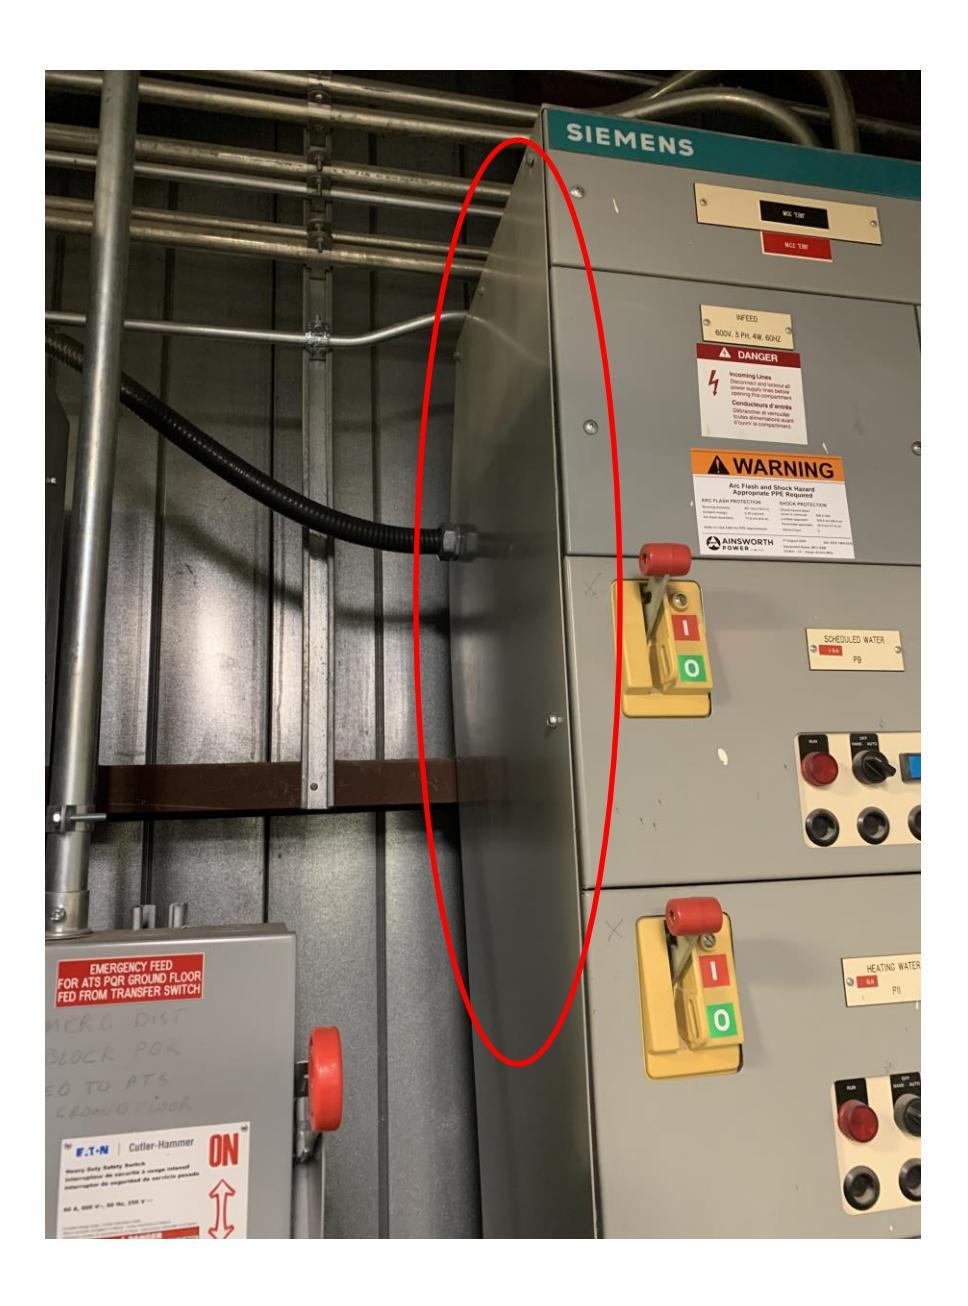
MCC 'EBB':

- ii. 2 Blown fuse found at 'Cooling Tower Heater'. Subsequently, replaced with 3 new fuses (supplied by client)
 - iii. MCC side cover is bended

2) 2 Blown fuse found in Cooling Tower Disconnect.Subsequently replaced 3 fuses.

4) Side cover found bend.

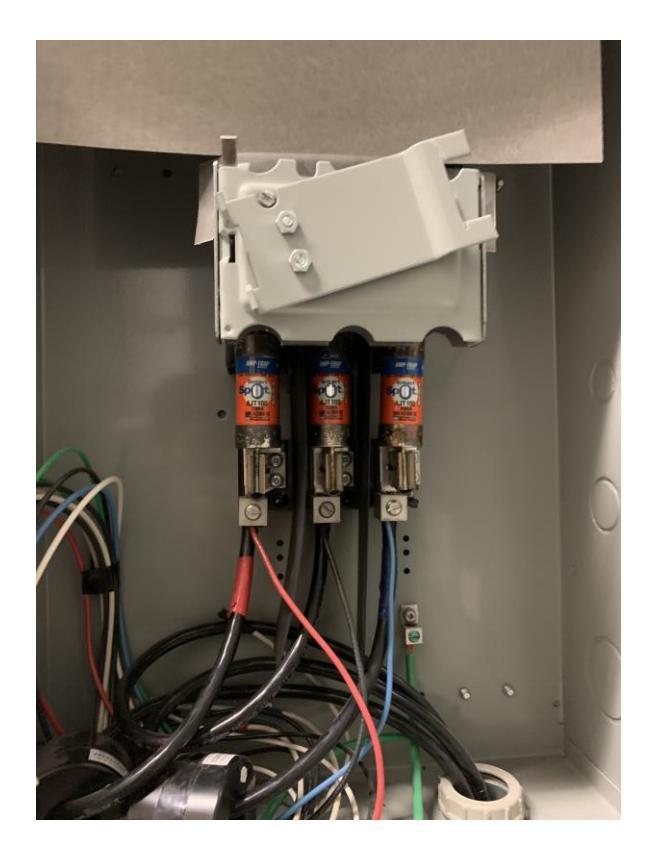
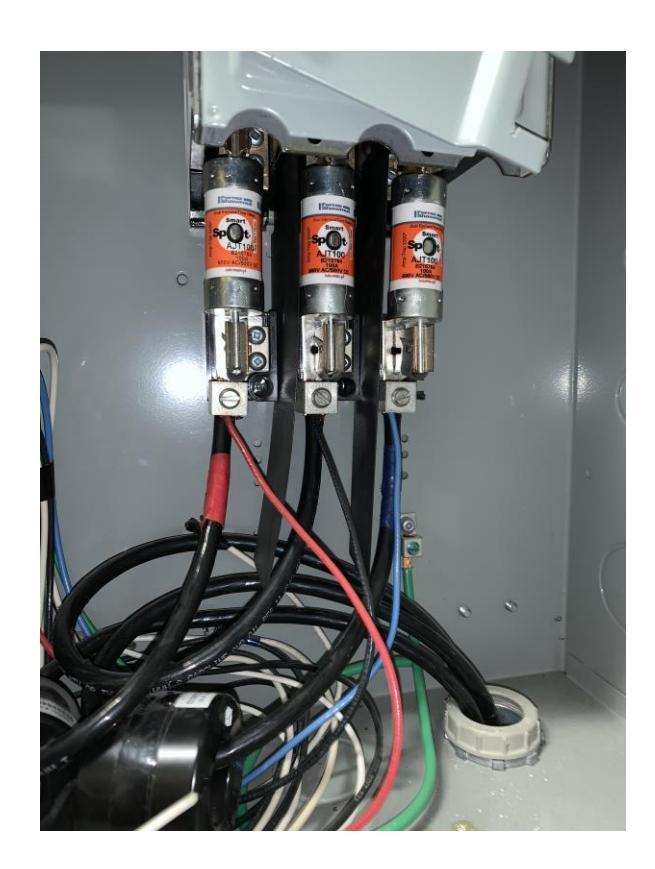
<u>'RP-BUSDUCT' DISCONNECT – LEVEL 2</u>

- i. A: 50A / B: 52A / C: 43A
 - b. Recommend isolation of disconnect for detailed inspection and cleaning, as well as supply and install of replacement fuses, and then re-scanning

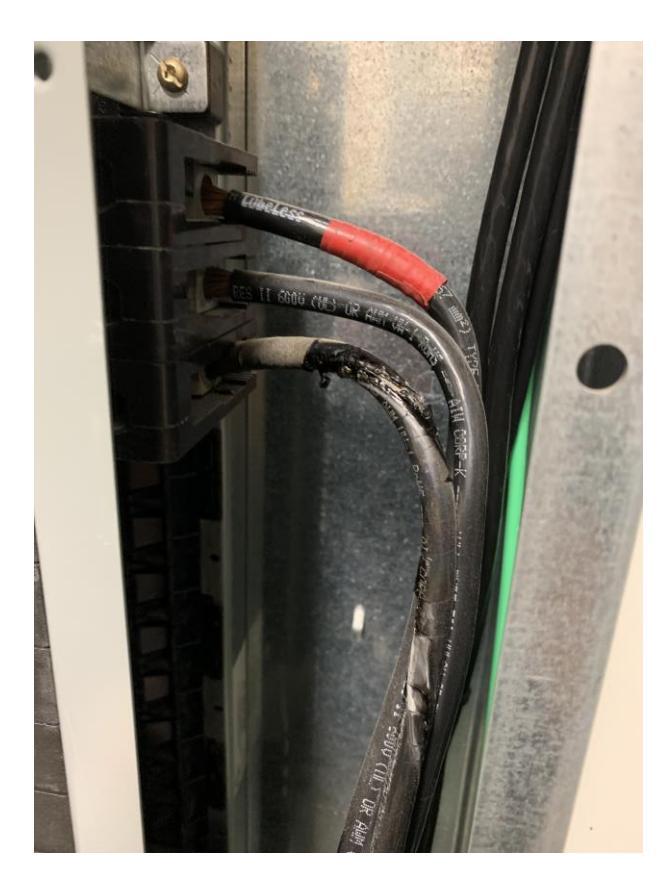
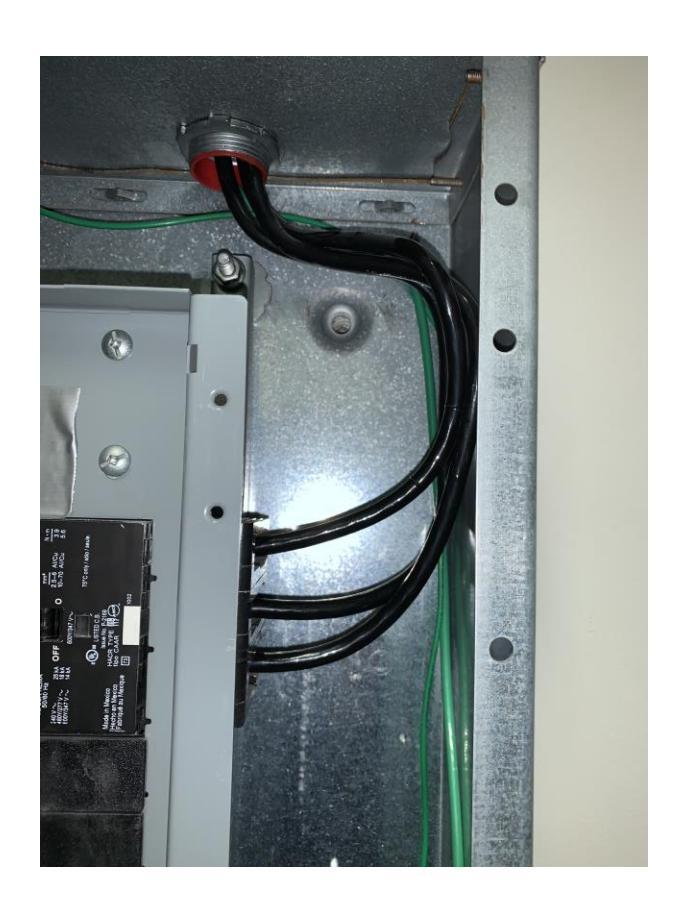
<u>'RP-2C' – LEVEL 2</u>

- 3) Regarding 'RP-2C' in 'PP-2HH' Level 2
 - a. Melted cable insulation found
 - b. Recommend isolation to allow for detailed inspection of cable, as well as tracing of cable route for installation of new cable

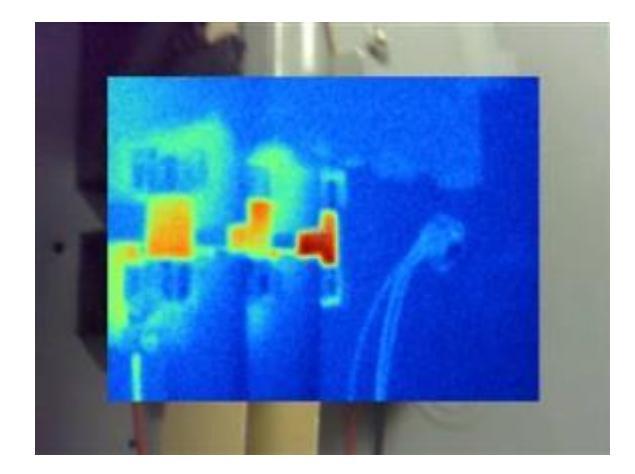
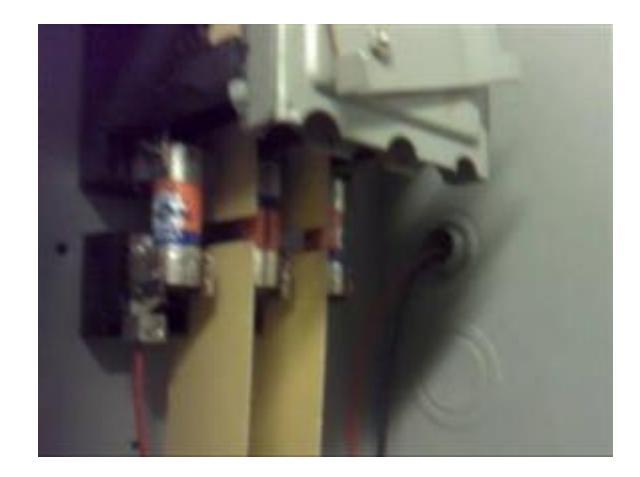
| Name | TX RP-6B PD (20A) - Level 6 |

- 4) Regarding 'RP-6B' Disconnect Level 6
 - a. Amperage recording of:
 - i. A: 5.5A / B: 5.5A / C: 6.5A
 - b. Recommend isolation of disconnect for detailed inspection and cleaning and then re-scanning
